# New Gen Cascadia with Cruise Inop and Brake Lights on Due to Double Check Valve Mounted Improperly

Discussion created by Nahum Veach on Jul 25, 2018  
Latest reply on Sep 13, 2018 by Austin Musicant

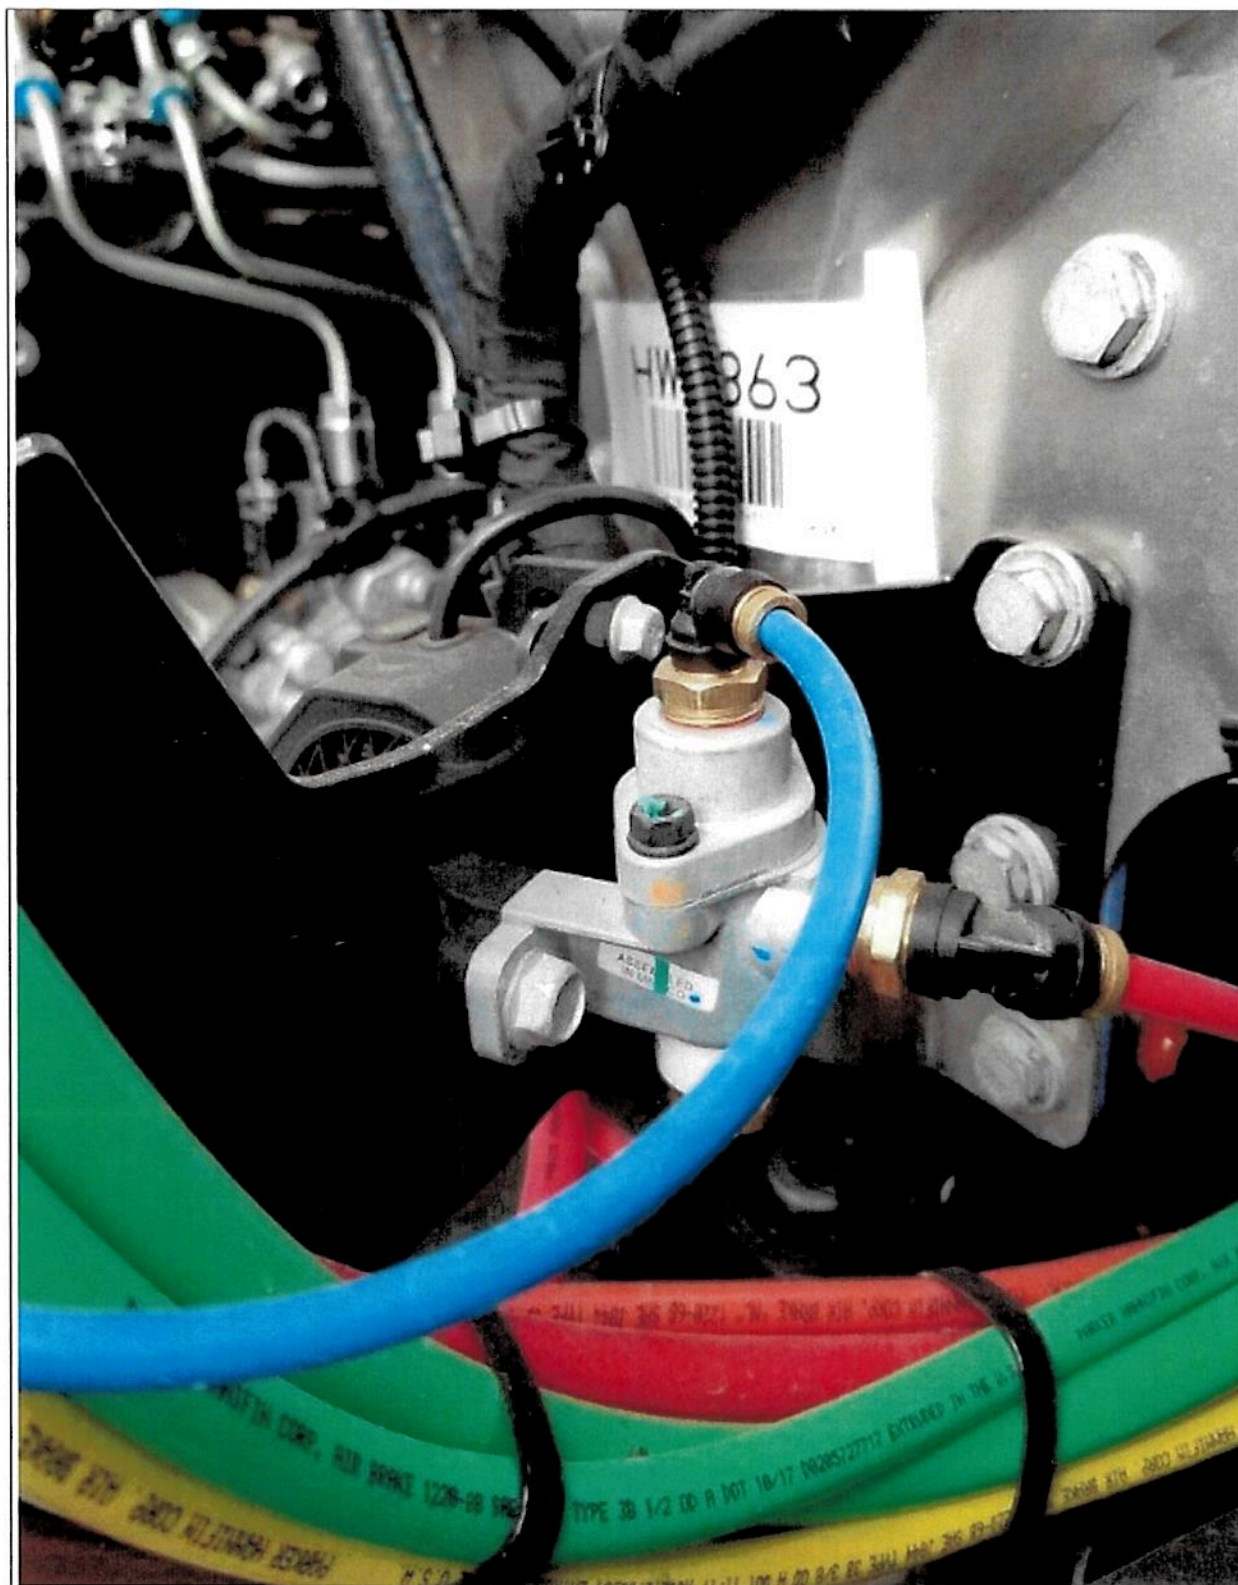
New Gen Cascadia with the brake light problem, last six of vin JL1052 and miles on unit 48,552. This unit came in for cruise control not working. Found on test drive with computer hooked up that when cruise would stop working that brake pedal would show depressed even though it was released. We thought it had a faulty brake light switch because when it would not read correctly the normally closed 3.5 psi switch would read open. We changed the brake light switch and found the normally open side had excessive resistance (switch was faulty). We then found that the normally closed side of the switch would read open when pedal was released and brake lights would be stuck on (with new switch installed). We suspected another faulty switch. We found that when this would happen, that if we unplugged the orange 1/4 application line from outside of the pass thru it would have a small amount of air trapped in it. Once line was unplugged and the pressure was released, brake lights would turn off and the switch would read correctly. So we had to find out what was causing the air to be trapped in the 1/4 application line. First we found that the abs modulator valve at the trailer protection valves was not exhausting when the pedal was released (as compared to multiple other similar trucks). Replaced the abs modulator valve, now it exhausts when pedal is released, but air still trapped in application line, closing the stop lamp switch contacts. We contacted FTL support and started a case looking for advice. Support suggested a foot valve. Before we condemned the foot valve, wanted to prove air was staying in any of the lines off of the foot valve. Found that the green line did not have air on it when "broken", but the red air line did. We found if we bypassed the double check valve for the trailer hand valve by hooking the two 3/8" red air lines together that it would function correctly and the brake lights would not stick on. So we installed new double check valve think that it was sticking. we found it still was having same issue. We found that how the double check valve was mounted that when the brake pedal was released and the air would exhaust from the system the double check valve being mounted vertically it would close and trap a small amount of air in the system. The valve is a Bendix valve so we contacted Bendix tech support and gave them the part number of the valve, and told them what we thought was happening, and suspected the valve is mounted incorrectly. They advised that the part number we gave them it needs to be mounted HORIZONTALLY because it is a non-bias valve (does not have a return or centering spring inside). We mounted the valve horizontal and it fixed the problem.
