Bulletin No.: PIC4996A Published date: 11/26/2018

# PIC4996A Tips for Servicing Fuel Level Sensors/ Fuel Gauge Inoperative or Inaccurate

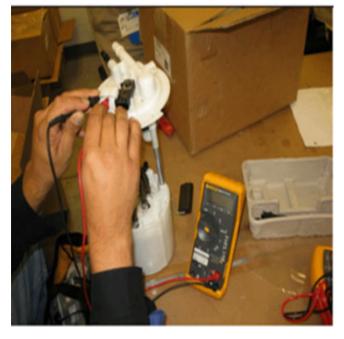
If the SI diagnostic leads to a potential level sensor failure at the component, test the circuit from the connector at the top of the fuel module

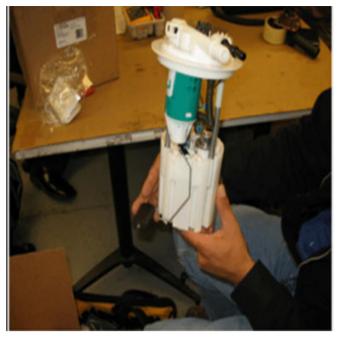
When testing the sweep of the fuel level sensor, slowly sweep the float arm from the empty position to the full position watching the ohm meter looking for a momentary O.L. or open reading. You should see the sweep range from approximately 40 ohms to 250 ohms, + or - 5 ohms.

Note: Do not remove the fuel level sensor from the fuel module unless you get a faulty reading during the testing of the sensor. This may cause damage to the fuel level sensor unnecessarily.

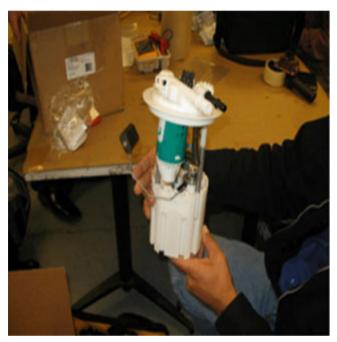
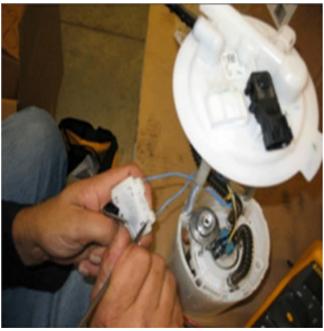
If during testing you identify a faulty sensor, remove the sensor from the unit by lightly prying the lock tab on the fuel level sensor body inside the fuel level module.

Once sensor is removed from assembly carefully depress lock tabs on both sides of the sensor to remove the terminals from the fuel level sensor assembly.

Install terminals into a new fuel level sensor.

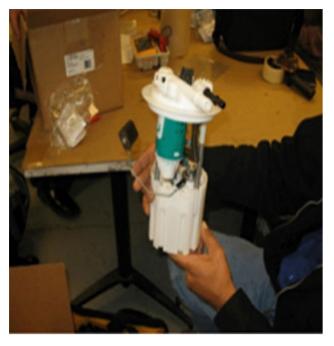
Carefully, install new fuel level sensor into module. Perform the sweep test again with your meter leads on the connector at the top of the fuel level module.

Upon a successful sweep test, reinstall module into the fuel tank, reassemble the components and verify successful repair.

If the sweep test fails with the new fuel level sensor installed replace the complete fuel module.
