Technical Service Bulletin

GROUP	NUMBER
AUTOMATIC TRANSMISSION	18-AT-016
DATE	MODEL
NOVEMBER 2018	SONATA (LFa) 2.0T SANTA FE (TMa) 2.0T/2.4L

AUTOMATIC TRANSAXLE SOLENOID DTC P074100, P074300, P074800, P075300, P075800, P076300, P076800, P077300 & P270900

This TSB supersedes TSB 17-AT-006 to revise the Service Procedure (Steps 29~31) and add the 2019 Santa Fe (TMA)

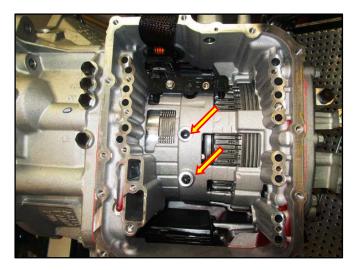
18. Confirm two O-rings are installed correctly in the case.

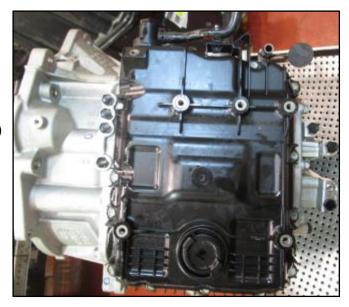
23. Install a new gasket to the oil pan and reinstall the pan.

Install 14 bolts to the pan and tighten the bolts to specification.

Torque: 8~10 lb.ft (1.2~1.4 kgf.m/12~13 N.m)
