# Service Campaign Bulletin

Campaign No. 2018070001, July 2018

SUBJECT: **C-Class (205) Model Year 2017 and 2018**  
**Check Windshield Wiper Transmission, Replace if Necessary**

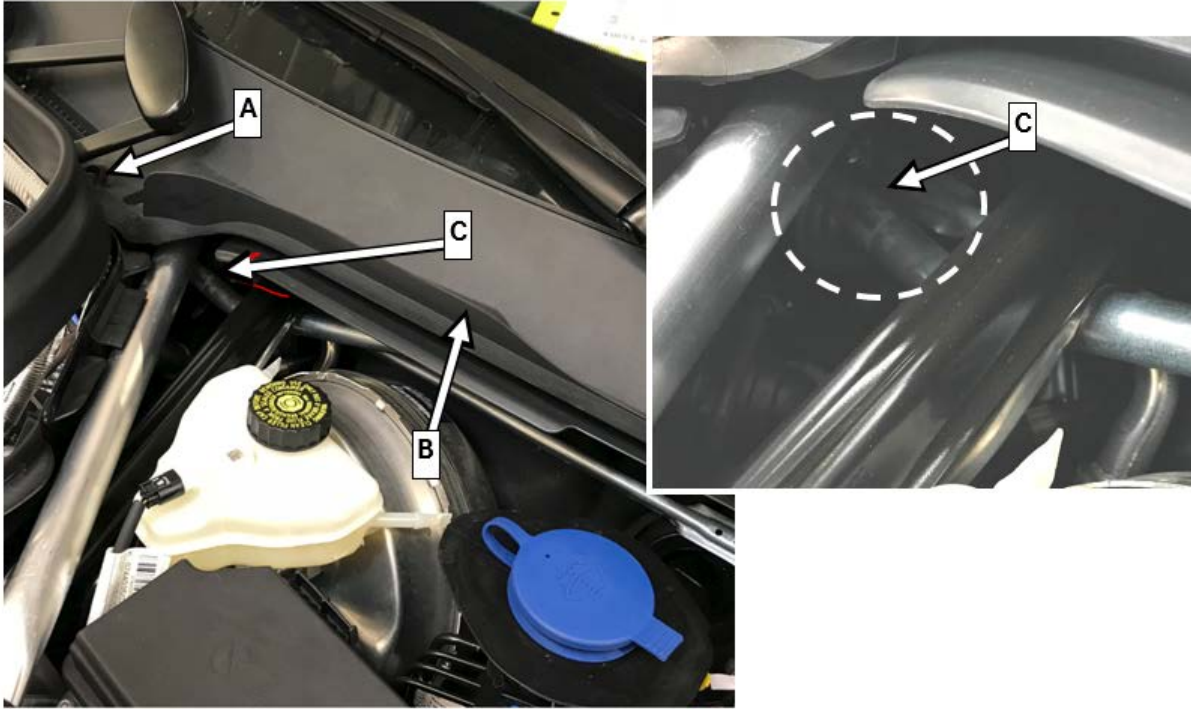
Figure 1

1. Remove cover over the brake unit in the engine compartment.
2. Remove attachment rivet (**A, figure 1**), slightly lift the water collector (**B, figure 1**) and read the manufacture date of the windshield wiper system (**C, figure 1**).
  - a. If production date is between May 31, 2017, to August 3, 2017: **Carry out work procedure.**
  - b. If production date is **NOT** between May 31, 2017, and August 3, 2017: **End measure.**
