December 20, 2018

Version 11

Warranty Extension: MIL Comes On with DTCs P0301 thru P0304**Supersedes 13-078, dated June 13, 2018, to revise the information highlighted in yellow.****AFFECTED VEHICLES**

Year	Model	Trim	VIN Range
2008-12	Accord	ALL V6 A/T	Check the iN VIN status for eligibility.

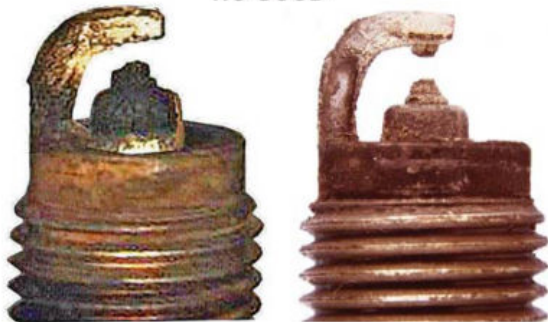
2. Remove and check the spark plug(s) on the affected cylinders (example: if P0301 is stored, check the spark plug on cylinder No. 1).

Are the spark plug(s) fouled?

GOOD

NO GOOD

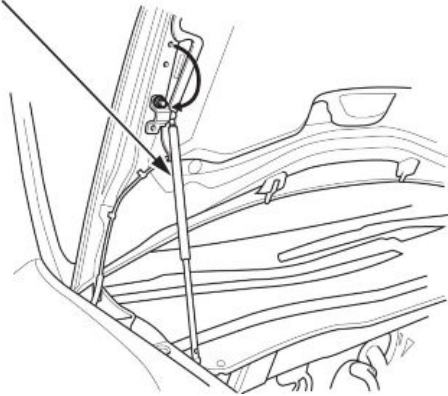
HOOD SUPPORT STRUT

- Use fender covers to avoid damaging painted surfaces.
 - To avoid damaging any wires and terminals, unplug the circuit connectors carefully while holding the connector portion.
 - Mark all the circuits and hoses to avoid misconnection. Make sure they do not contact other circuit wiring, hoses, or interfere with other parts.
1. Using both hood support struts, prop up the hood in a wide-open position.

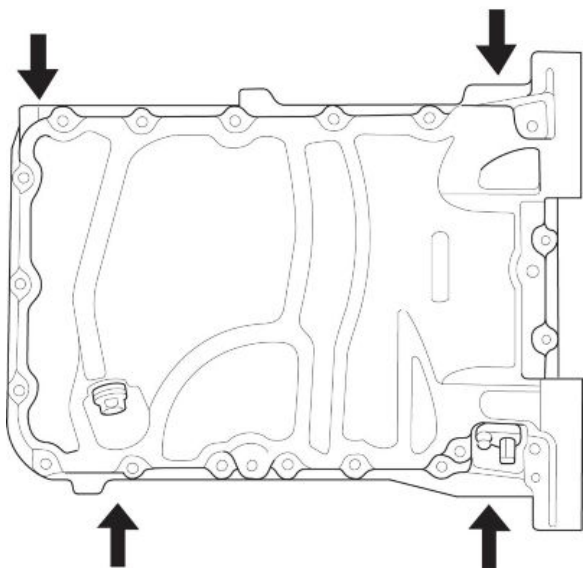
48. Using a flat blade screwdriver, separate the oil pan from the engine block in the areas shown.

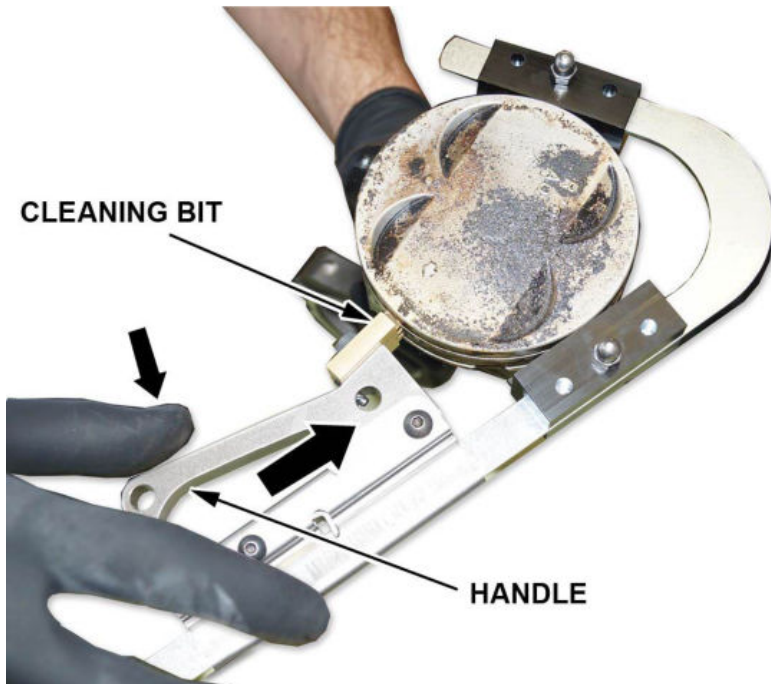
4. Press the handle on the piston ring groove cleaner tool and slide the cleaning bit onto the appropriate piston ring grooves.

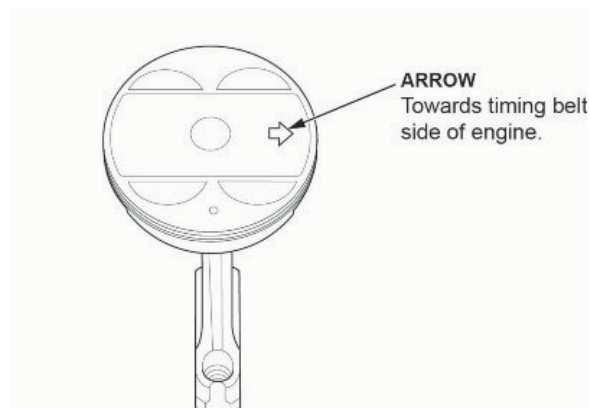
13. Install the piston/connecting rod assembly into the cylinder bore with the arrow on top of the piston facing the timing belt side of the engine.

Be careful not to damage the cylinder wall when installing the piston.
