## Warranty Extension: MIL Comes On With DTCs P0301 thru P0304

Supersedes 13-080, dated June 13, 2018, to revise the information highlighted in **yellow**.

| Year | Model | Trim | VIN Range |
|---|---|---|--|
| 2008-10 | Odyssey | EX-L, Touring | Check the iN VIN status for eligibility. |

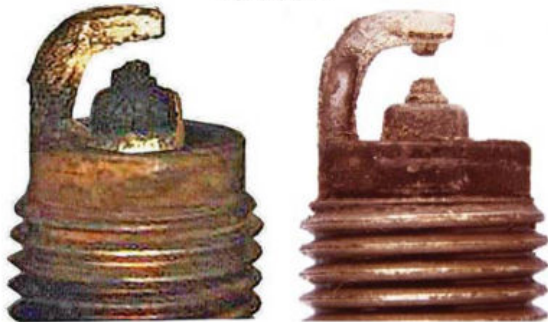
2. Remove and check the spark plug(s) on the affected cylinders (example: if P0301 is stored, check the spark plug on cylinder No. 1).

*Are the spark plug(s) fouled?*

**GOOD**

**NO GOOD**

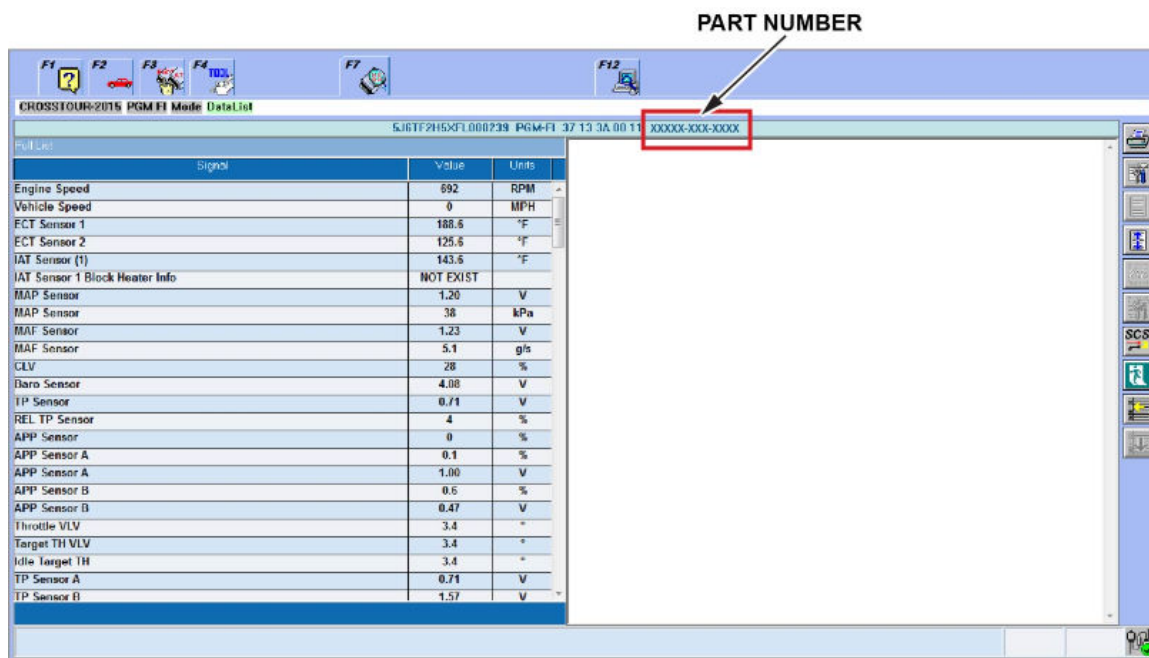
- Check the PCM software version P/N located above the PGM FI Data List.

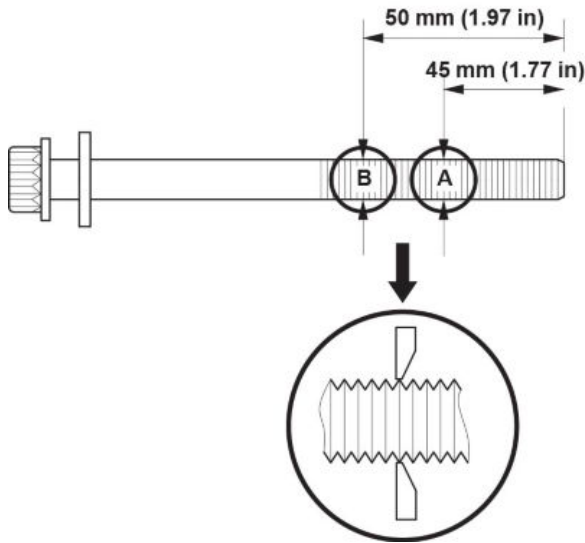
41. Measure the head bolts to determine if they need replacement. If either diameter is less than **11.3 mm (0.445 in.)**, replace the cylinder head bolt.

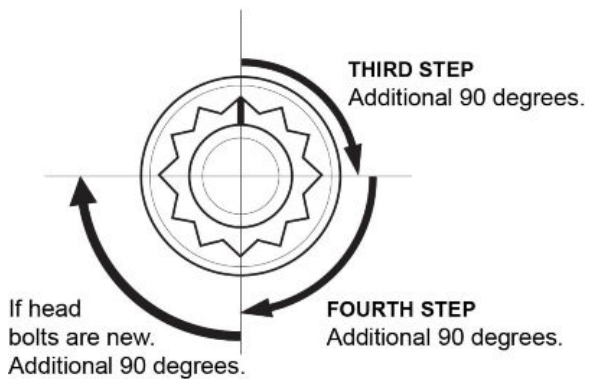
#### NOTES

- 41.1. Apply new engine oil to the threads and under the bolt heads.
- 41.2. Torque the cylinder bolts in sequence to **29 N•m (22 lb-ft)**.
- 41.3. Tighten in sequence an additional **90 degrees** (third step).
- 41.4. Tighten in sequence an additional **90 degrees** (fourth step).
- 41.5. If the bolts are new, tighten an additional **90 degrees**.

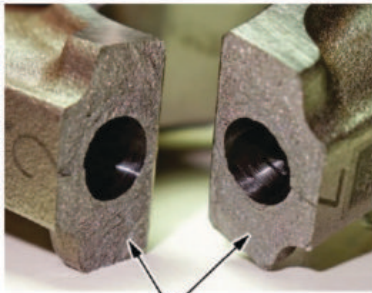
The uneven mating surfaces are uniquely matched and not interchangeable.

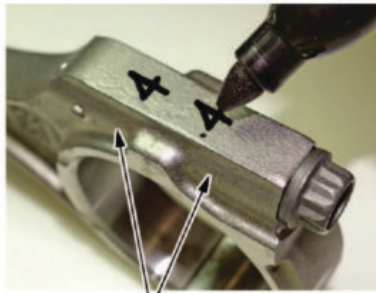
Mark the connecting rod and rod cap with the cylinder number.

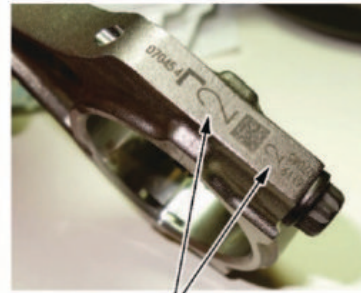
These are manufacturing marks, and do not indicate the cylinder number.

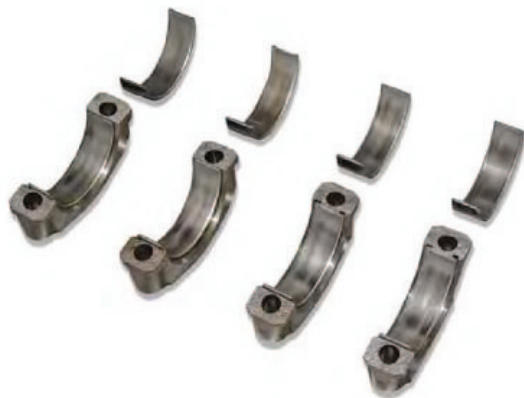
50. Visually inspect all the connecting rod bearing for signs of damage.

- If your fingernail catches on a scratch or groove in the bearing, replace it. Pictured are normal reusable rod bearings after about 35,000 miles. Some discoloration is normal and does not require replacement.
- If the bearings look like they must be replaced, contact your DPSM for authorization.

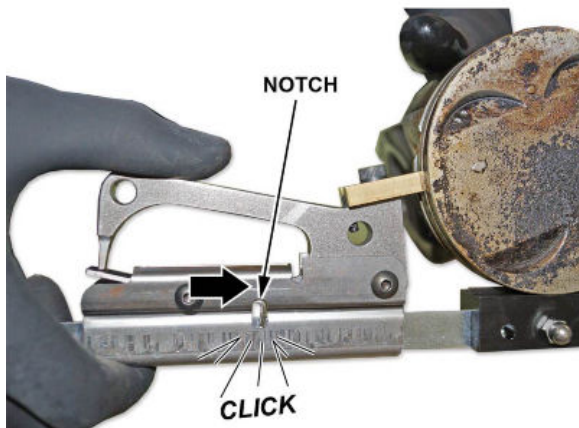
5. Once the cleaning bit is in the appropriate ring grooves of the piston, make sure the tool handle clicks in to place.

There is only one notch on the tool for the handle to engage.

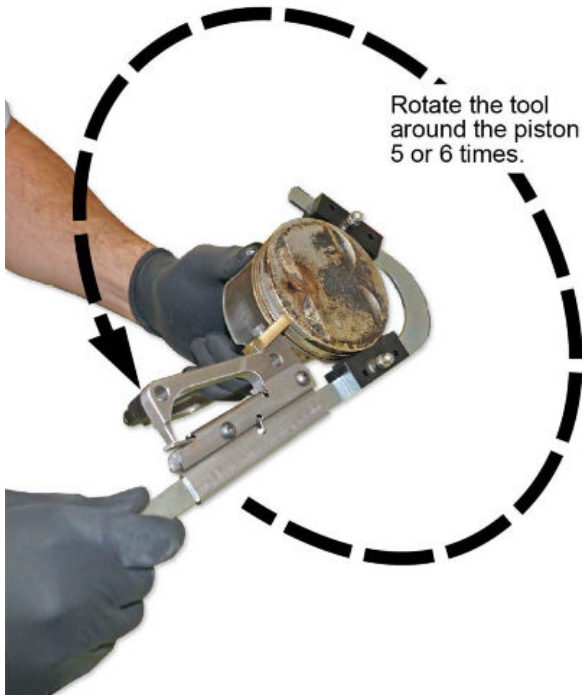
6. Hold the piston steady and rotate the tool counter-clockwise five to six times to remove any carbon deposits in the piston ring grooves. **Do not** rotate the tool clockwise.

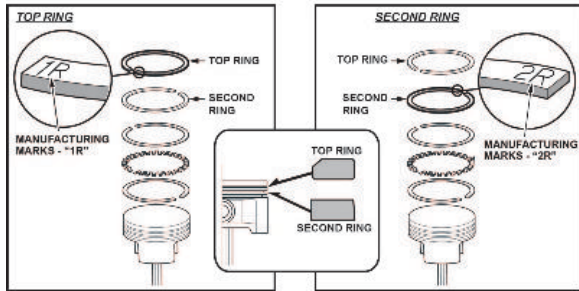
9. Install the piston rings as shown.

The first (top) ring has a 1R manufacturing mark and the second (middle) ring has an 2R manufacturing mark. The manufacturing marks must be facing upward.

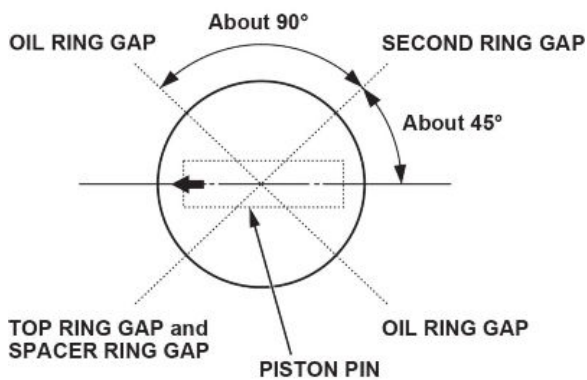
10. Rotate the rings in their grooves to make sure they do not bind.  
11. Position the ring end gaps as shown.

If the ring gaps are not positioned correctly, excessive blowby may occur.

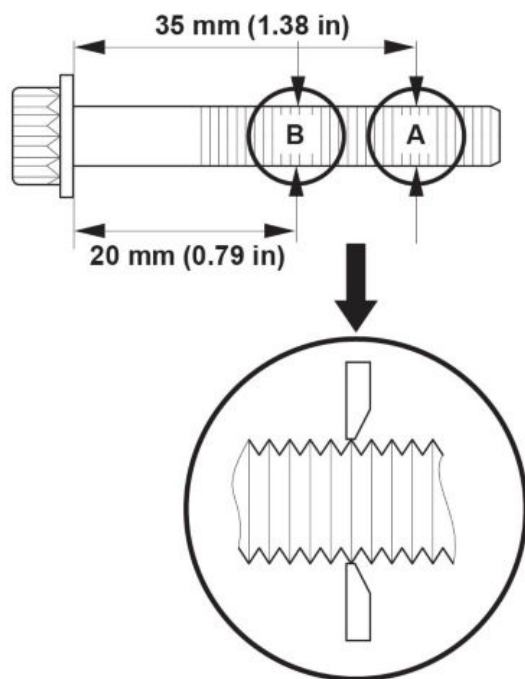
16. Stop after the ring compressor pops free, and check the connecting rod-to-rod journal alignment before pushing the piston into place.
17. Measure the diameter of the connecting rod bolts to determine if they need replacement. Calculate the difference in diameter between point A and point B. It should not be more than **0–0.1 mm (0–0.004 in)**.

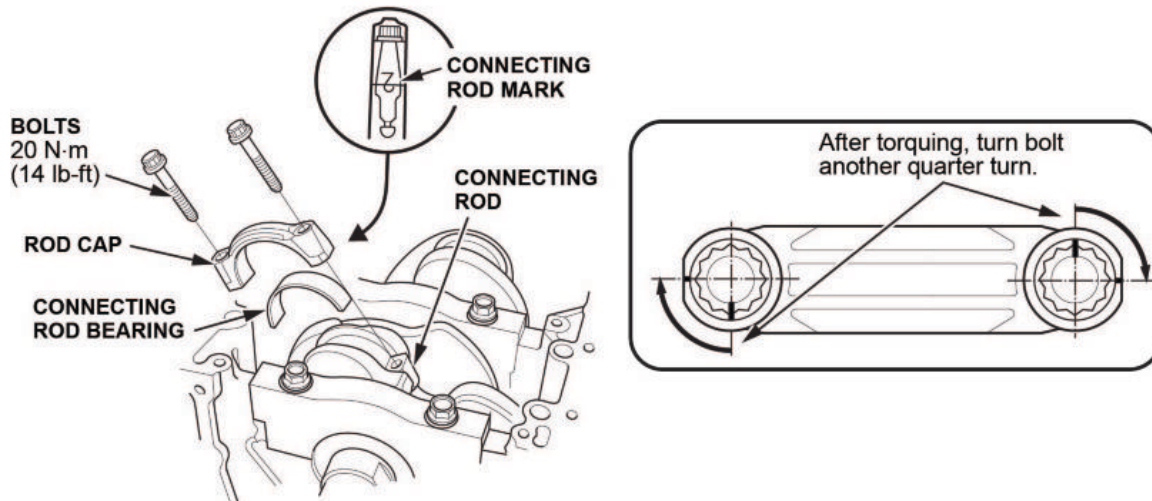
18. Apply new oil to the connecting rod bolt threads and flanges. Torque the bolts to **20 N•m (14 lb-ft)** then tighten the connecting rod bolts an additional **90 degrees**.
