# HVAC Evaporator Drain Hose Clogged Due to Insect Intrusion

**Service Category** Vehicle Interior

**Section** Heating/Air Conditioning

## Introduction

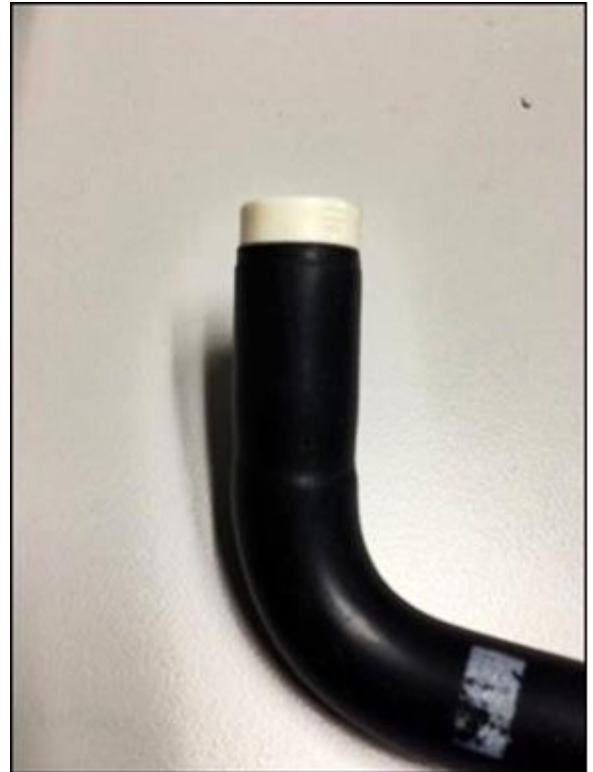
Figure 1

1. Follow the instructions provided in the Safety Requirements for Handling the ARINIX® Tip (Water Hose Connector) section of this bulletin.
2. Locate the HVAC evaporator drain hose.
3. Following the vehicle specific Repair Manual, remove the HVAC evaporator drain hose.
4. Put on all necessary PPE and install the ARINIX® Tip (Water Hose Connector) into the NEW HVAC evaporator drain hose listed in the Parts Information section of this bulletin.
5. When installing the ARINIX® Tip, verify it is fully seated in the HVAC evaporator drain hose as shown in Figure 1.
6. Following the vehicle specific Repair Manual, install the HVAC evaporator drain hose.

1. Follow the instructions provided in the Safety Requirements for Handling the ARINIX® Tip (Water Hose Connector) section of this bulletin.
2. Locate the HVAC evaporator drain hose.
3. Following the vehicle specific Repair Manual, remove the HVAC evaporator drain hose.
4. Put on all necessary PPE and install the ARINIX® Tip (Water Hose Connector) into the NEW HVAC evaporator drain hose listed in the Parts Information section of this bulletin.
5. When installing the ARINIX® Tip, verify it is fully seated in the HVAC evaporator drain hose as shown in Figure 1.
6. Following the vehicle specific Repair Manual, install the HVAC evaporator drain hose.

6. When installing the ARINIX® Tip, verify it is fully seated in the HVAC evaporator drain hose as shown in Figure 1.
7. Following the vehicle specific Repair Manual, install the HVAC evaporator drain hose.

1. Follow the instructions provided in the Safety Requirements for Handling the ARINIX® Tip (Water Hose Connector) section of this bulletin.
2. Locate the HVAC evaporator drain hose.
3. Following the vehicle specific Repair Manual, remove the HVAC evaporator drain hose.
4. Before installing the ARINIX® Tip (Water Hose Connector) into the original HVAC evaporator drain hose, the end of the hose **MUST** be cut perpendicular as shown in Figure 2.
5. Put on all necessary PPE and install the ARINIX® Tip into the original HVAC evaporator drain hose listed in the Parts Information section of this bulletin.
6. When installing the ARINIX® Tip, verify it is fully seated in the HVAC evaporator drain hose as shown in Figure 1.
7. Following the vehicle specific Repair Manual, install the HVAC evaporator drain hose.

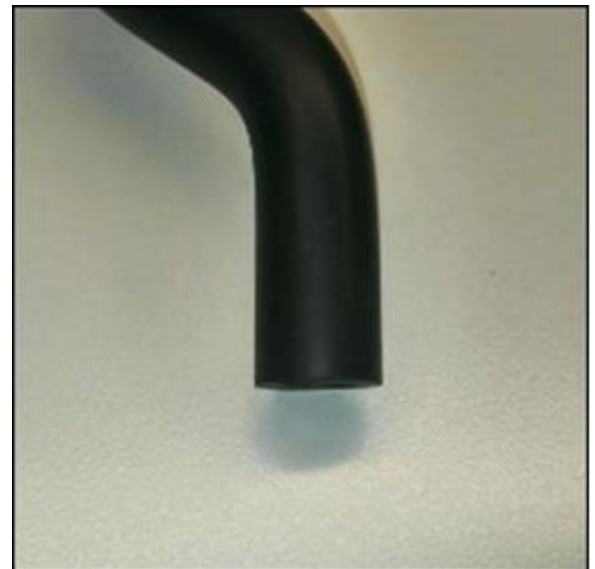
Figure 2

1. Follow the instructions provided in the Safety Requirements for Handling the ARINIX® Tip (Water Hose Connector) section of this bulletin.
2. Locate the HVAC evaporator drain hose.
3. Following the vehicle specific Repair Manual, remove the HVAC evaporator drain hose.
4. Before installing the ARINIX® Tip (Water Hose Connector) into the NEW HVAC evaporator drain hose, the end of the hose MUST be cut perpendicular as shown in Figure 2.

5. Put on all necessary PPE and install the ARINIX® Tip into the NEW HVAC evaporator drain hose listed in the Parts Information section of this bulletin.
