SERVICE ACTION

Reference number:	SA-10-1127V3	Issued: 23 November, 2018
Subject:	Fuel Filler Latch	
Model(s):	Vantage 19MY	
VIN range:	Refer to the separately published list of Vehicle Identification Numbers (VINs)	
Applicable to:	All Dealers	
Distribute to:	After Sales Manager Executive Manager Service Manager Sales Manager	Warranty Staff Technician(s) Parts Staff

Reason for this Service Action

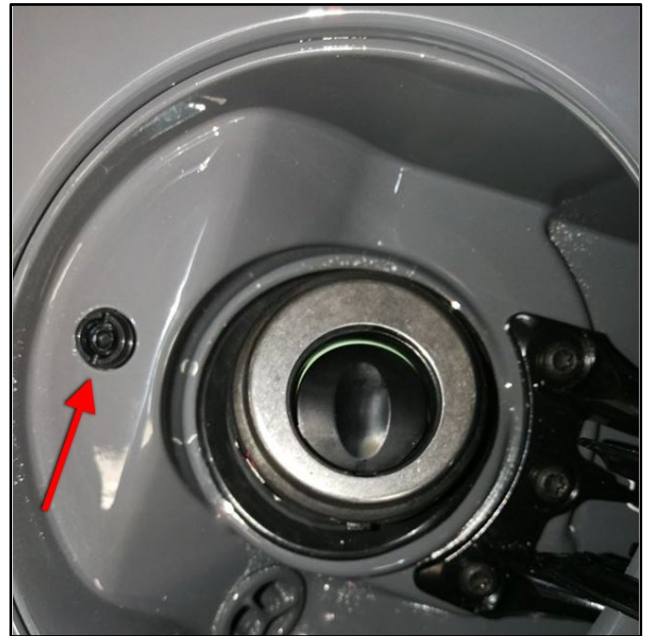
Figure 1

Aston Martin has found that the fuel filler latch mechanism can move out of position. If the fuel filler latch is not in the correct position the fuel filler door will not open or close correctly.

1. **Note: The fuel filler latch is shown by the arrow in Figure 1.**

Open and close the fuel filler door five times to check the operation of the fuel filler latch.

If the fuel filler door does not open or close correctly, do Part B of this Service Action.
