Bulletin No.: PIP5612A
Published date: 12/6/2018

PIP5612A Whistle Noise From The Crank Case

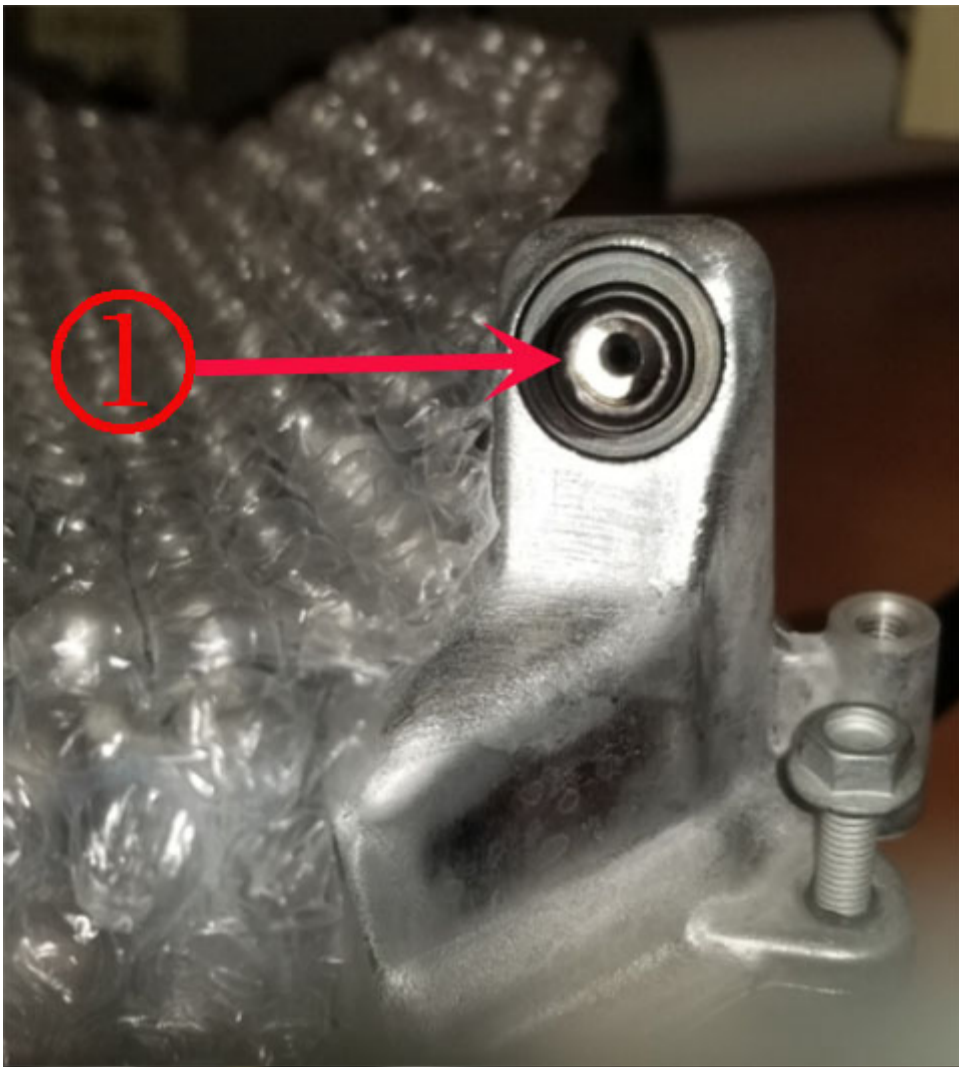
Looking at the PCV port in the left valve cover As seen below.

1. Shows a good PCV orifice

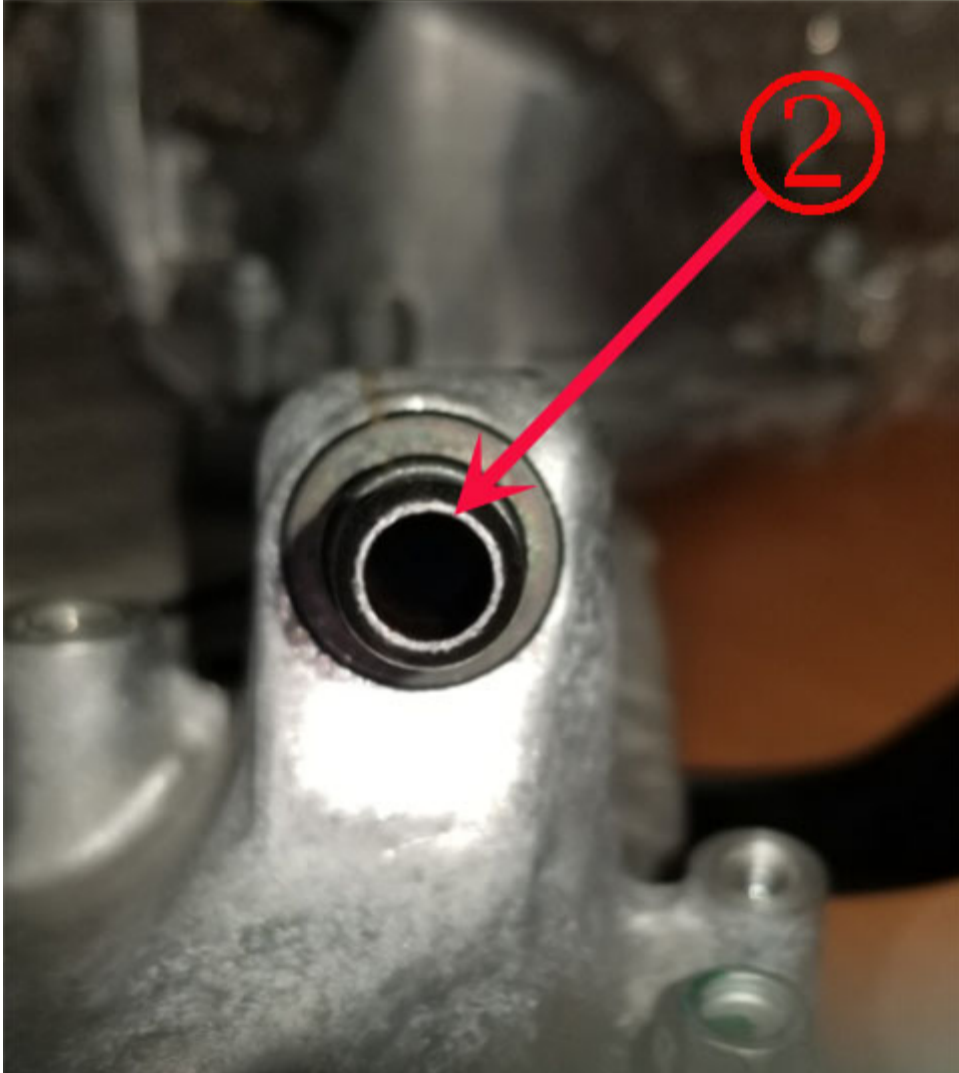
Involved Region or Country	North America
Condition	A vehicle may have a humming , whining or whistle noise from engine bellhousing area.
Cause	This could be caused by a restriction or excessive vacuum in the PCV system.

2. Shows the the PCV orifice missing

If this is found replace the left valve cover.
