Preliminary Information

PIT5646 Aluminum Upper Control Arm Color Differences

Models

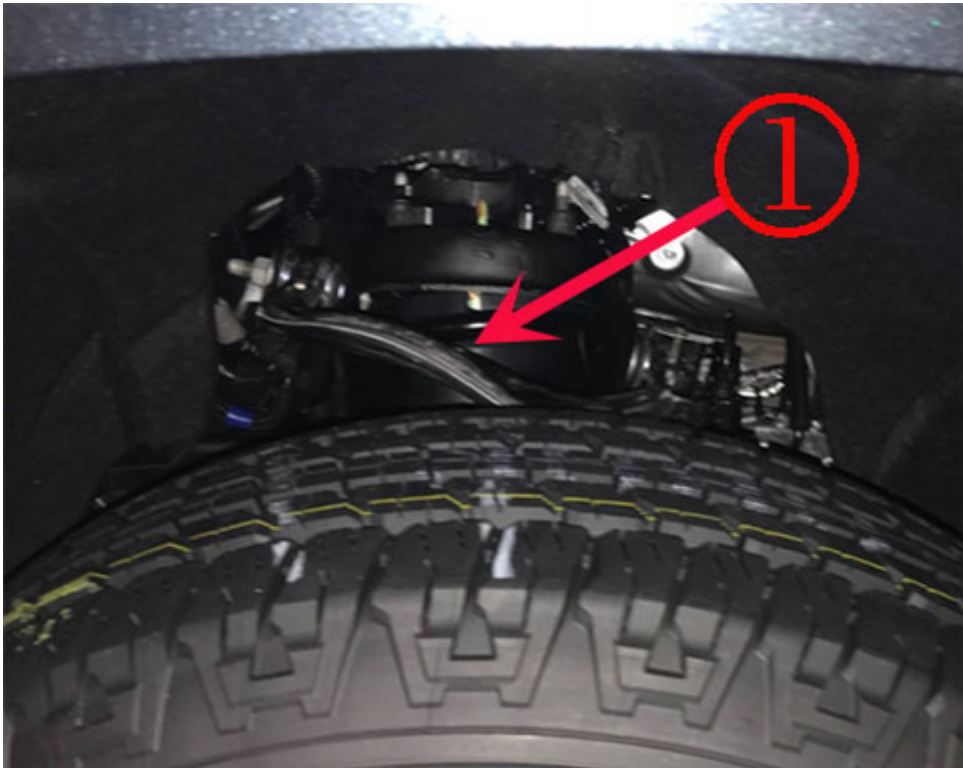
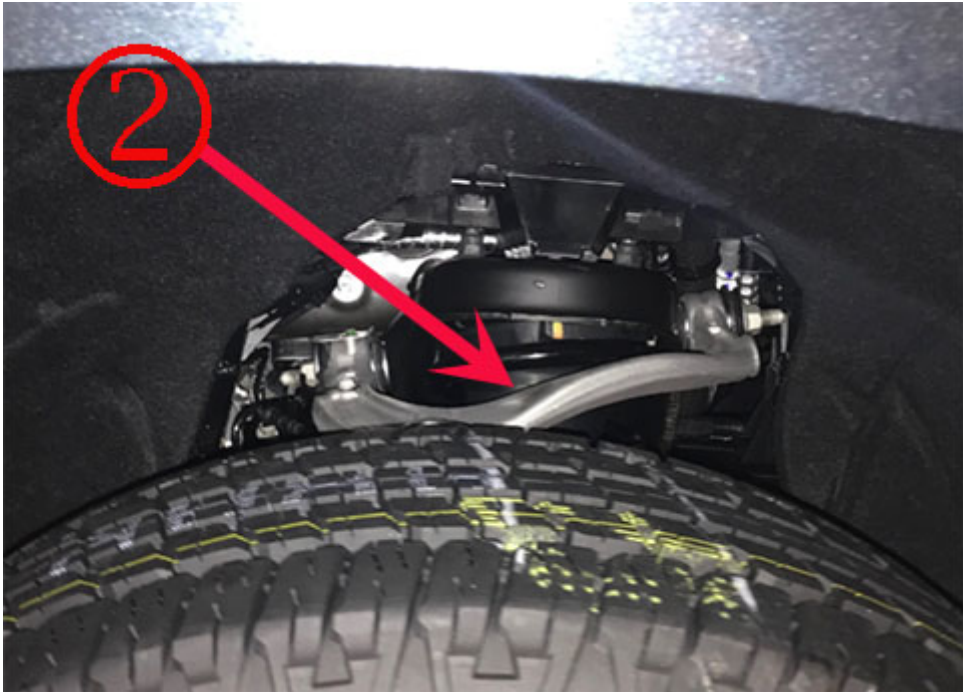
Involved Region or Country	North America
Condition	Some customers may comment that the color of the aluminum upper control arms are different from left to right, or when compared to a like vehicle. Some control arms may have a bright silver appearance (2) and others may have a dark gray appearance (1), shown below .
Cause	There was a change to use a graphite release agent during the casting process of the upper control arms. The use of the graphite release agent will make the control arms have a dark gray appearance.

None, this is purely cosmetic and the control arms should NOT be replaced. As the truck ages, both types of control arms will appear the same color as a layer of aluminum oxidation develops. Going forward, all new production/service control arms will appear dark gray.
