Preliminary Information

PIC6073E Diagnostic Tip: EL-51578 MOST Bus Diagnostic Tool Kit

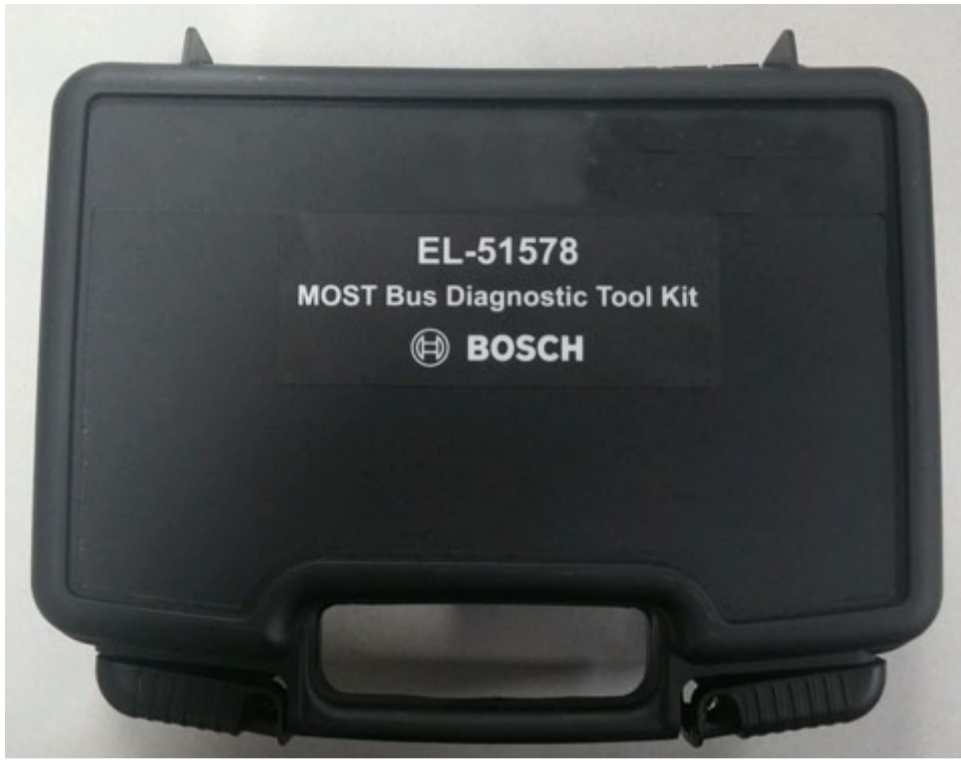
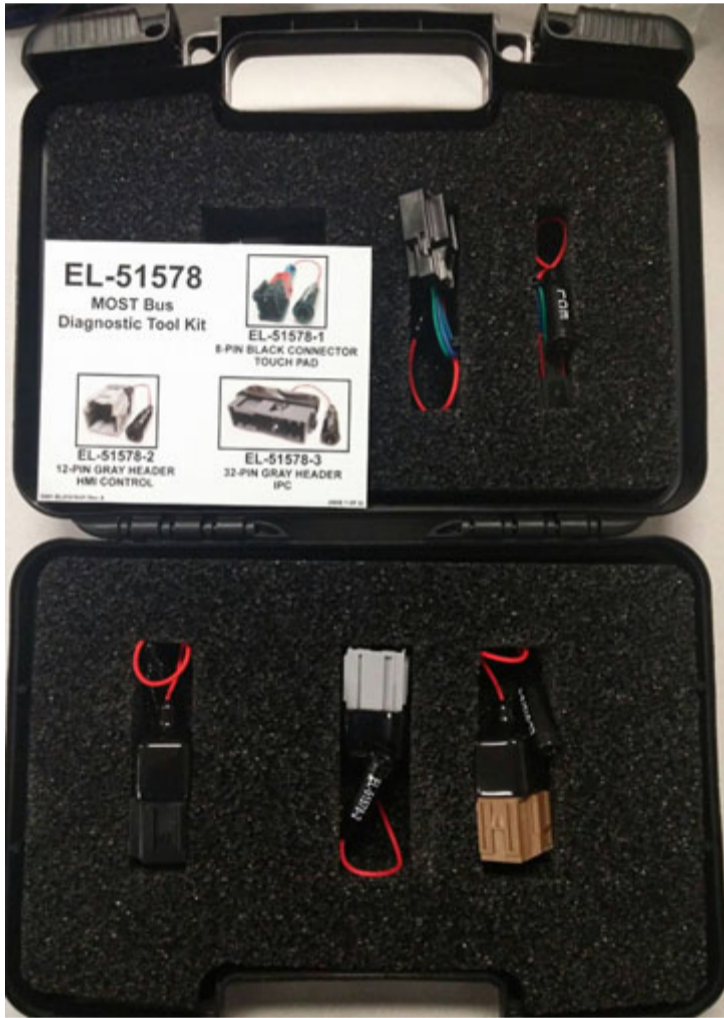
The EL-51578 MOST Bus Diagnostic Tool Kit has been released to aid in diagnosing MOST buss concerns. The kit contains header connectors that are installed to bypass MOST bus modules. The bypass connectors also contain a terminal for verifying ECL voltages (MOST control circuit). The kit does not contain a bypass for the radio, which is the master of the buss.

The Radio U0028 sym00 will be used to determine MOST buss state of health. If the module with the concern is bypassed, the Radio U0028 sym00 will report as history. Infotainment functions will return with the exception to what the bypassed module controls. For example, if the amplifier is bypassed and DTC U0028 sym00 changes from current to history, ignore the symptom of no audio as the amplifier is bypassed. Other examples, display will be inoperative with HMI bypassed. DIC and steering wheel controls will be inoperative with IPC bypassed. CD/DVD will be inoperative with Media disc player bypassed.

Usually there may be 1 of 2 modules suspect with a current Radio U0028 sym00 set depending on which Node positions are listed. If both of these 2 suspect modules are bypassed and the Radio U0028 sym00 stays current, check the MOST bus circuits and ECL for opens, shorts, high resistance, or terminal concerns.
