## Service Information Bulletin

SUBJECT	DATE
Symptom Diagnostics - Oil Present at the Turbocharger Compressor Housing	December 2018

## 2 Symptom Diagnostics - Oil Present at the Turbocharger Compressor Housing

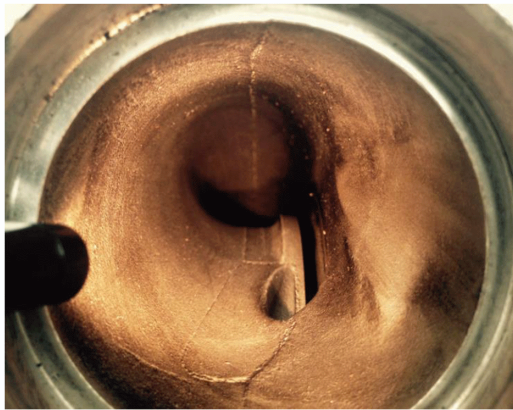
<p style="text-align: center;"><b>1</b></p> <p style="text-align: right;">d090127a</p>

Note: Some oil residue at the turbocharger compressor housing is acceptable (See figure 1 below). This residue may look like a soot coating on the compressor housing and will be dry to touch. This residue occurs over a long period of time usually in combination with high idle time.

<p style="text-align: center;"><b>2</b></p> <p style="text-align: right;">d090127b</p>
1. Acceptable oil in the turbocharger compressor housing	2. Excessive oil in the turbocharger compressor housing

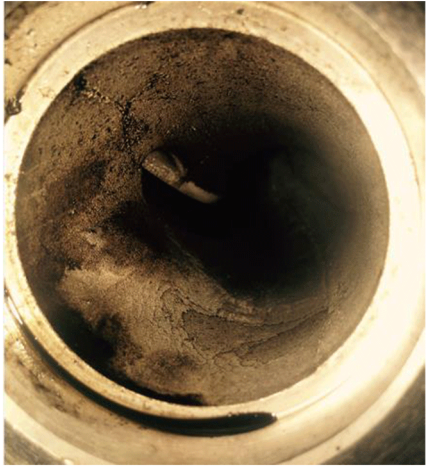
Excessive oil (See figure 2 below) in the turbocharger compressor housing will be wet to touch and can be present from a number of different failure modes;

- High Air Intake restriction
- Boost leaks
- High crankcase pressure
- Obstructed turbo oil drain
- Failed turbo

If it is uncertain whether the compressor housing is acceptable or excessive, complete the following diagnostics. Do NOT replace the turbocharger without completing the following diagnostics.

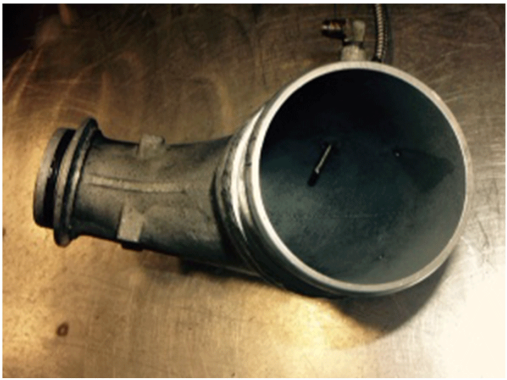
<p style="text-align: center;"><b>1</b></p> <p style="text-align: right;">d090128a</p>

12. Run the engine at 900 rpm for 20 minutes. Is oil present in the previously cleaned turbocharger compressor elbow ?

<p style="text-align: center;"><b>2</b></p> <p style="text-align: right;">d090128b</p>
1. Clean - no oil passing	2. Oil passing after cleaning

- a. Yes; replace turbocharger. Clean out all air systems .
- b. No; release unit.
