Technical Journal

“Vehicle key not found” displayed in Driver Information Module (DIM)

REF NO: TJ 34013.1.2	ISSUING DEPARTMENT: Technical Service	CAR MARKET: United States and Canada	
PARTNER: 3 US 7510 Volvo Car USA		ISSUE DATE: 2018-08-02	STATUS DATE: 2018-08-03
FUNC GROUP: 3669	FUNC DESC: Miscellaneous	Page 1 of 3

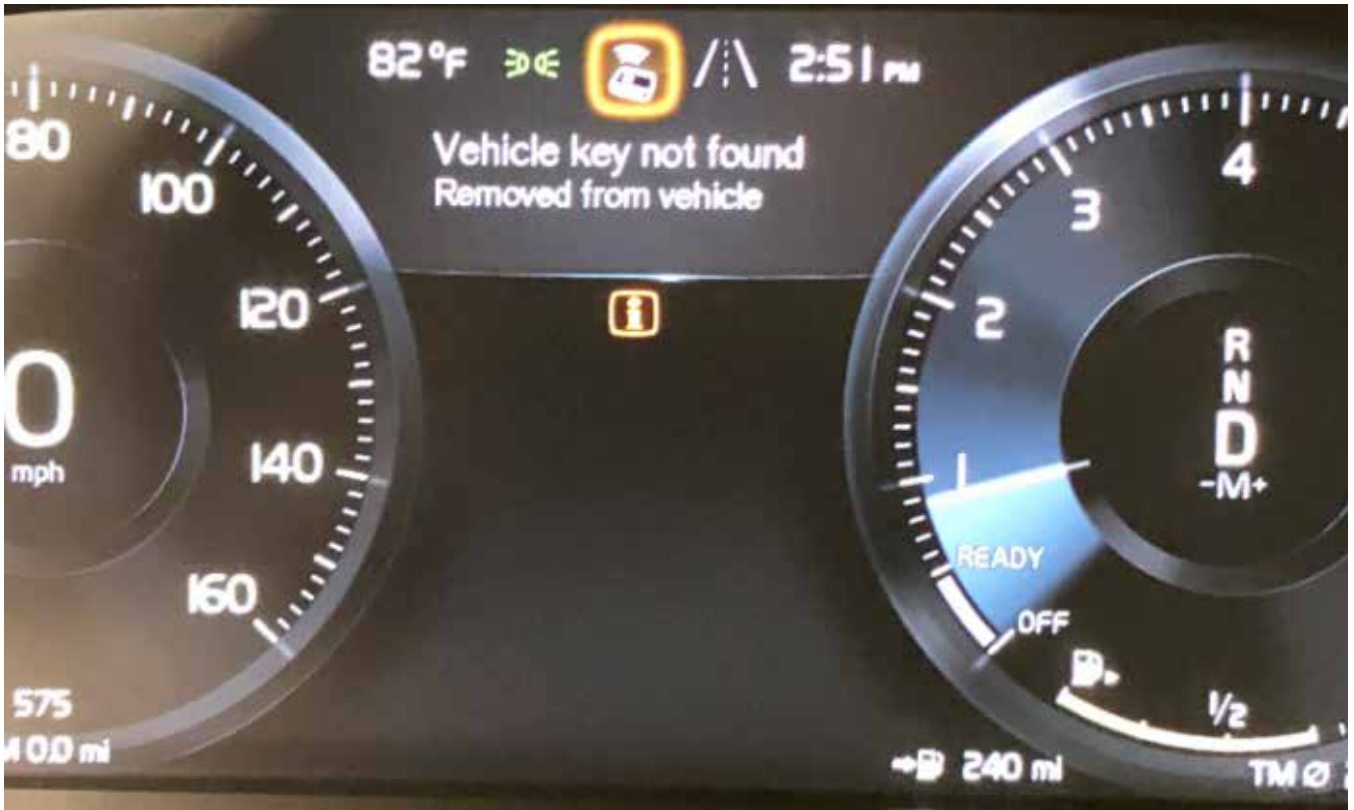
File Name	File Size
Vehicle Key Not Found.PNG	0.4976 MB

If a “Vehicle key not found” message (refer to attached image) is displayed in the DIM intermittently, follow the advice under “Service”.

Revised CEM software was released 2018w20.

Perform a Total Upgrade according to TJ 31543.
