Technical Journal

Keyless Drive receiver issues (short remote control range, key messages)REF NO:
TJ 27316.7.2ISSUING DEPARTMENT:
Technical ServiceCAR MARKET:
United States and CanadaPARTNER:
3 US 7510 Volvo Car USAISSUE DATE:
2018-03-06STATUS DATE:
2018-03-12FUNC GROUP:
3669FUNC DESC:
Miscellaneous

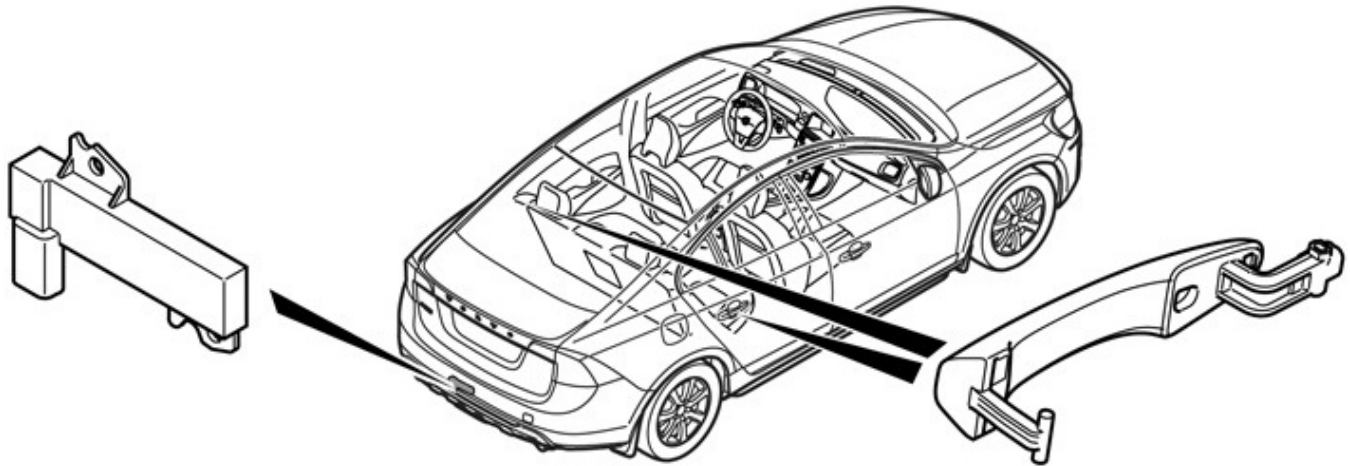
Test the function with both remote controls at all 3 external antennas (right, left and rear). If both remote controls have short range at more than one antenna, the fault is likely in the remote receiver.

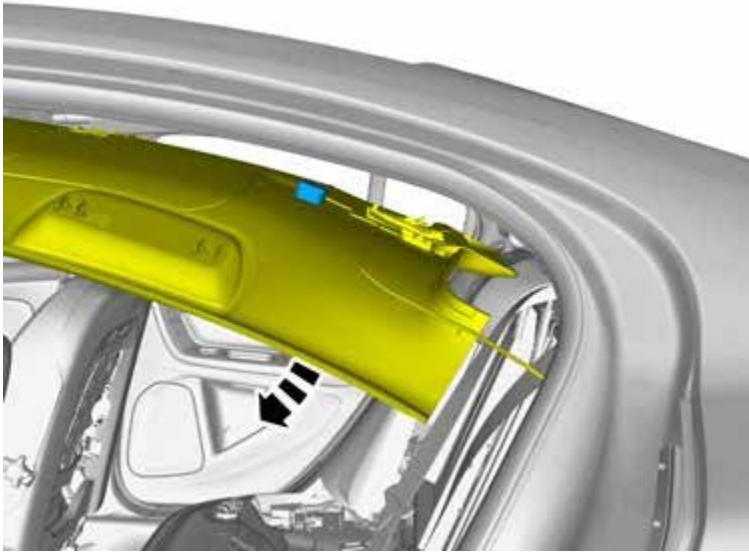
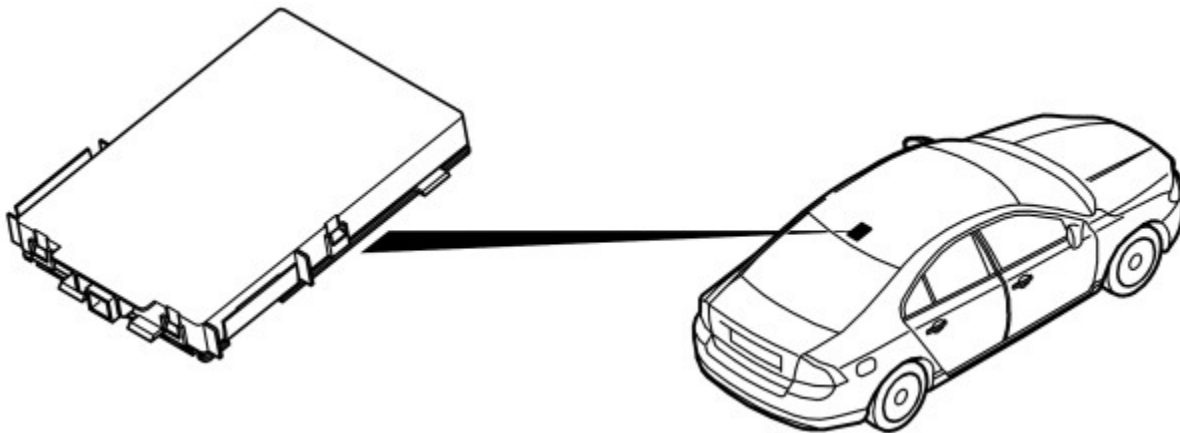
Keyless Drive remote receiver description:

The component is located on top of the headliner directly above the rear seat and is referred to as:

- '4/119 TRX' in the wiring diagram
- 'Receiver 30682115' in the VIDA parts catalogue
- 'Receiver lock system keyless entry RKE' in the VIDA repair instructions and Design and Function
