ADJUSTING THE ENTRANCE DOOR HINGE COVER PANEL

This adjustment procedure will correctly set the panel gap between the entrance door hinge cover and the defroster cover panel on MY2018 J Coaches.

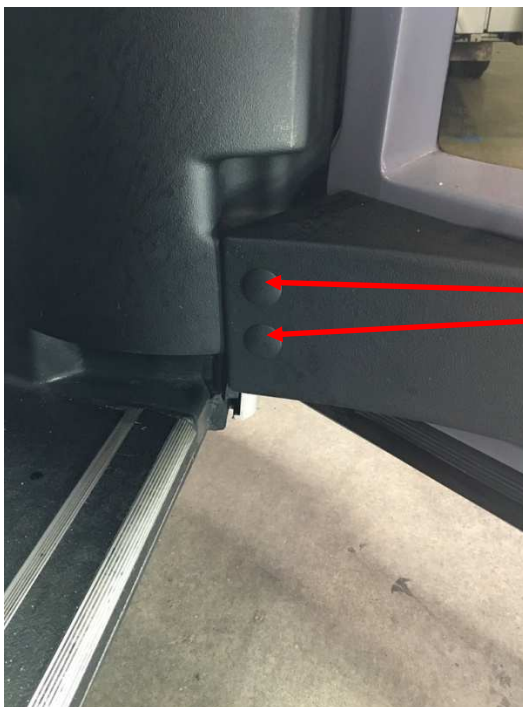
Fully open the entrance door and locate the two left side ratchet fasteners on the step light panel, remove, and discard.

Remove 2 Ratchet Fasteners

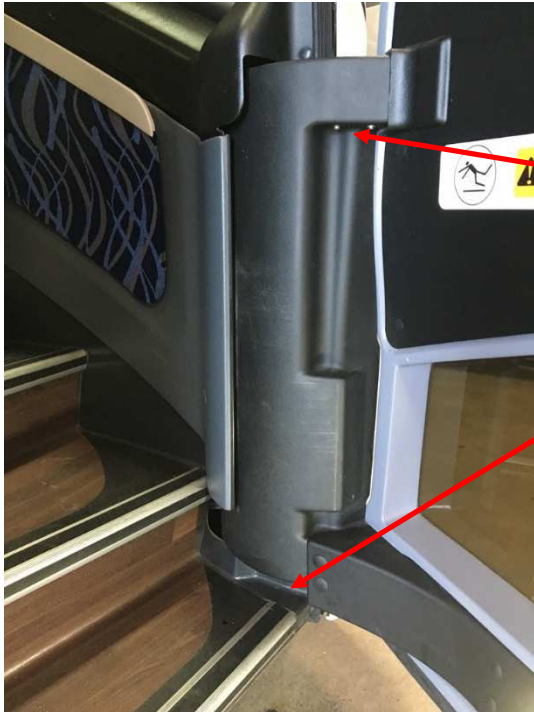
Locate and remove the hinge cover mounting screws. Retain the screws for use later.

Remove 3 Panel
Mtg Screws

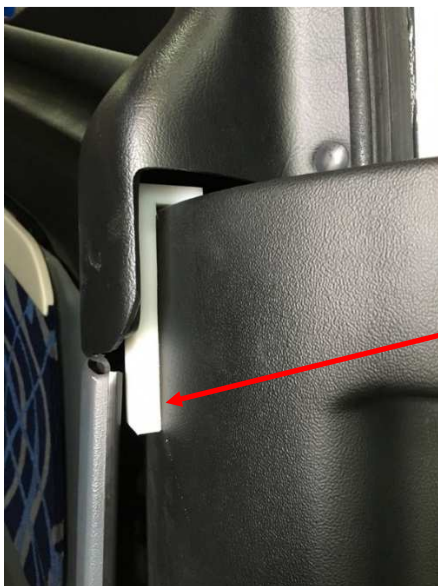
Install the upper spacer tool T03-2970 between the hinge cover and the defrost panel.

Spacer Tool T03-2970

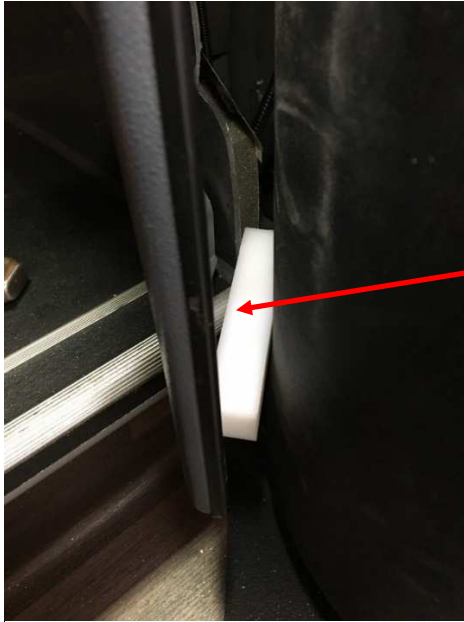
Install the lower spacer tool T03-2969 between the hinge cover and the step edge extrusion.

Spacer Tool T03-2969

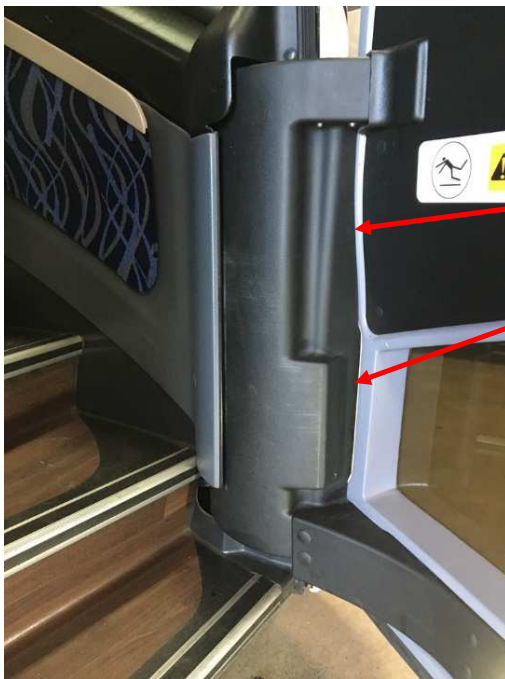
Ensure the right edge of the hinge panel is correctly set against the door.

RH Side Panel
Edge Fitment

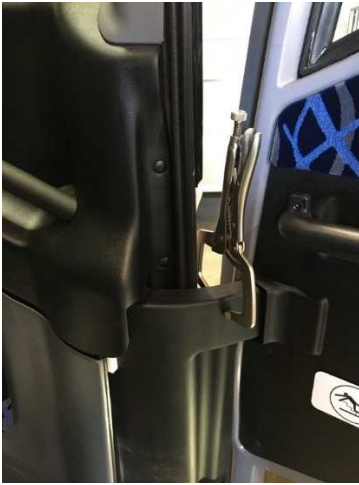
Clamp the hinge trim panel to the upper and lower hinges.

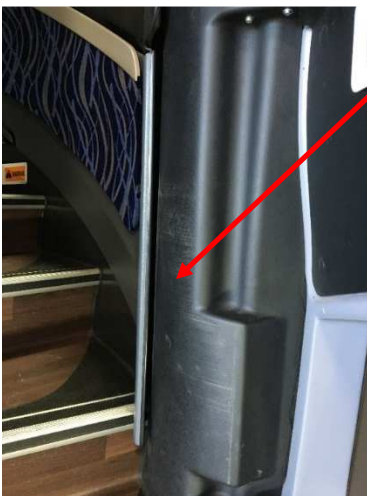
Panel gap should now be approximately 3/8" in the full open door position.

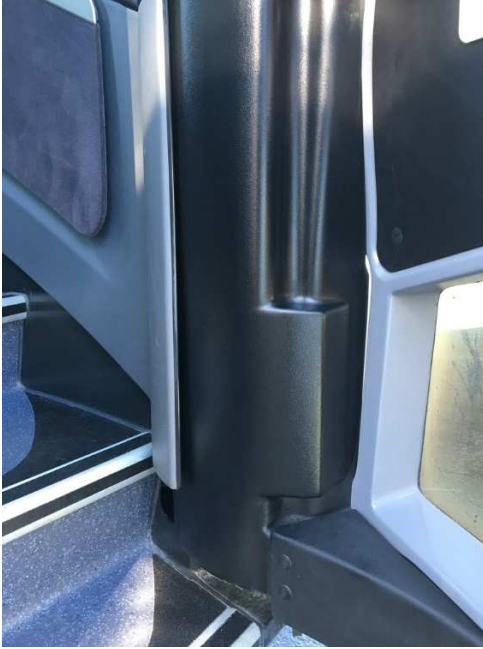
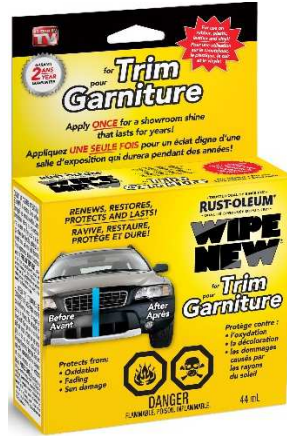
If needed use Rust-Oleum Wipe New finish restorer to remove any scratch marks from the hinge cover panel
