## SLI

**Communication #:** T-18-06-01

Driver-Side Slingshade Door Latch Interference

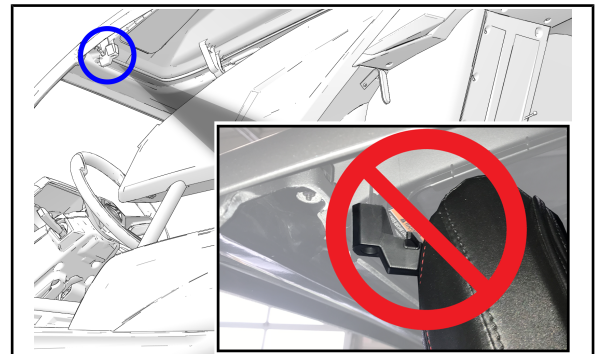
All 2017-2019 Slingshot models equipped with the Slingshade accessory (including factory-equipped GT models) present the possibility of contact between the driver's seat headrest and the Slingshade door latch. With the Slingshade door closed, the seat headrest can make contact with the door latch while tilting the seat forward. If the seat is allowed to tilt forward unrestrained, the force of the seat can damage the door latch.

**Damage to the driver-side Slingshade door latch can be avoided by opening the Slingshade door before tilting the driver's seat forward. Opening the door will also maximize accessibility to the storage compartment behind the driver's seat.**
