## SS 1033049 Transmission Oil Cooler Line Clip - New Cascadia

New Cascadia

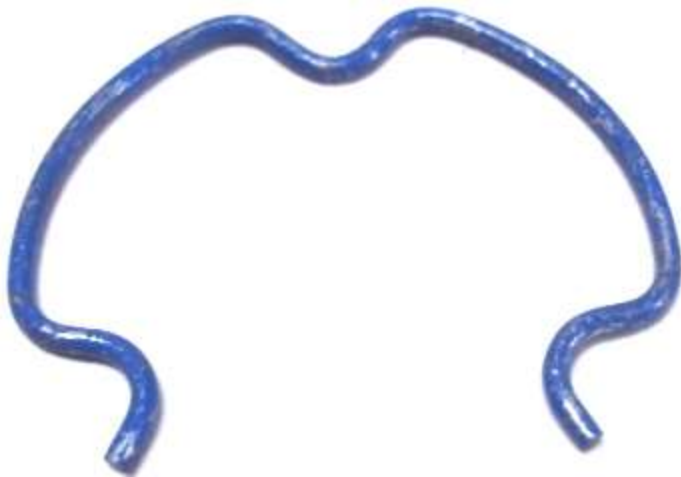
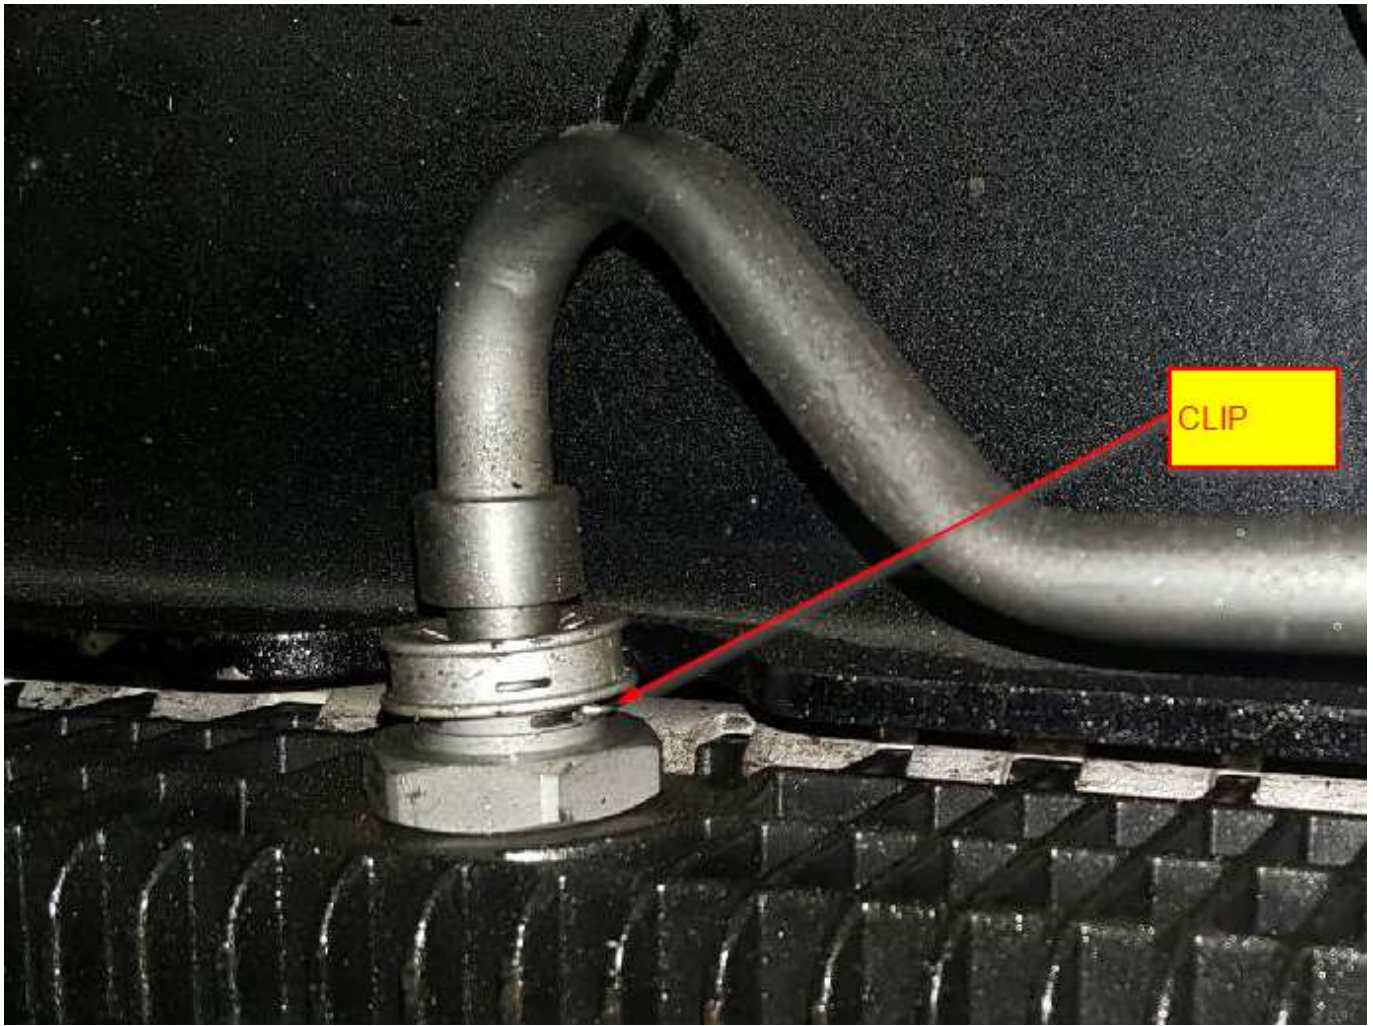
The clip used to connect the transmission oil cooler line is still being determined. Once the proper clip number is obtained we will post it to this solution.

Below is a picture of the clip:

Isn't it #BHT 91099?

what happens is the clip falls off, then the oil cooler lines comes disconnected , and if your not careful burning up your transmission seen it happen 3 times already. what we have done to correct this issue is install the clip, with the plastic retainer and place heat shrink over both the clip and plastic retainer this makes sure that the clip is secured in place and wont wiggle free
