# Service Bulletin

Subject: **Clutch Housing Update**

Product: **B3 675/800-F3 675/800-Dragster 800-Stradale-Rivale**

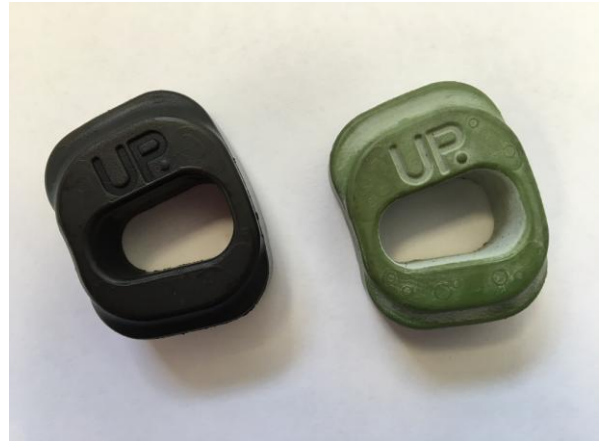
- *Remove the clutch (this operation doesn't need to remove the engine oil)*
- *Place on the workbench the clutch housing and remove the six screws that hold the mounting plate*
- *Replace the rubber cush drive (lubricating them with engine oil to facilitate the insertion) with new type ones, black and green included in the kit as shown in the picture:*

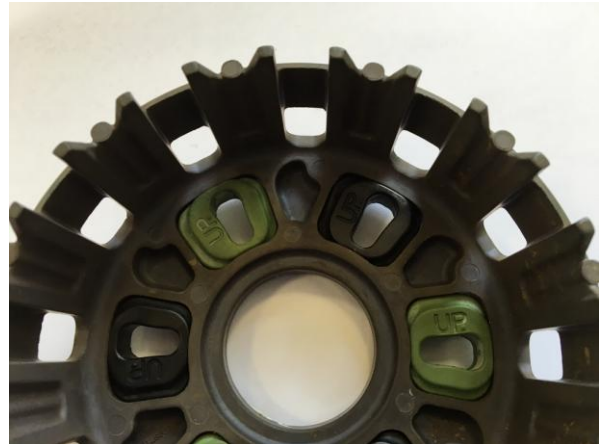
- *Place the new rubber cush drive on the clutch housing with the inscription "UP" upwards, and alternating the two colors (black - green) as indicated in the picture:*

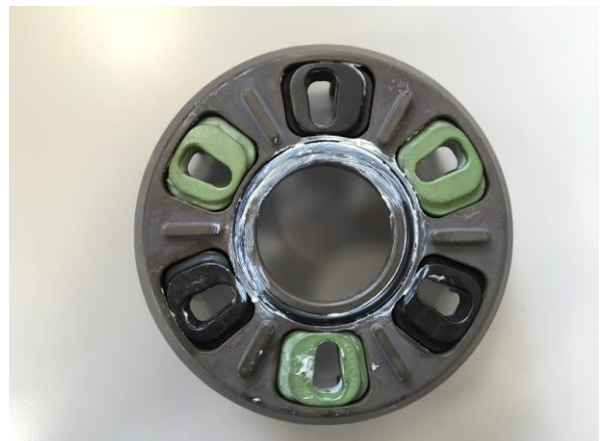
- *Assemble the clutch housing making sure that the O-ring does not get pinched during the assembling, using some grease in order to keep it in place as indicated in the picture:*

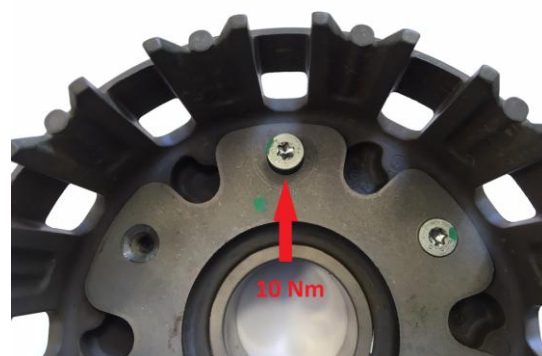
- *Reassemble the clutch housing, fixing the plate with the 6 screws and using some medium Loctite on the thread tightening them to 10 Nm as picture:*
