## Technical Service Bulletin

**19-AT-001-G**

**GENESIS G70, G80  
and G90**

**AUTOMATIC TRANSMISSION FLUID TEMPERATURE SENSOR  
AND INPUT/OUTPUT SPEED SENSOR  
DTC P0711, P0712, P0713, P0717, P0721 & P0722**

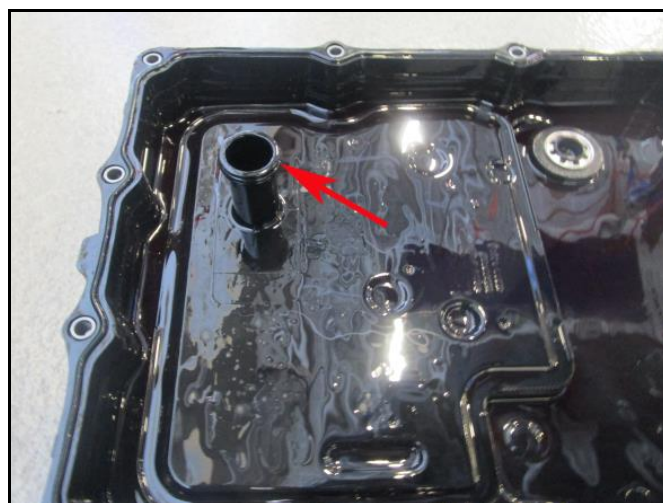
13. Confirm the O-ring is installed at the location shown.

Reinstall the valve body cover and torque to specification.

**Torque: 10~12 lb.ft (1.4~1.6 kgf.m, 14~16 N.m)**

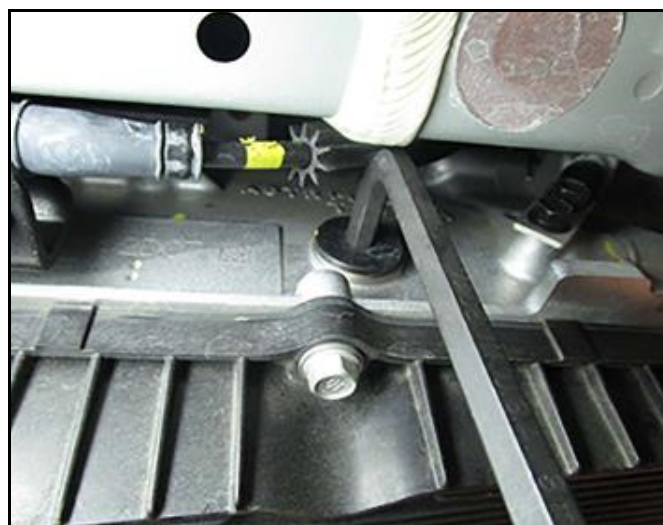
14. With the engine off, lift the vehicle on a hoist.

Use an 8mm or 5/16" hex wrench and remove the fill plug and washer.
