# PIC4996B Tips for Servicing Fuel Level Sensors/ Fuel Gauge Inoperative or Inaccurate

Brand:	Model:	Model Years:	VIN:		Engino	Transmissions:
			from	to	Engine:	Hansinissions.
Buick	Allure (Canada)	2005 - 2016	All	All	All	All
Buick	LaCrosse	2006 - 2019	All	All	All	All
Chevrolet	Impala	2006 - 2019	All	All	All	All
Chevrolet	Monte Carlo	2006 - 2007	All	All	All	All
Pontiac	Grand Prix	2004 - 2008	All	All	All	All

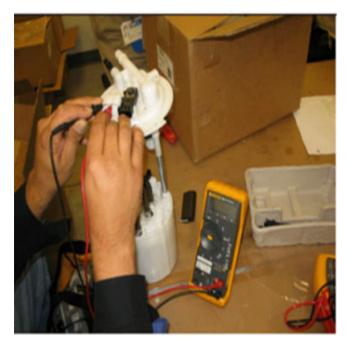
If the SI diagnostic leads to a potential level sensor failure at the component, test the circuit from the connector at the top of the fuel module

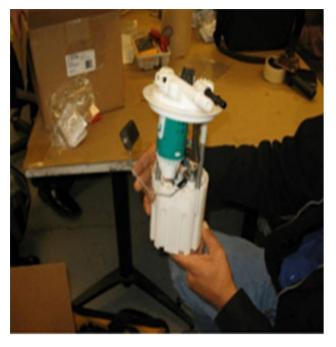
Carefully, install new fuel level sensor into module. Perform the sweep test again with your meter leads on the connector at the top of the fuel level module.

Upon a successful sweep test, reinstall module into the fuel tank, reassemble the components and verify successful repair.

If the sweep test fails with the new fuel level sensor installed replace the complete fuel module.
