Technical Tip

Topic	17-19-01TT - Oil is Discolored Prior to 1 st Oil Change
Market area	United States 444 Volkswagen of America, Inc. (6444)
Brand	Volkswagen
Date	01/18/2019

Oil is Discolored Prior to 1st Oil Change

Model(s)	Year	Eng. Code	Trans. Code	VIN Range From	VIN Range To
Atlas	2019	3.6L CDVC	All	All	All

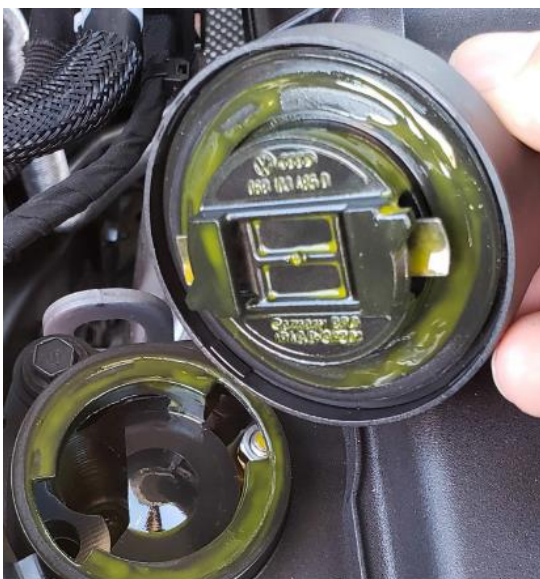
Figure 1

Oil is discolored. Dye was added to the engine during testing at the factory.

No further work is needed as this is discoloration resulting from the dye. Refer to the examples below.
