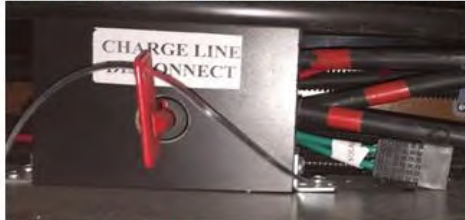
1. You have a charge line disconnect under the rear power sofa. Please check if that is ON or not. That is not only for the solar panel but also for the alternator to charge the house batteries when driving.

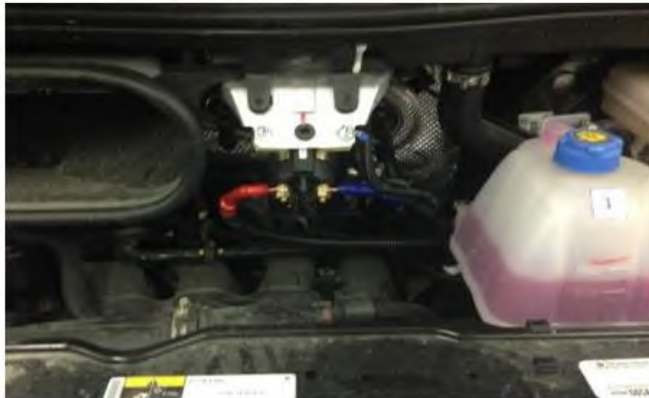
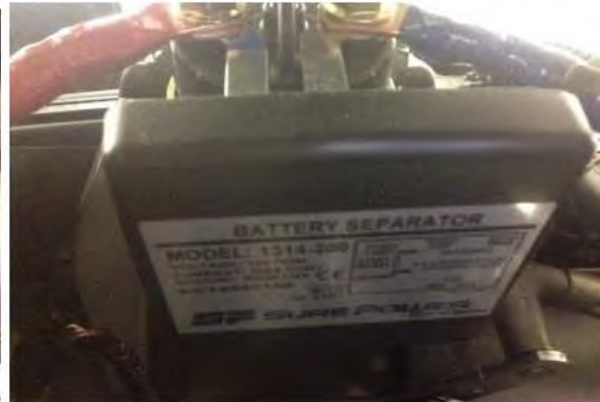
2. Check connections from the alternator line if they are loose (picture attached). It shows 2 lines on upper left that came from the front.
3. Check the battery separator if it's still working properly. Someone has to diagnosed that. This information is written in your PW owner's manual on page 45.

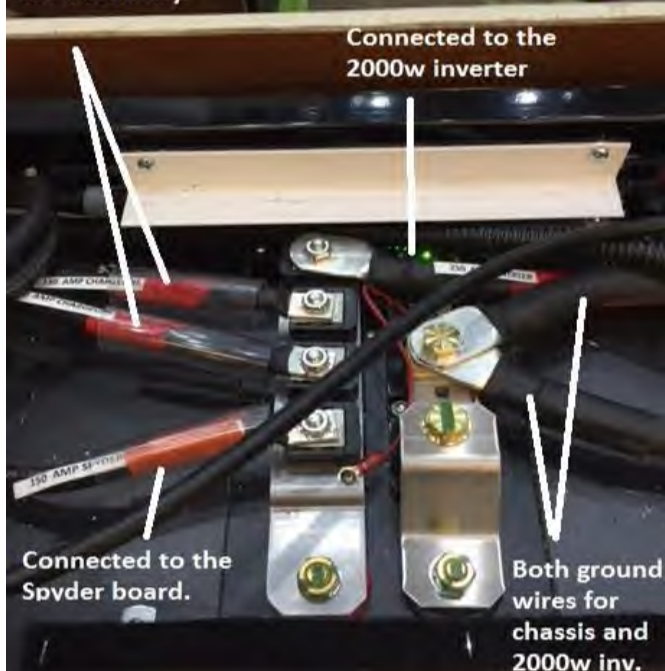
**Both lines are chargelines coming from the front of the coach (when alternator charges the batteries).**
