# Technical Journal

TITLE:  
**Replacement of ERAD components**

<b>REF NO:</b> TJ 33358.5.1	<b>ISSUING DEPARTMENT:</b> Technical Service	<b>CAR MARKET:</b> United States and Canada	
<b>PARTNER:</b> 3 US 7510 Volvo Car USA		<b>ISSUE DATE:</b> 2019-01-02	<b>STATUS DATE:</b> 2019-01-10
<b>FUNC GROUP:</b> 4600	<b>FUNC DESC:</b> Rear axle, drive shaft	<b>Page 1 of 23</b>

<b>Title</b>	ERAD transmission	<b>Page</b>	1 ( 19 )
<b>Action</b>	Replacement	<b>Operation number:</b>	98210-2

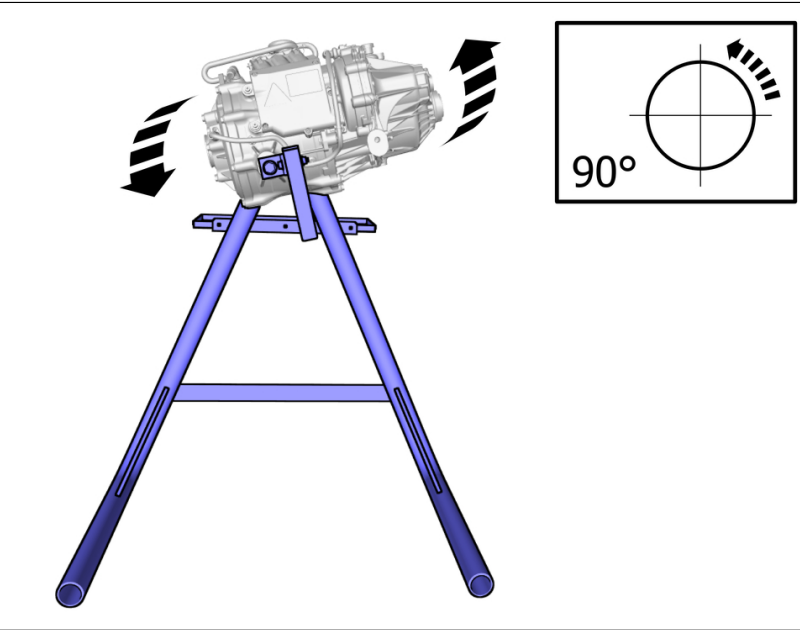
Turn the engine

Remove the screws.

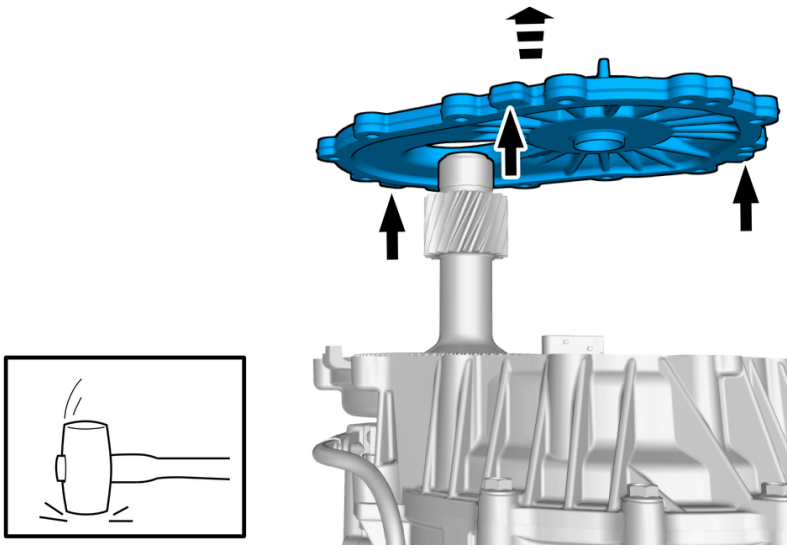
Old sealing.
