DOC #	PROCESS NAME	PAGE	REVISION	STATION	BY	DATE
AR866	SOI-F Rear Upper Shock Mount Bracket Installation	1 of 1	-	SER-E	C.Ward	3/22/2019

**Complaint:** Upper Shock has movement during Jounce

**Cause:** Insufficient structural support

**Correction:** Add bracket with weldment

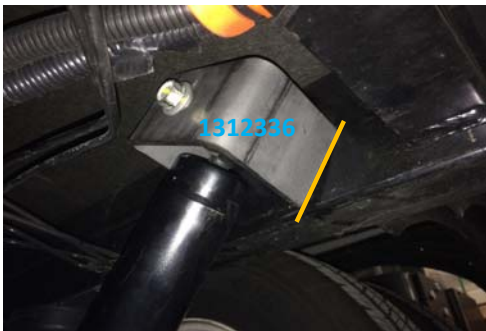
Step 5: Use supplied bracket (P/N: 1312336) and reinstall shock, placing the bracket in between the upper shock bolt and shock. Rotate the bracket until it is free of the potential shock travel (Approx. 45 degrees). Use a paint marker to mark the location of the shock bracket.

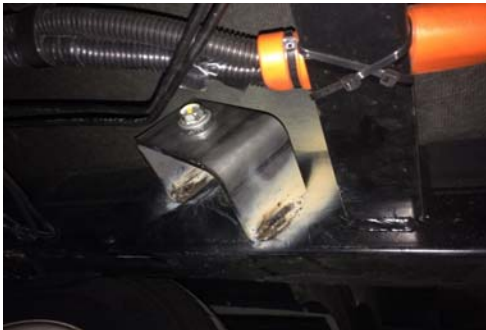
Step 6: Remove shock and add just the bracket and hardware to the frame. Weld the outside of the bracket to the frame; ¼" fillet weld, 2.75" long. Make sure the bolt is installed to prevent hole misalignment.

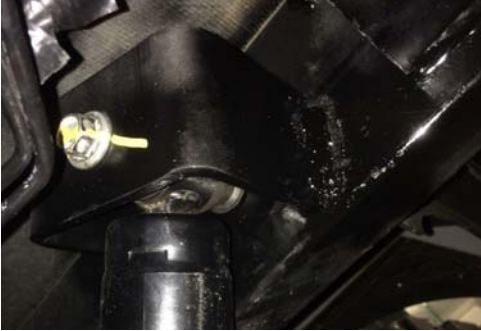
Step 9: Reinstall shock and torque hardware to correct specification. (46 Ft/Lbs Upper Shock - 66 Ft/Lbs Lower Shock, per Ford Specs)
