# PIC5894A Multiple IPC Warning Indicators DIC Messages Displayed and or Loss of Communication DTCs in Various Modules

Brand:	Model:	Model Years:	VIN:		Engino	Transmissions:
			from	to	Engine:	Transmissions.
Chevrolet	Impala	2014	ALL	ALL	ALL	ALL

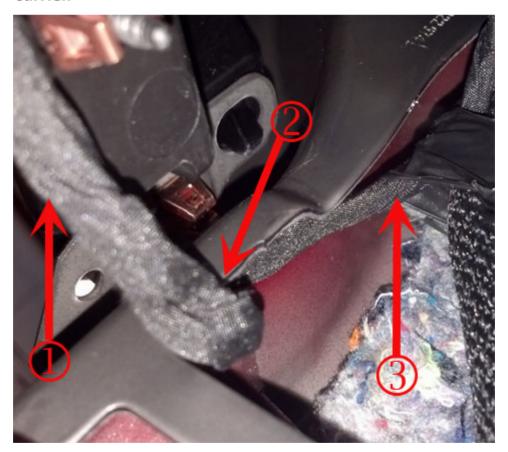
These conditions can be caused by a pinched DLC branch in the IP Harness behind the IP Carrier.

- 1) To DLC
- 2) Location of Pinch
- 3) To BCM

For wiring repairs covered under warranty, please refer to latest version of bulletin 10-00-89-005 for warranty information on wire/connector repairs.

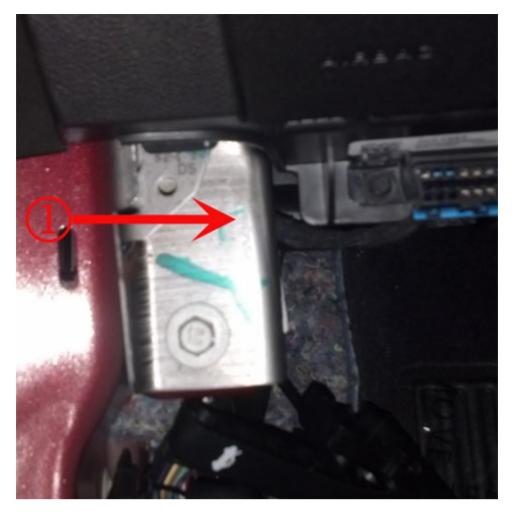
1) Location of Pinched DLC branch directly behind IP Carrier
