Preliminary Information

PIC6353 Digital Engine Coolant Temperature Gauge Disappears Over an Ignition Cycle

Brand:	Model:	Model Years:	VIN:		Engino	Transmissions:
			from	to	Engine:	
Chevrolet	Corvette	2017	All	All	All	All

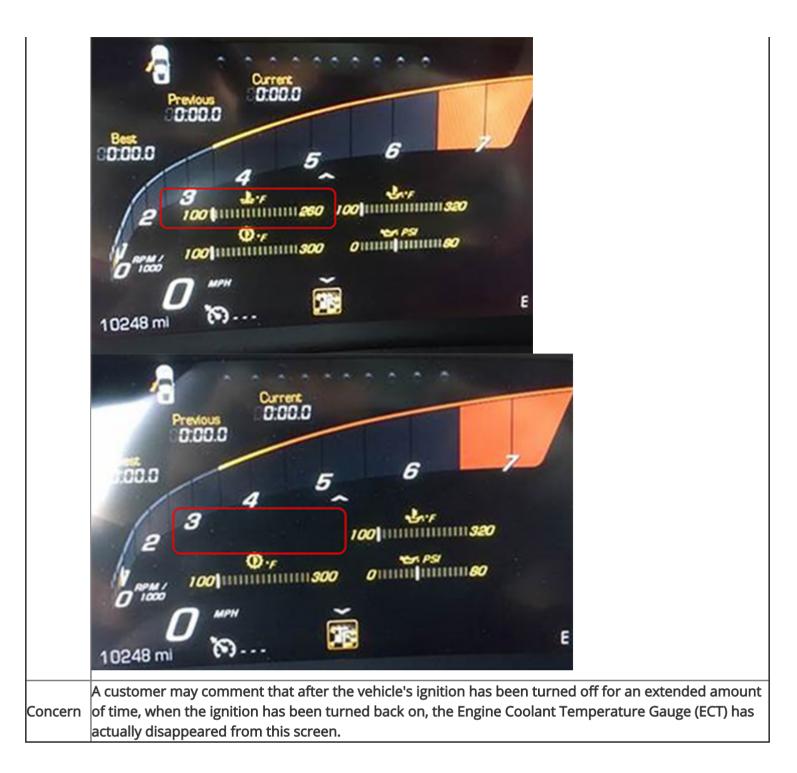
Involved	
Region or	North America
Country	
	The 7th generation Corvette is equipped with a reconfigurable Instrument Panel Cluster (IPC). This allows the driver to personalize both the appearance of the display, as well as which gauges he or she would like to monitor while driving. In this IPC, there are three different styles or "Themes" that can be selected. They are titled Tour, Sport, and Track. When in the Track Theme, there is an available screen where the customer is able to select 4 digital gauges in one view. See the two photos below for an example of this concern.
	The ECT gauge is visible in the first photo. It is missing in the second photo.

<u>Correction:</u> This concern is caused by a software issue within the IPC.

This is a known issue and GM is currently working on a software fix for this concern.

Currently, there is no permanent repair, so do not make any attempts to resolve the concern.

As a temporary solution, the customer may select this gauge again to add it back to the display screen.

It will remain in place for the remainder of the ignition cycle, until the ignition is turned off for an extended amount of time again.
