Latest Vehicle Concern Fixes

High Pitch Electronic Noise From HVAC System

Range Rover 18 - 19MY **RR Sport 18 - 19MY**

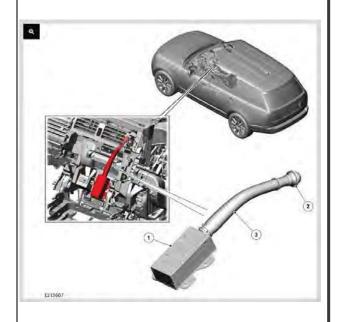
· Customers may report a high pitch electronic type noise is emanating from the HVAC center vents.

• The hose between the air ionization unit and the HVAC center vent duct does not sufficiently dampen the 9kHz noise produced by the air ionizing unit fan.

- A new sound absorbing hose for the ionizing module has been created to address this concern.
- TSB LTB01283 will be published once adequate stock of the new hose is available, target timing early March release.
