# Technical Journal

**Remote Control Key No function**REF NO:  
**TJ 33031.4.2**ISSUING DEPARTMENT:  
**Technical Service**CAR MARKET:  
**United States and Canada**PARTNER:  
**3 US 7510 Volvo Car USA**ISSUE DATE:  
**2019-01-30**STATUS DATE:  
**2019-02-05**FUNC GROUP:  
**3666**FUNC DESC:  
**Access (central locking &  
remote)**

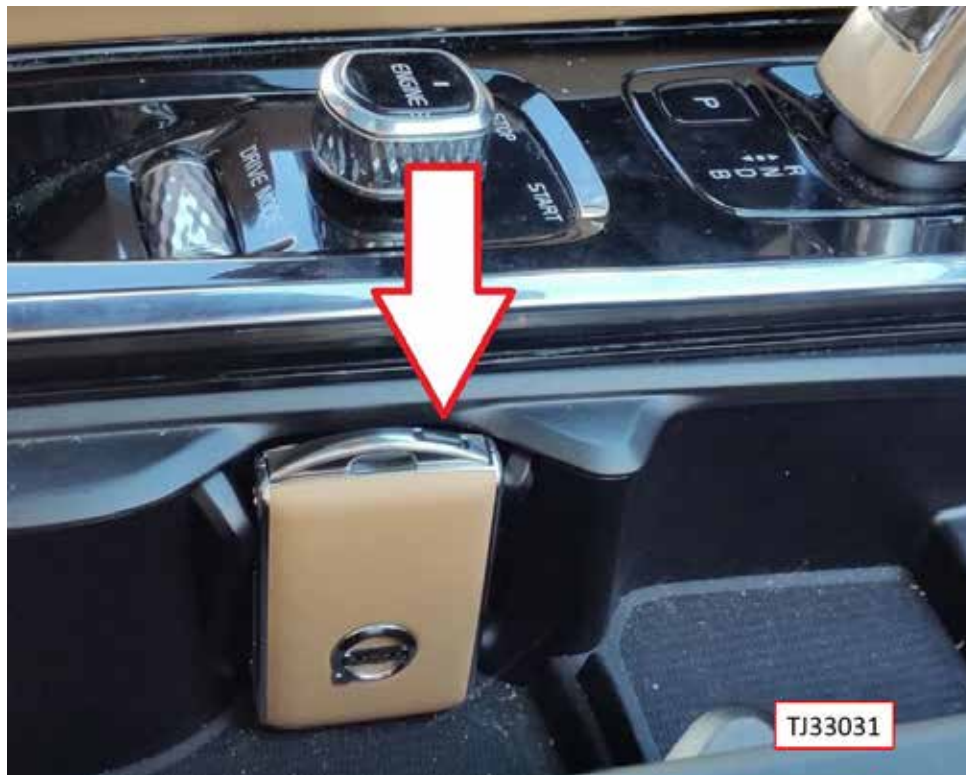
File Name	File Size
TJ33031.JPG	0.1052 MB

If remote control key lock/unlock and/or keyless functions are not working but the car **is** detecting the remote control key while placed in the cup holder next to the antenna (see attached picture “TJ33031.jpg”), please **measure voltage** of the battery in the remote control key, if remote control key battery is not OK replace battery, **the battery voltage should be between 2.7-3.3 volt to be OK.**

If remote control key lock/unlock and/or keyless functions are not working and the remote control key **is NOT** detected while placed in the cup holder next to the antenna (see attached picture “TJ33031.jpg”), please erase all concerned remote control keys and reprogram them to the car by downloading the “Keyless Vehicle Key application” through VIDA.
