February 2019  
FL799A  
NHTSA #18V-742  
Transport Canada #18-575  
REVISED NOTICE

## Subject: Honeywell Brake Light Pressure Switches

**Models Affected: Specific Freightliner Cascadia vehicles manufactured March 8, 2016, through June 30, 2017.**

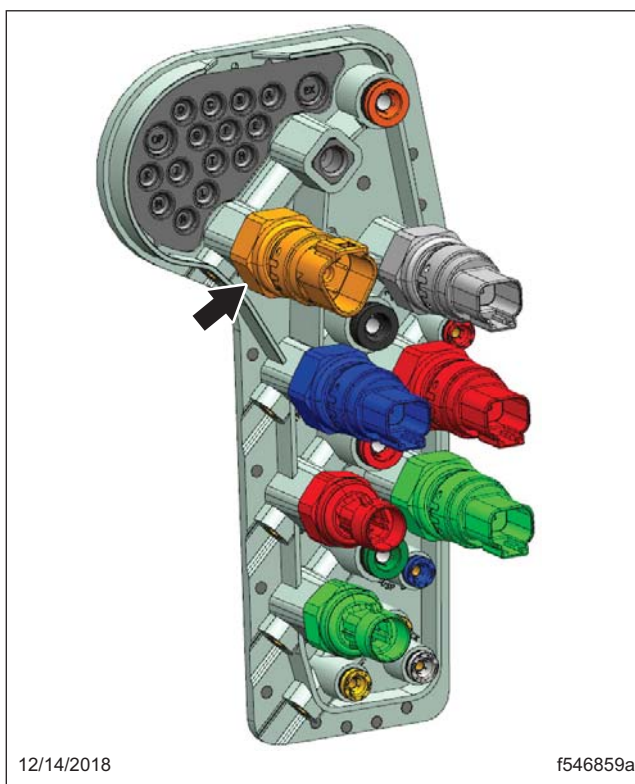
Fig. 1, Brake Light Pressure Switch

1. Check the base label (Form WAR259) for a completion sticker for FL799 (Form WAR260) indicating this work has been done. The base label is usually located on the front wall under the dash. If a sticker is present, no work is needed. If there is no sticker, proceed with the next step.
2. Park the vehicle, apply the parking brakes, and shut down the engine. Chock the tires.
3. Remove the lower steering column and throttle cover dash panels.
4. Disconnect and remove the brake light pressure switch. See [Fig. 1](#). Tag the switch for return per the Warranty Failed Parts Tracking shipping instructions.

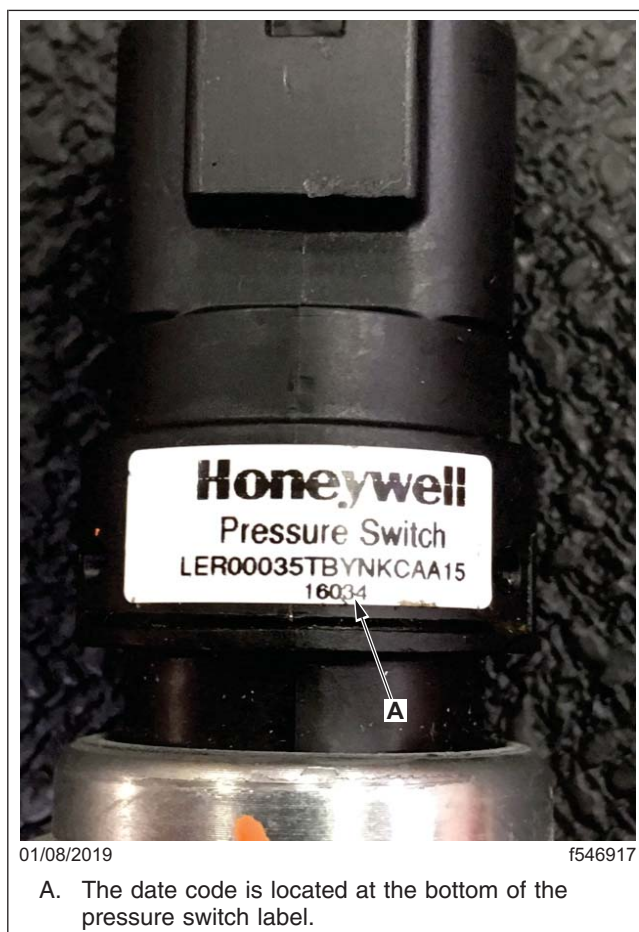
**Fig. 2, Brake Light Pressure Switch Date Code**

5. Before installing the new pressure switch, inspect the date code at the bottom of pressure switch label. See [Fig. 2](#). The date code format is YYDDD. For example: June 30, 2017 is formatted as 17181.

If the date code is 16001 through 17181, DO NOT install on the vehicle. Submit a PAR to return it to the PDC.

If the date code is outside this range, continue with the next step.

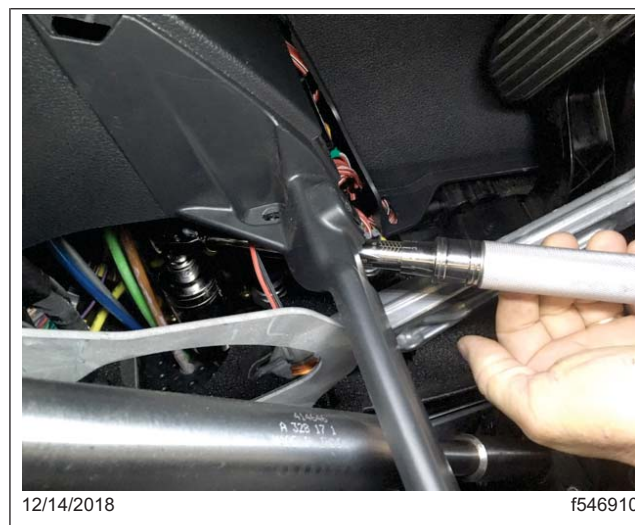
**Fig. 3, Tightening the Brake Light Pressure Switch**

6. Install the new pressure switch. Torque the switch 7 to 9 lbf-ft (9.5 to 12 N·m). See [Fig. 3](#).
