Technical Service Bulletin

SUBJECT:			No: TSB-19-23-002
ADDITIONAL SERVICE PARTS FOR TRANSAXLE REMOVAL & INSTALLATION - SERVICE MANUAL REVISION			DATE: March 2019
			MODEL: 2013-15 Outlander Sport/RVR
CIRCULATE TO:	<input type="checkbox"/> GENERAL MANAGER	<input checked="" type="checkbox"/> PARTS MANAGER	<input checked="" type="checkbox"/> TECHNICIAN
<input checked="" type="checkbox"/> SERVICE ADVISOR	<input checked="" type="checkbox"/> SERVICE MANAGER	<input checked="" type="checkbox"/> WARRANTY PROCESSOR	<input type="checkbox"/> SALES MANAGER

This TSB updates the Automatic Transmission section of the affected Service Manuals, to include additional service parts for the transaxle removal and installation procedure. These parts were made available in May, 2015.

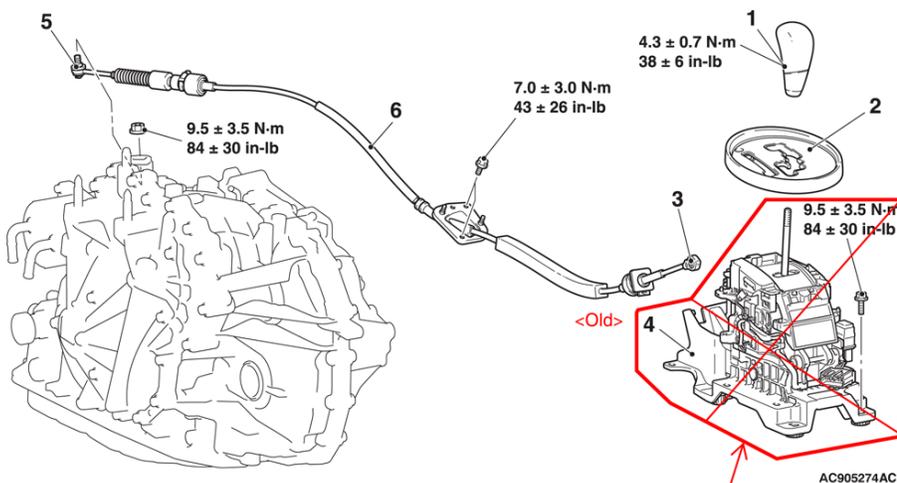
Selector lever assembly removal steps

- Move the selector lever to the "N" position.
 - Rear floor console assembly (Refer to GROUP 52A – Rear Floor Console Assembly .)
1. Selector lever knob
 2. Shift indicator panel

3. Transaxle control cable connection (selector lever side)
4. Selector lever assembly

Please make the indicated changes to the 2013 Outlander Sport/RVR Service Manual, Group 23-Automatic Transmission -> 23A-CVT -> Transaxle Control -> Removal & Installation.

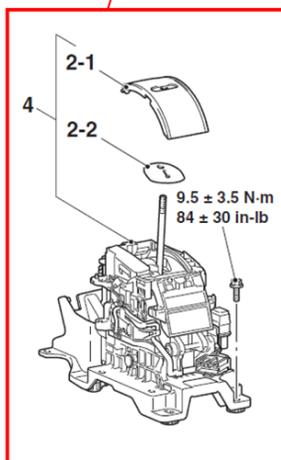
<New>

<Added>

- 2-1. Lever cover
 2-2. Indicator slider

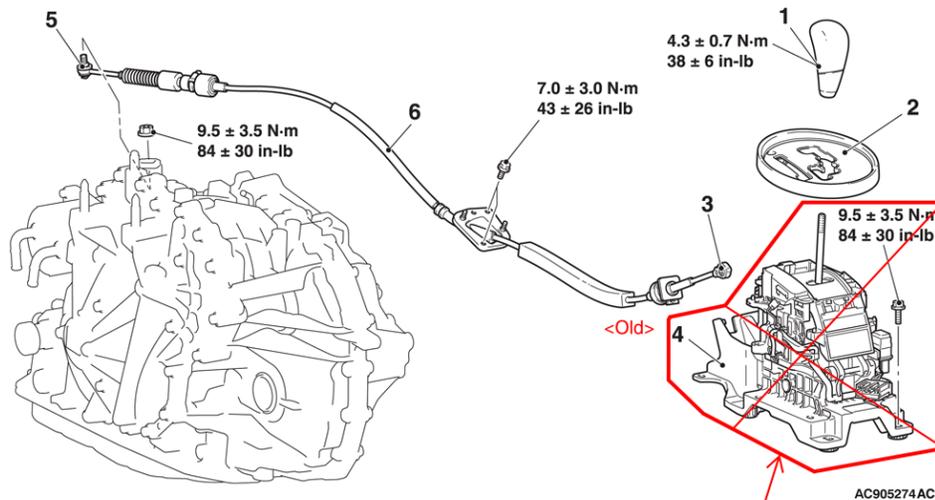
Selector lever assembly removal steps

- Move the selector lever to the "N" position.
 - Rear floor console assembly (Refer to GROUP 52A – Rear Floor Console Assembly .)
1. Selector lever knob
 2. Shift indicator panel
- Front floor console center and floor console front (Refer to GROUP 52A – Front Floor Console Assembly .)
3. Transaxle control cable connection (selector lever side)
 4. Selector lever assembly

Please make the indicated changes to the following Service Manuals:

- 2014 Outlander Sport/RVR Service Manual, Group 23-Automatic Transmission -> 23A-CVT -> Transaxle Control -> Removal & Installation
- 2015 Outlander Sport/RVR Service Manual, Group 23-Automatic Transmission -> 23A-CVT <F1CJC/W1CJC> -> Transaxle Control -> Removal & Installation
- 2015 Outlander Sport/RVR Service Manual, Group 23-Automatic Transmission -> 23C-CVT <F1CJA/W1CJA> -> Transaxle Control -> Removal & Installation

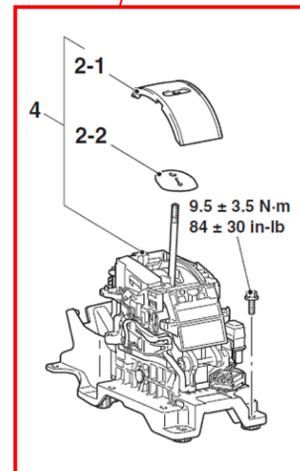
<New>

<Added>

- 2-1. Lever cover
- 2-2. Indicator slider
