SERVICE BULLETIN

Classification: AT18-005b	Reference: NTB18-055b	Date: March 20, 2019
------------------------------	--------------------------	-------------------------

CVT FLUID LEVEL QUICK CHECK GAUGE

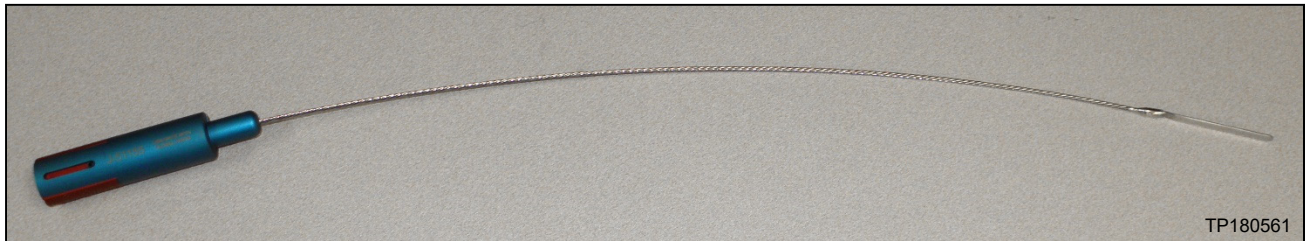
Figure 1

CVT Oil Level Quick Check Gauge (J-51155)

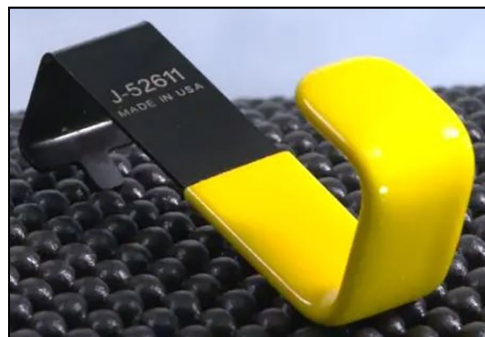
Figure 2

CVT Charge Pipe Cap Release (J-52611)

NOTE: The tool shown in Figures 3 & 4 is the same as the one shown in Figure 2, but looks slightly different.

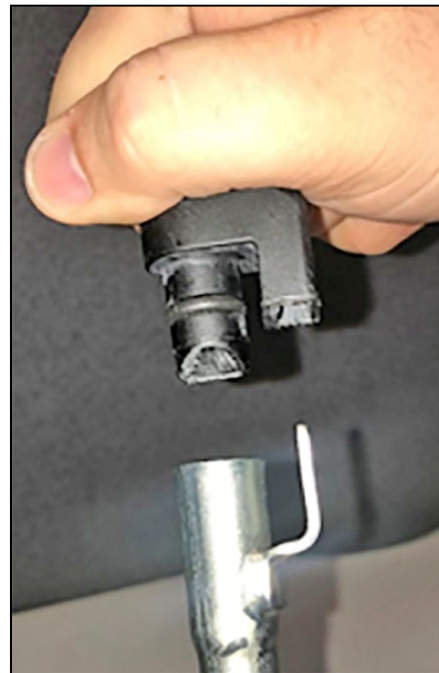
Figure 5

10. Pull to remove the cap from the charging pipe.

- Tool CVT Oil Level Quick Check Gauge (J-51155) can now be used to determine the CVT fluid level.
