LATEST VEHICLE CONCERN FIXES

| Check Engine Light with P0521-85 Set in the PCM | 17MY F-PACE AJ20D |

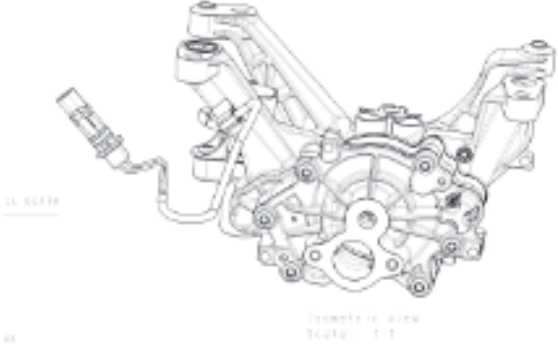
| Check Engine Light with P0521-85 Set in the PCM | 17MY F-PACE AJ20D |
|--|--|
| <p><u>Customer Voice:</u></p> <ul style="list-style-type: none">- Check engine light appears on the instrument cluster- in some cases intermittently. <p><u>Technical Description:</u></p> <ul style="list-style-type: none">- P0521-85 is set in the PCM for Oil Pressure Sensor Range/Performance <p><u>Status:</u></p> <ul style="list-style-type: none">- Under Investigation- Follow TOPIx steps for diagnosis, looks for signs of oil leaks around the oil pump/ sensor. If none are found, perform circuit checks at the sensor and pump. Please submit a TA and follow LTS instructions on next steps. Include the current oil level in the vehicle and last service record in your submission, as well as a picture of the filter. Should you replace any parts for this concern, please hold onto the parts (pump, sensor & filter assembly) and submit an EPQR with your parts manager mailing information. | <p>isometric view Scale: 1:1</p> The image shows a technical isometric drawing of an engine assembly, likely a 2.0-liter diesel engine. It includes various components such as the cylinder head, intake manifold, and oil pan. The drawing is labeled 'isometric view' and 'Scale: 1:1'. |
