APPLE PAY WALLET- POP-UP WINDOW APPEARS IN THE IPHONE DISPLAY

G05 (X5 Sports Activity Vehicle)	G07 (X7 SAV)	G14 (8 Series Convertible)	G15 (8 Series Coupe)
G20 (3 Series Sedan)	G29 (Z4 Roadster)

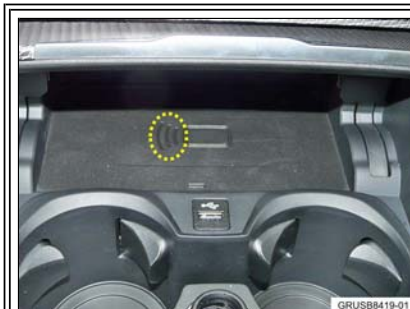
NFC only; no wireless charging.

- NFC is indicated by the 3 curved lines (circled) to the left of the cell phone outline

G20 shown; other models similar.

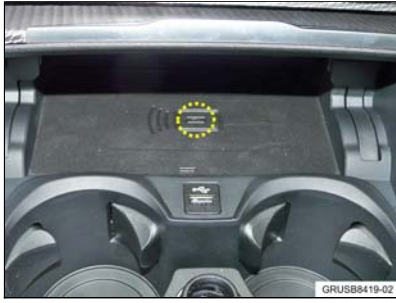
NFC and wireless charging.

- Wireless charging capability is indicated by the “lightning bolt” icon (circled) within the cell phone outline
