Technical product information

| Topic | Bentayga - Suspension warning light on - Diagnostic Trouble Codes - C104707 - C104807 |

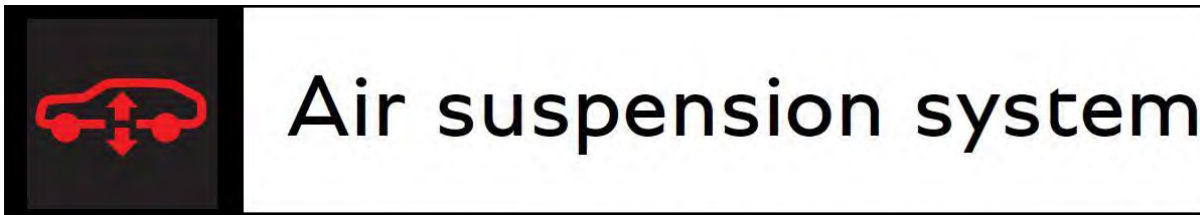
Air suspension system warning displayed in the Driver Instrument Panel (DIP) or the suspension drops from one corner of the vehicle
