David J. Johnson
 Director
 Service Engineering Operations
 Ford Customer Service Division

SUBJECT: **Customer Satisfaction Program 18N03 - Supplement #6**
 Certain 2015-2018 Model Year F-150 and 2017-2018 Model Year F-250-F-550
 Vehicles - Door Latch Freezing Concerns

REF: **Customer Satisfaction Program 18N03 - Supplement #5**
 Dated March 20, 2019

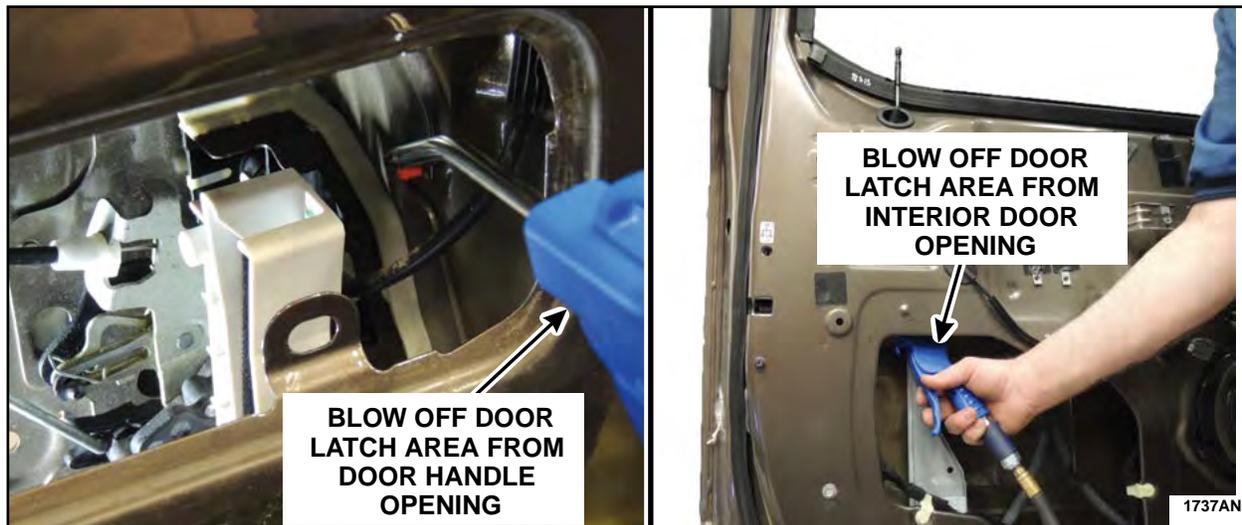
FIGURE 5

7. Using compressed air, blow out any debris or residual water from the door latch assembly, exterior door handle mechanism and cables for thirty seconds. Blow drying with compressed air for thirty seconds is critical to remove as much moisture as possible. See Figure 5.

NOTE: Driver front door latch shown, all door latches similar.

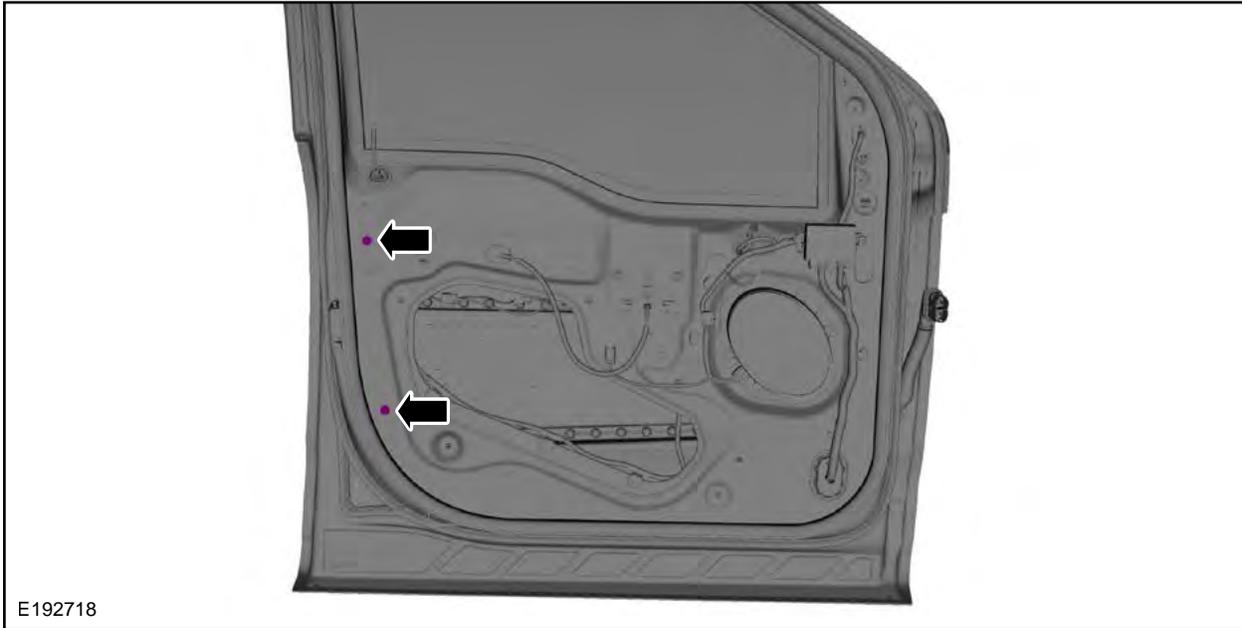
FIGURE 6

8. Loosen but do not remove the two door glass run bolts. See Figure 6.

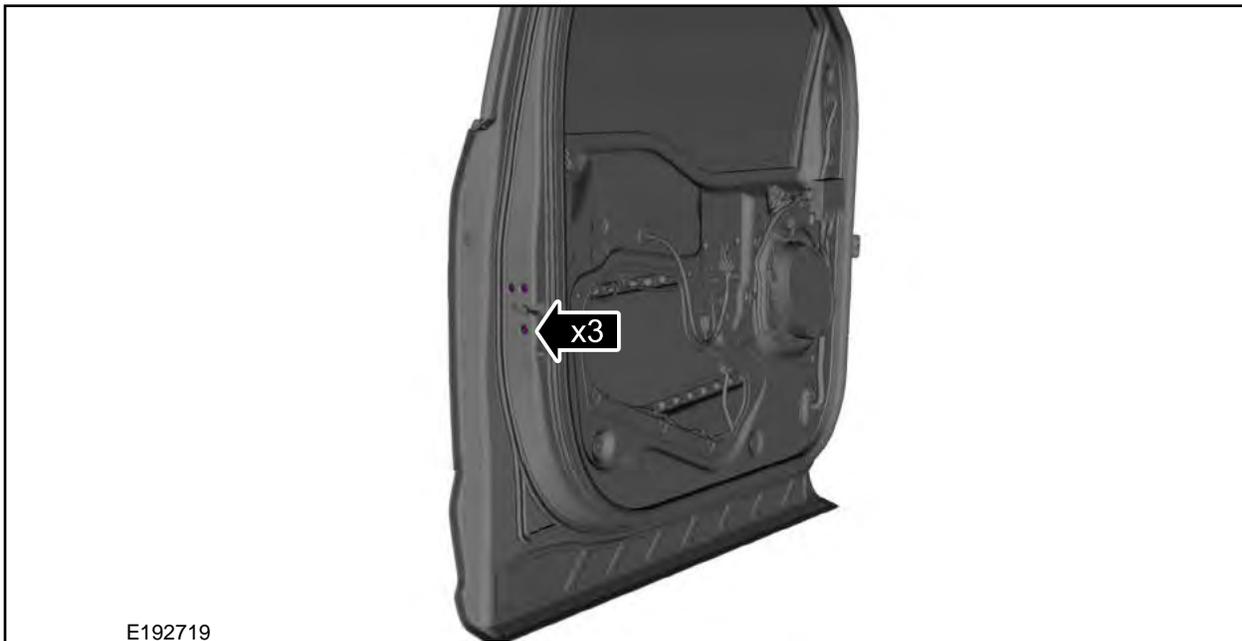
FIGURE 7

9. Loosen but do not remove the 3 door latch bolts. See Figure 7.

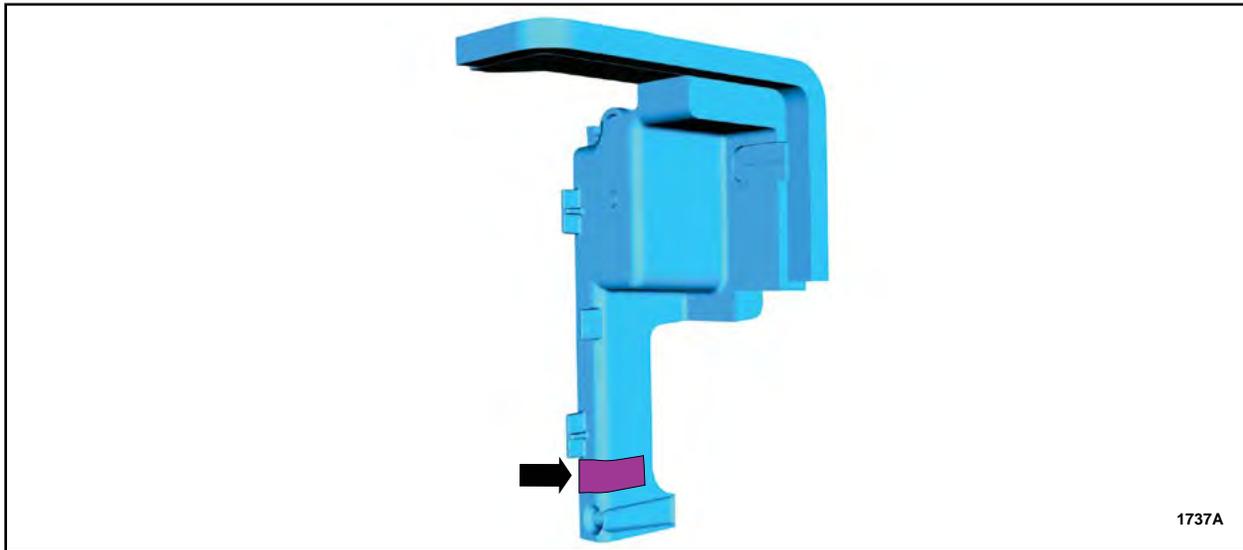
FIGURE 8

10. Apply supplied Foam Tape to the *new* water shield in the highlighted area. See Figure 8.

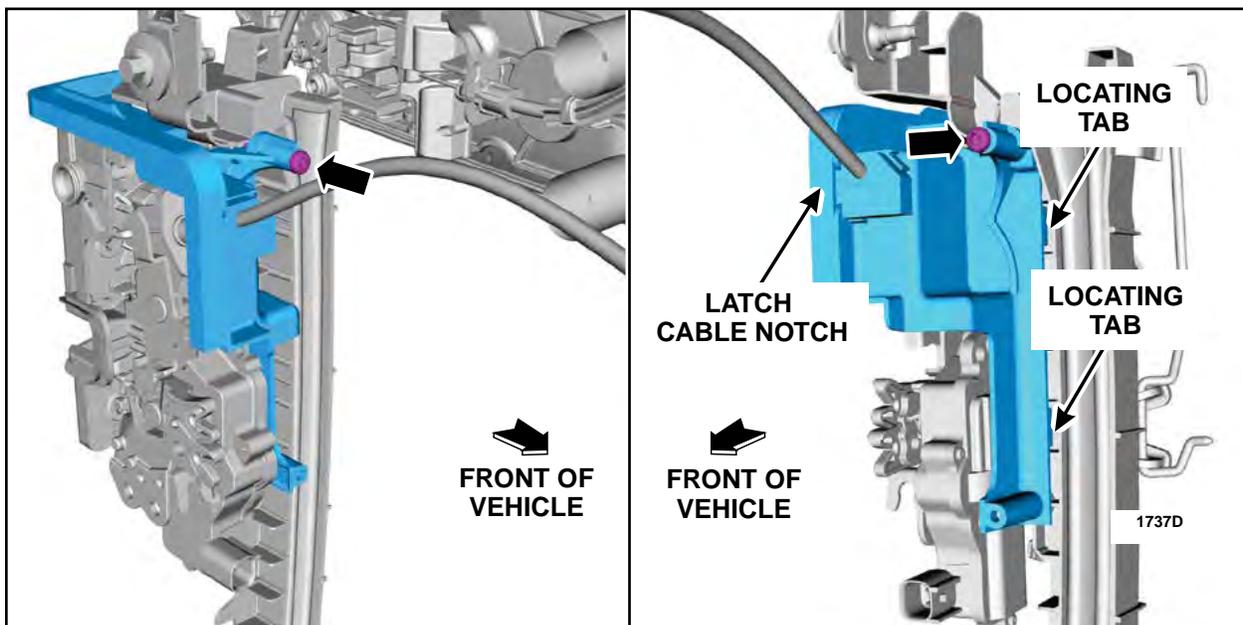
FIGURE 9

11. With the latch and door glass run assembly loose inside the door panel, install the door latch water shield into position. See Figure 9.

NOTE: The lower fastener hole of the shield is not used on the front water shields.

NOTE: Driver door latch shown, passenger door latch similar.

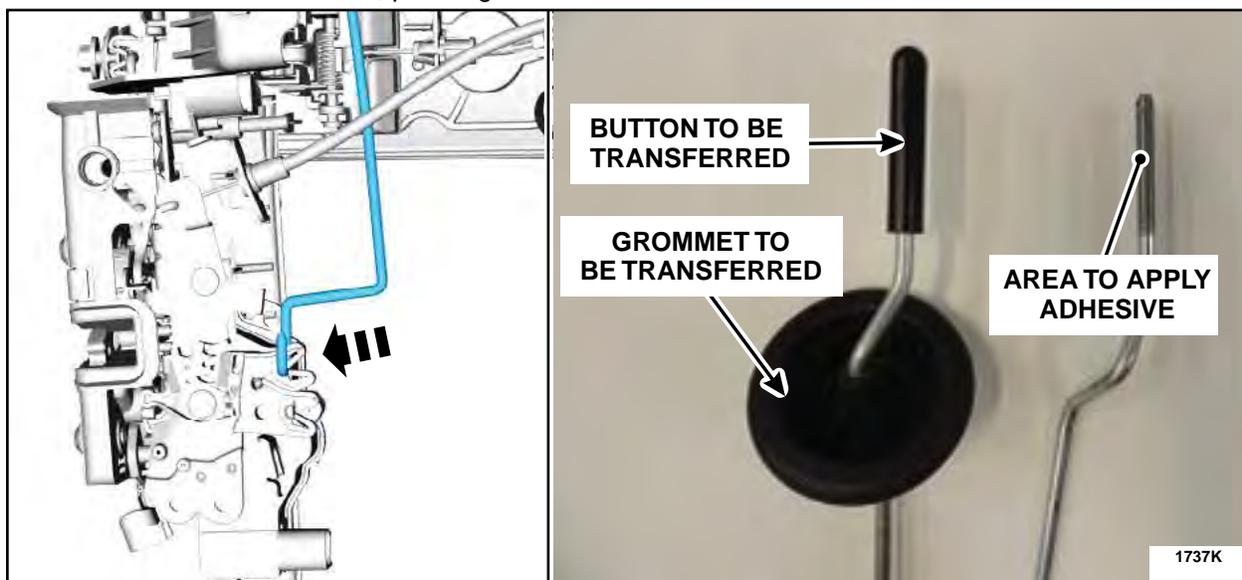
FIGURE 11

NOTE: If a replacement lock rod already has a button and grommet installed, transfer of the components is not required.

17. Replace the lock rod and transfer the necessary components. See Figure 11.

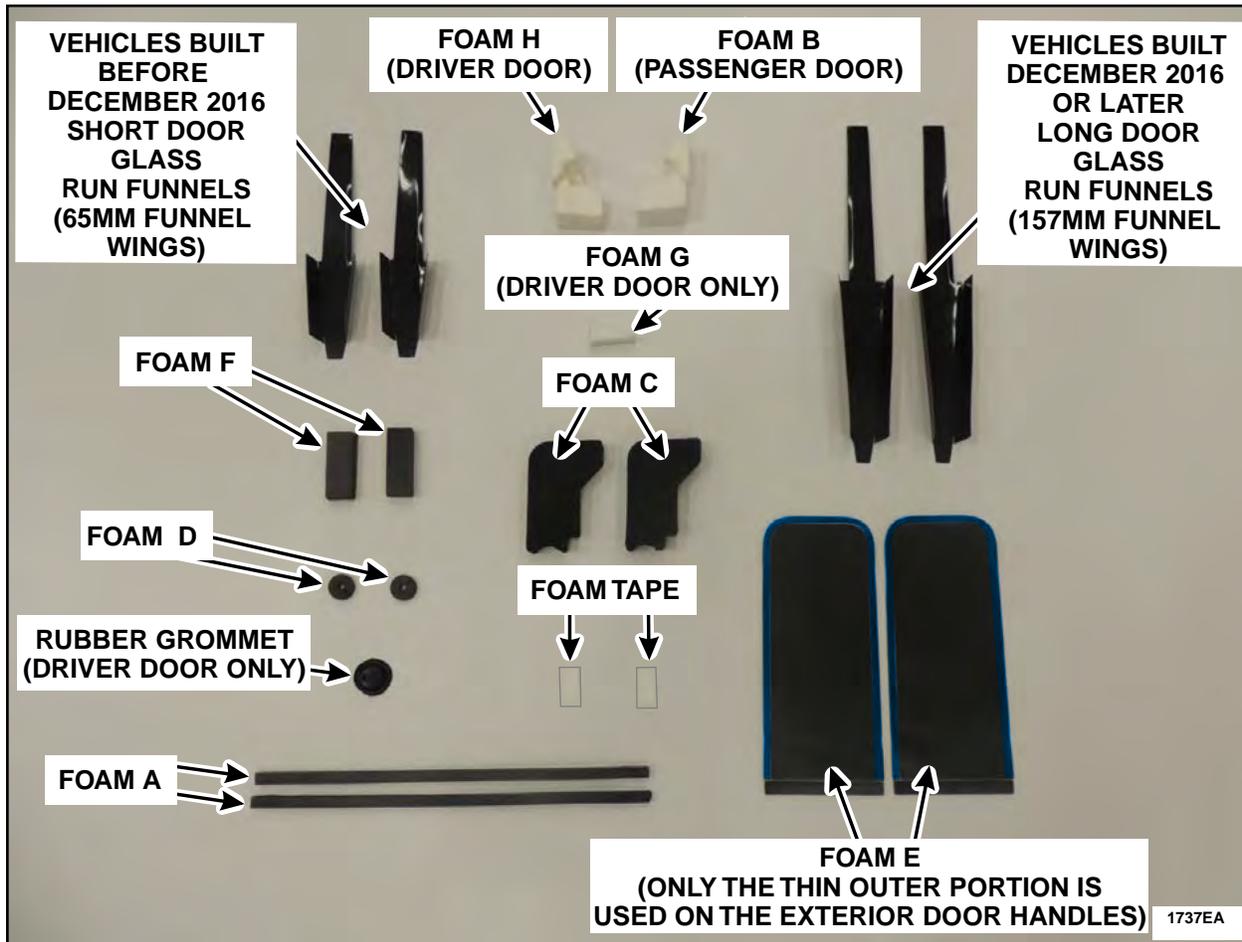
FIGURE 12

Complete Front Door Part Kit - Each Kit Will Include Either Long Door Glass Run Funnels Or Short Door Glass Run Funnels

NOTE: The parts being installed in this procedure are not labeled. Refer to Figure 12 for component identification.

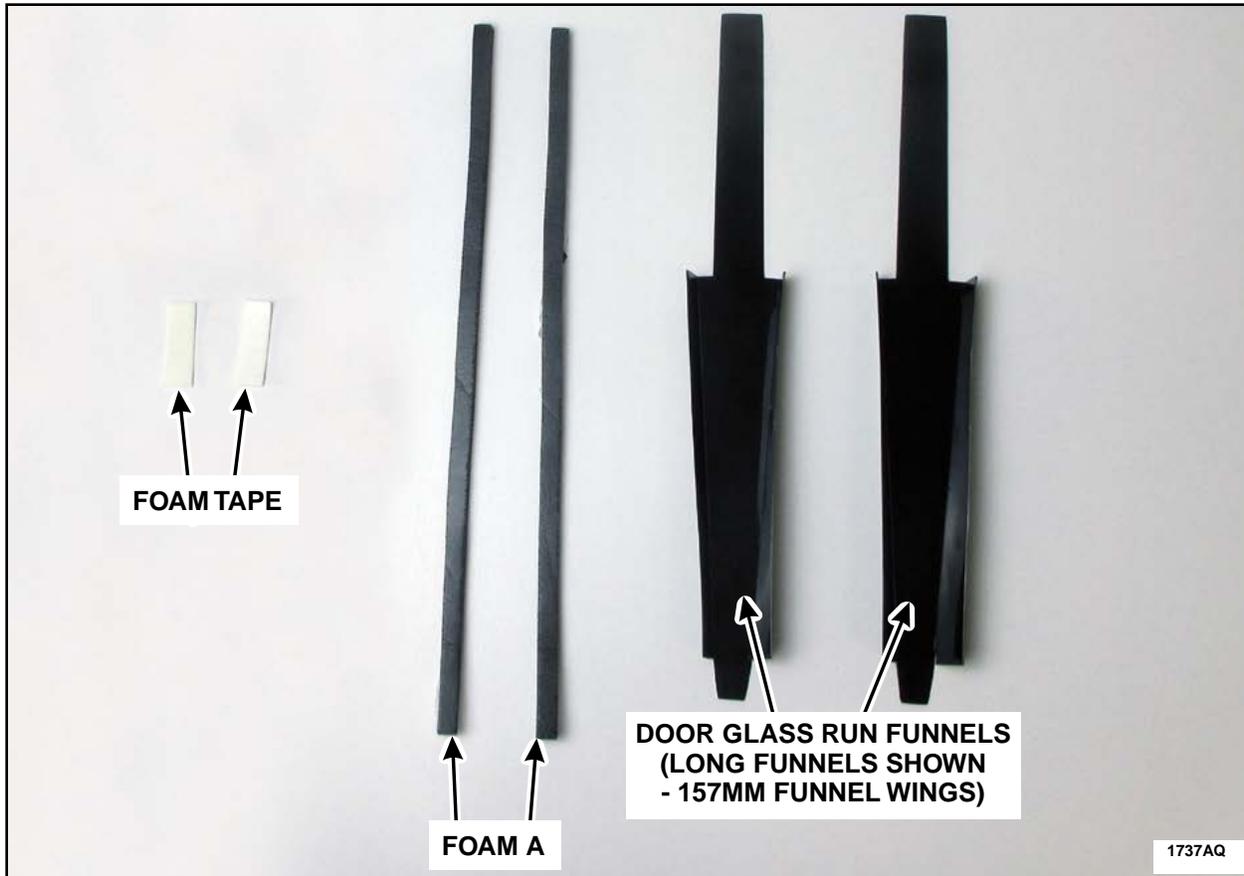
FIGURE 13

Front Door Glass Run and Belt Moulding Sealing Components

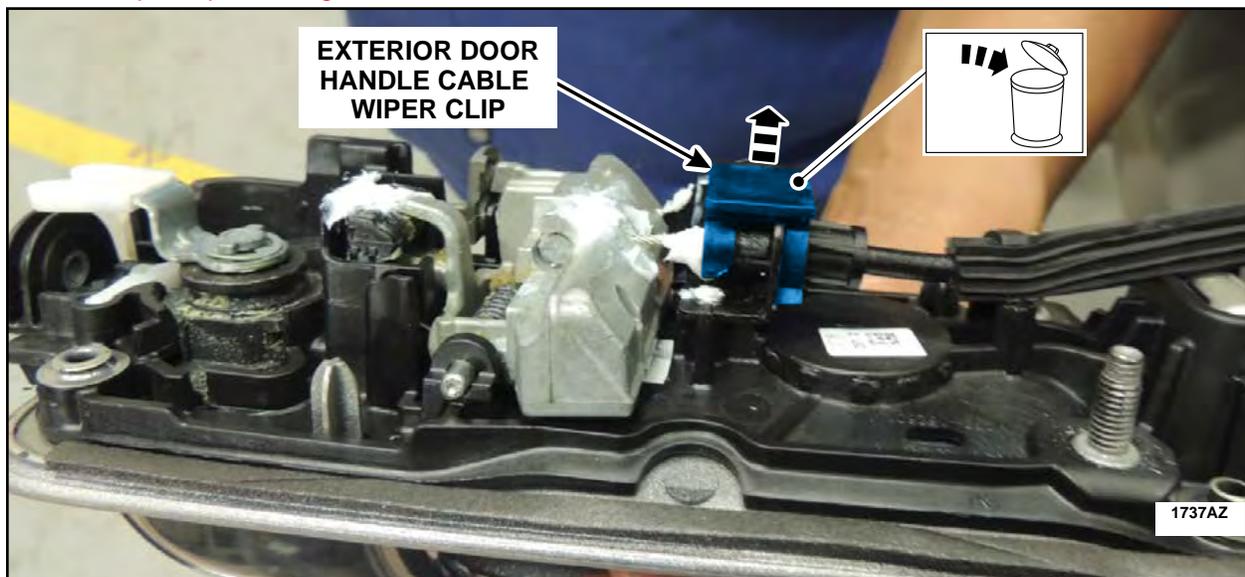
FIGURE 14

2. *If a cable wiper clip is present on the exterior door handle cable end, remove and discard the cable wiper clip. See Figure 14.*

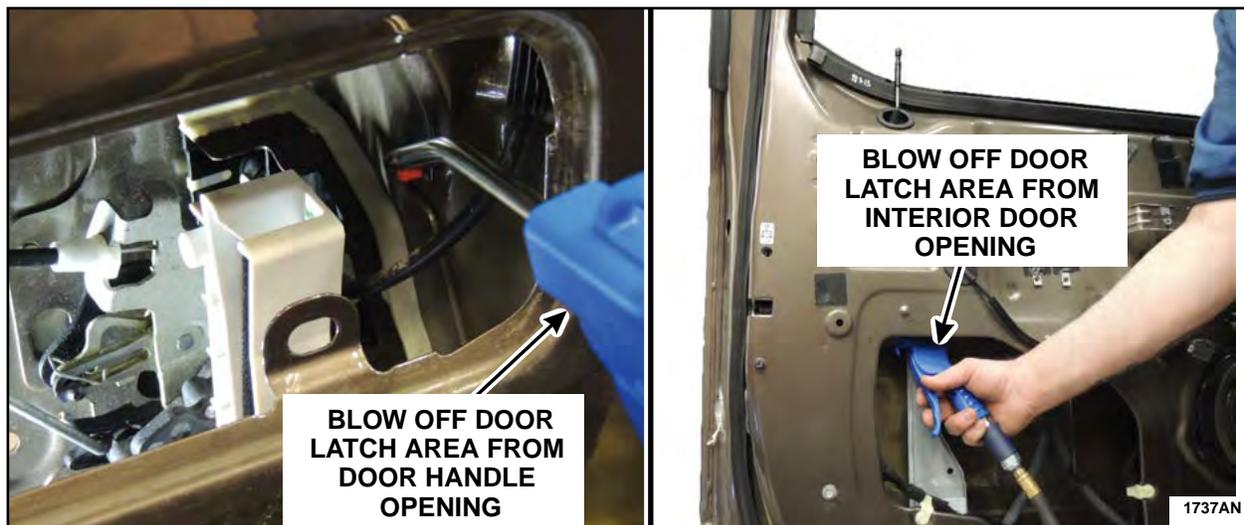
FIGURE 16

4. If not previously performed, use compressed air and blow out any debris or residual water from the door latch assembly, exterior door handle mechanism and cables for thirty seconds. Blow drying with compressed air for thirty seconds is critical to remove as much moisture as possible. See Figure 16.

NOTE: Driver front door latch shown, all door latches similar.

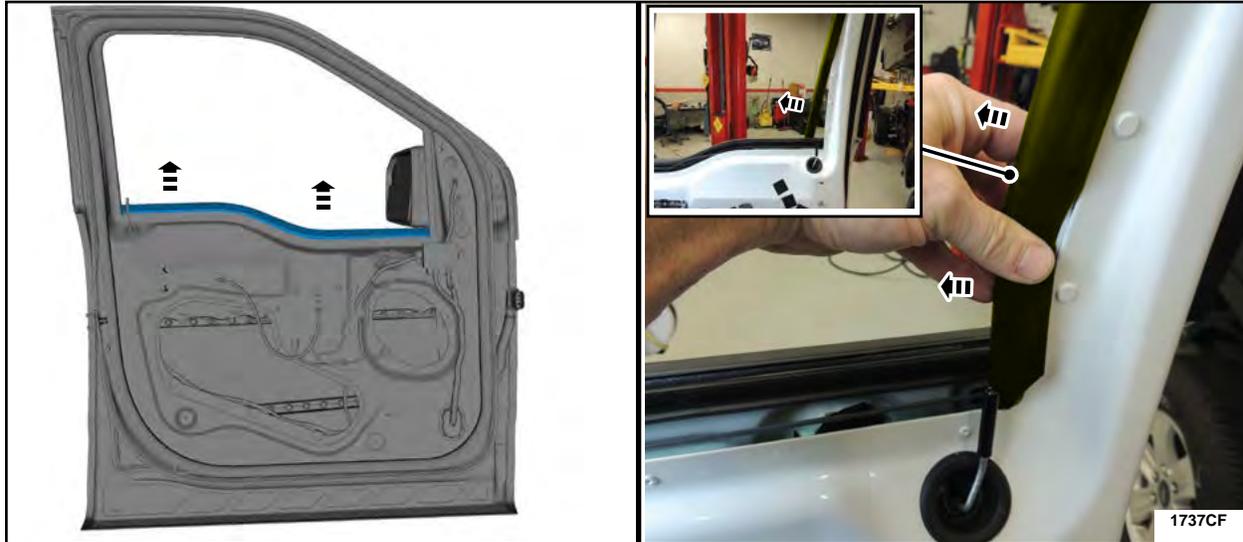
FIGURE 17

5. Position the front door window glass down.
6. Remove the inner belt moulding and position aside the latch side of the door glass top run.
See Figure 17.

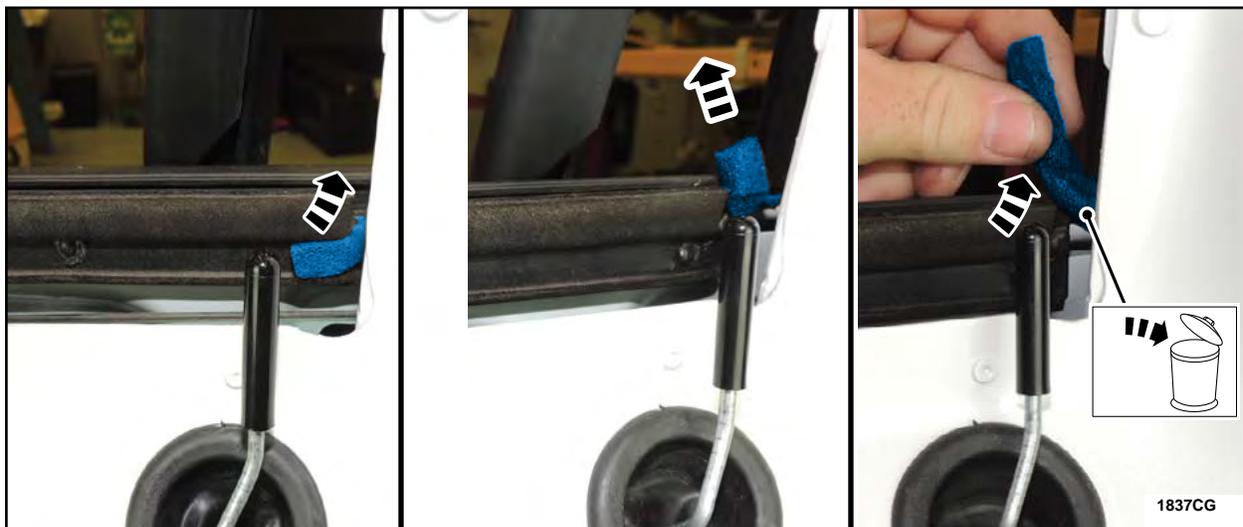
FIGURE 18

7. If present, remove and discard existing foam on the driver and passenger side outer belt moulding (also known as upper belt moulding) at this location. See Figure 18.

NOTE: Passenger door shown, driver door similar.

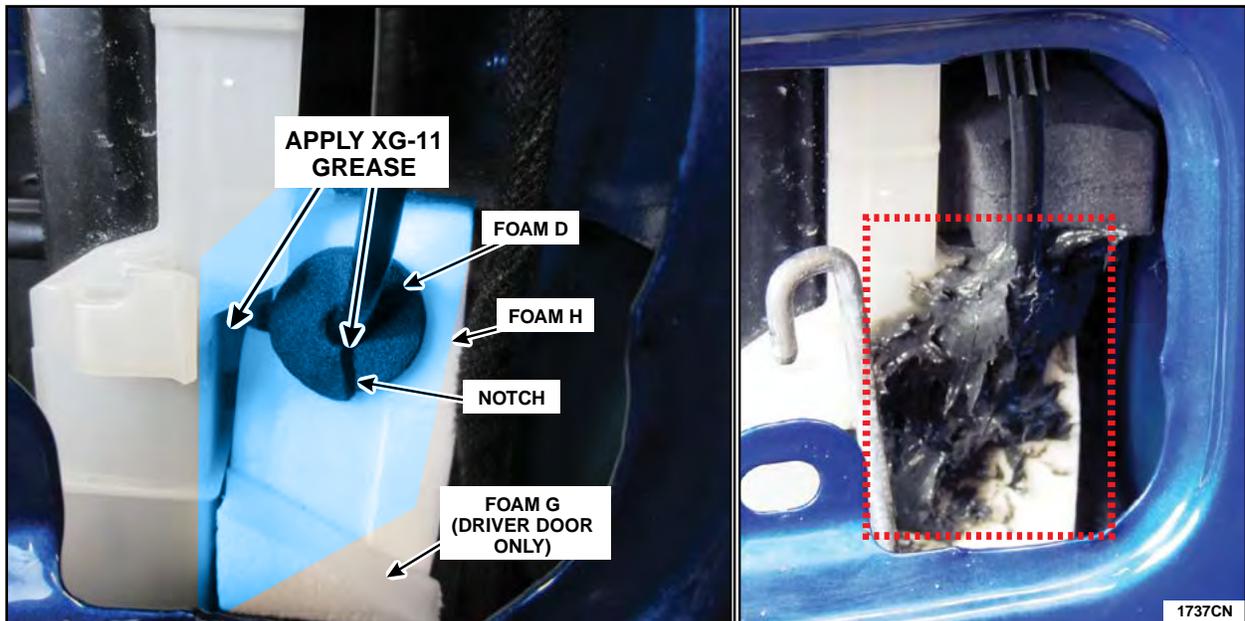
FIGURE 38

9. Apply XG-11 grease on top of and around Foam D after Foam D is installed. The Foam D notch, the gap between the cable and Foam D, and the gap between the door glass run and Foam H must be covered with grease. See Figure 38.

NOTE: Driver door shown, passenger door similar.

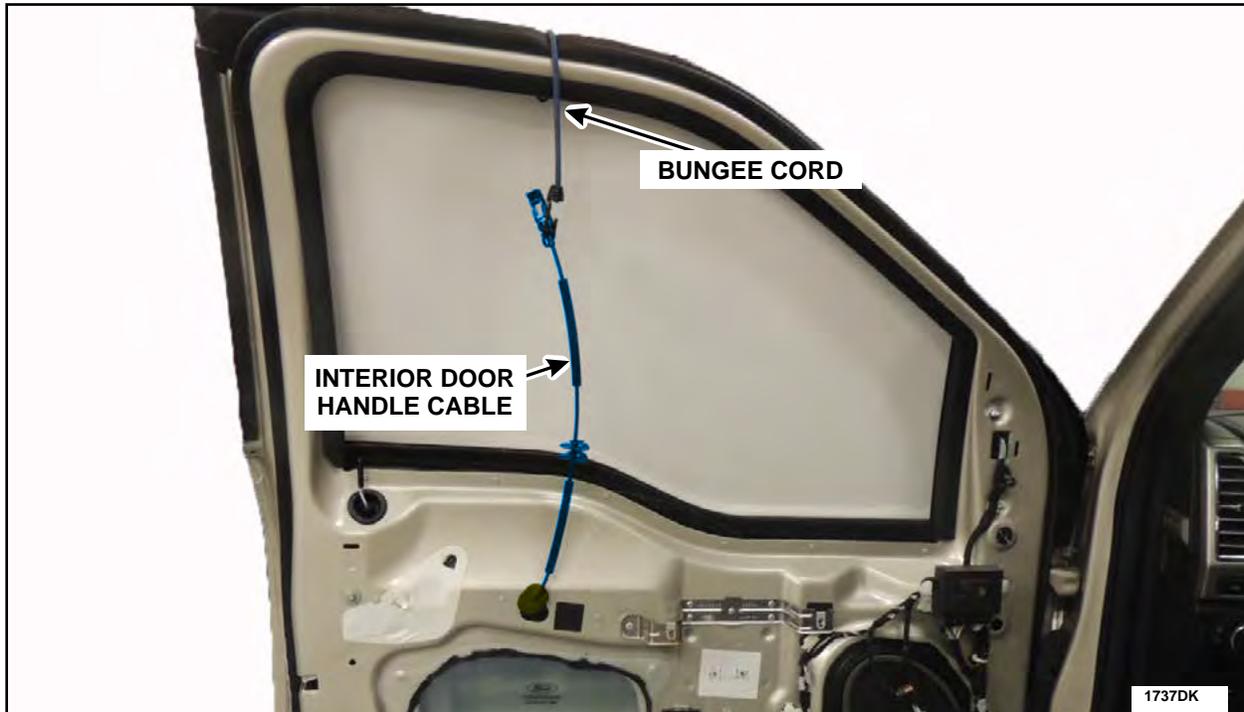
FIGURE 41

- Using a bungee cord or other similar device, secure the interior door handle cable to the door in an upward position to allow the Motorcraft® XL-6 Lubricant time to run down into the cable, until the interior door handle cable is reinstalled later in this procedure. See Figure 41.

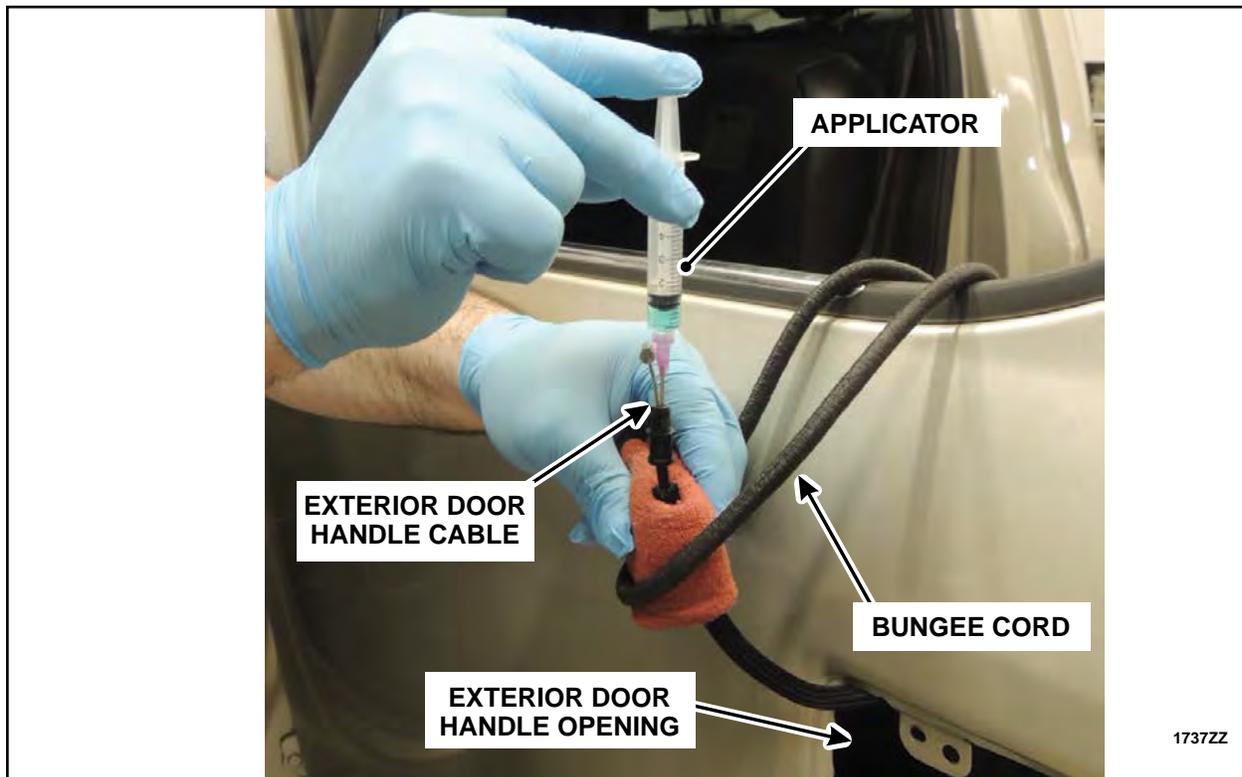
FIGURE 42

14. Towel dry the exterior door handle cable to absorb any residual moisture. Using a bungee cord or other similar device secure the exterior door handle cable to the door in an upward position as shown in Figure 42, to allow the undiluted Motorcraft® Premium Windshield Wash Concentrate (ZC-32-B2) or a 99 percent methyl hydrate (methanol) product time to run down into the cable, until the exterior door handle cable is reinstalled later in this procedure.

NOTE: Rear door shown, front door similar.

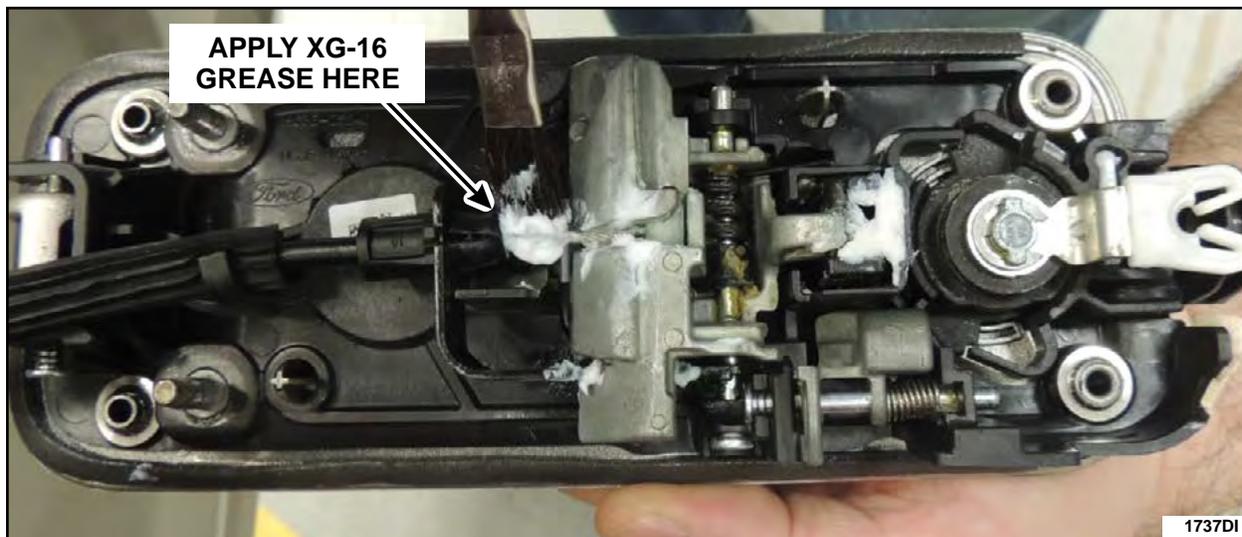
FIGURE 51

21. Remove the bungee cords used to hold the interior and exterior door handle cables up, seat the rubber grommet and if equipped, reinstall the interior door handle cable retaining clips.
22. Reconnect the exterior door handle cable to the door handle, then lubricate the door handle cable end with Motorcraft® XG-16 low temperature grease, as shown in Figure 51.

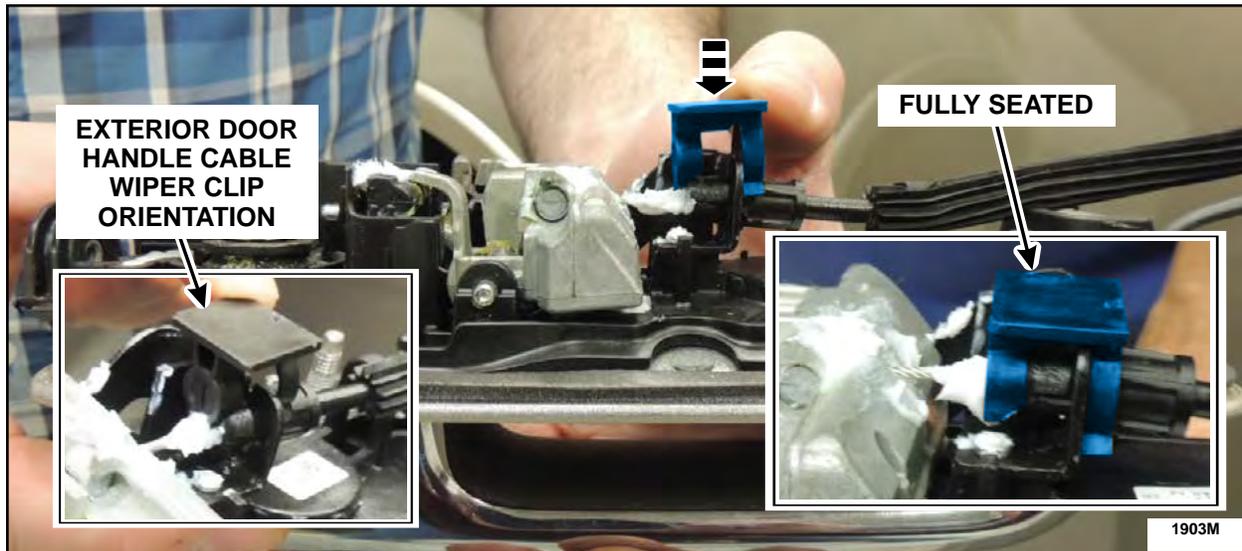
FIGURE 52

23. Install a *new* handle cable wiper clip on the exterior door handle cable end. See Figure 52.

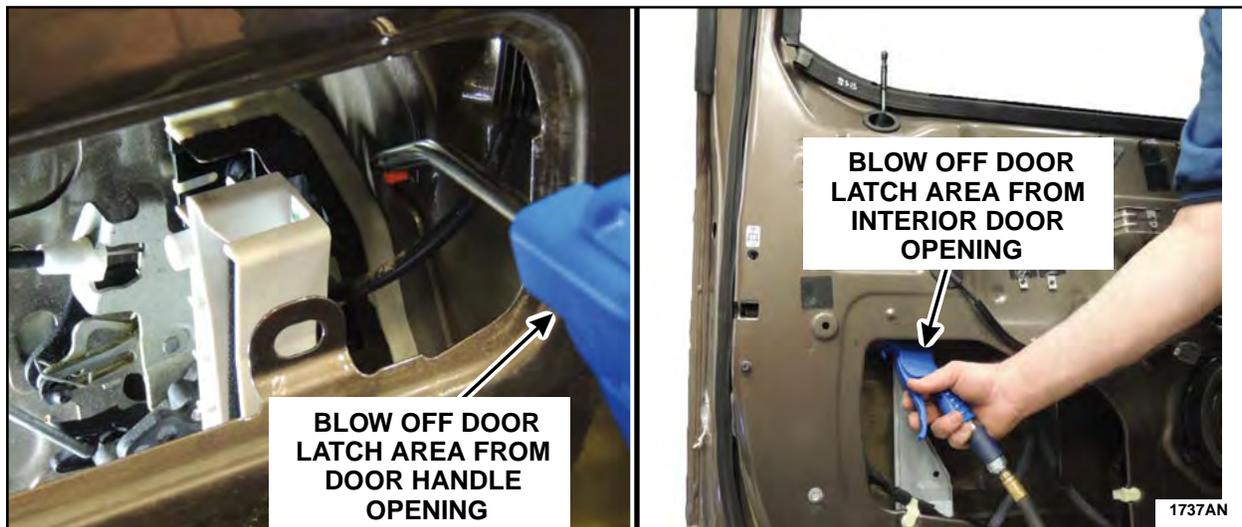
FIGURE 55

4. Using compressed air, blow out any debris or residual water from the door latch assembly, exterior door handle mechanism and cables for thirty seconds. Blow drying with compressed air for thirty seconds is critical to remove as much moisture as possible. See Figure 55.

NOTE: Driver front door latch shown, all door latches similar.

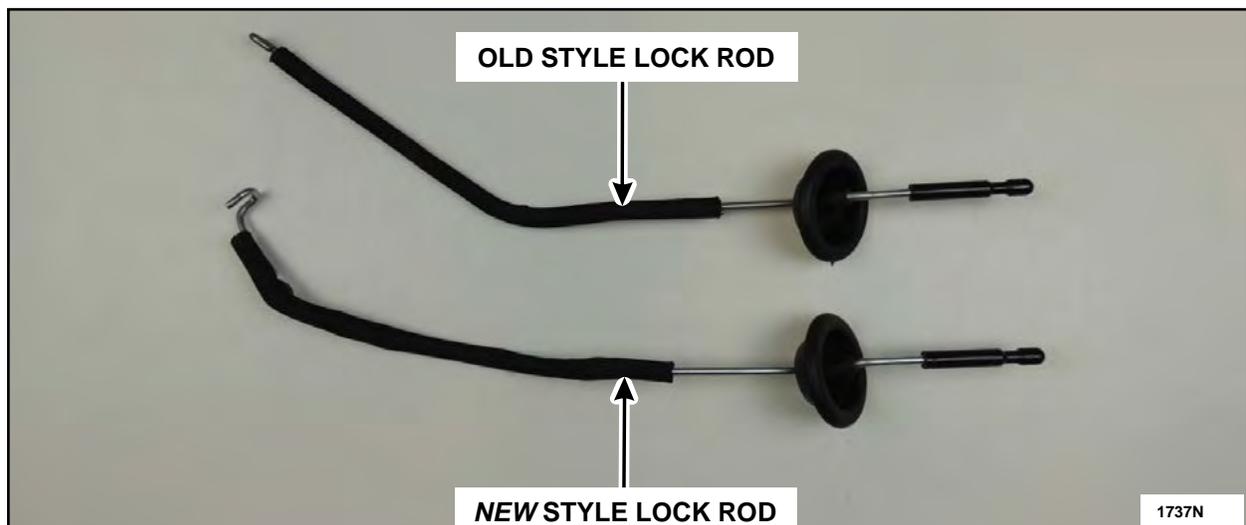
FIGURE 57

7. Refer to Figure 57 to determine if the door latch is equipped with the *new* style lock rod.

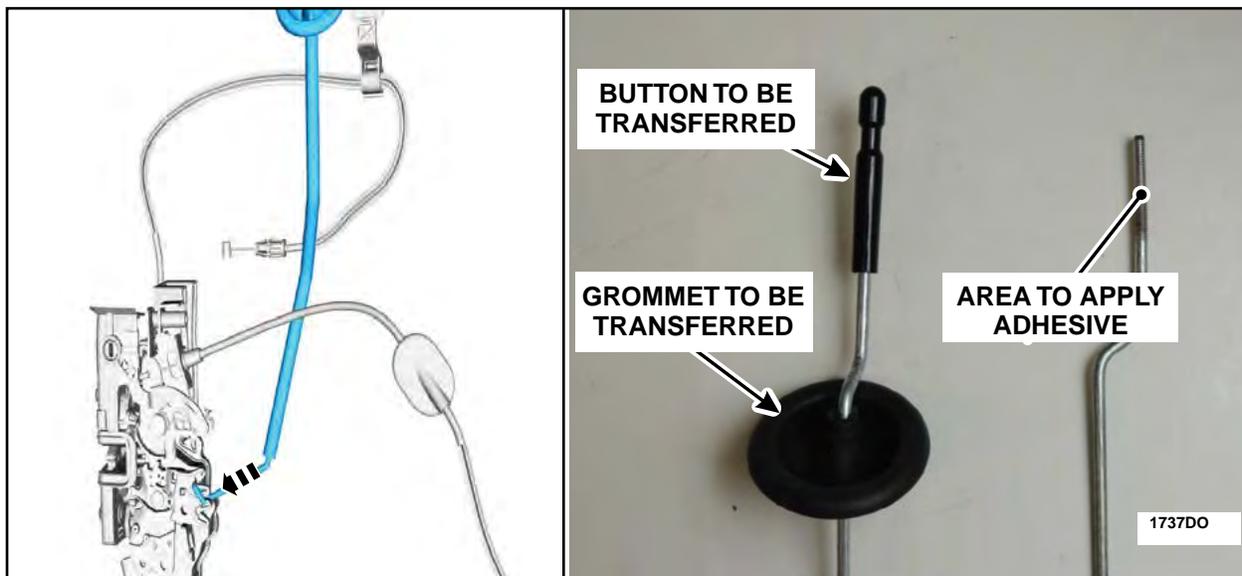
FIGURE 58

8. Lock rod replacement procedure. See Figure 58.

NOTE: If a replacement lock rod already has a button and grommet installed, transfer of the components is not required.

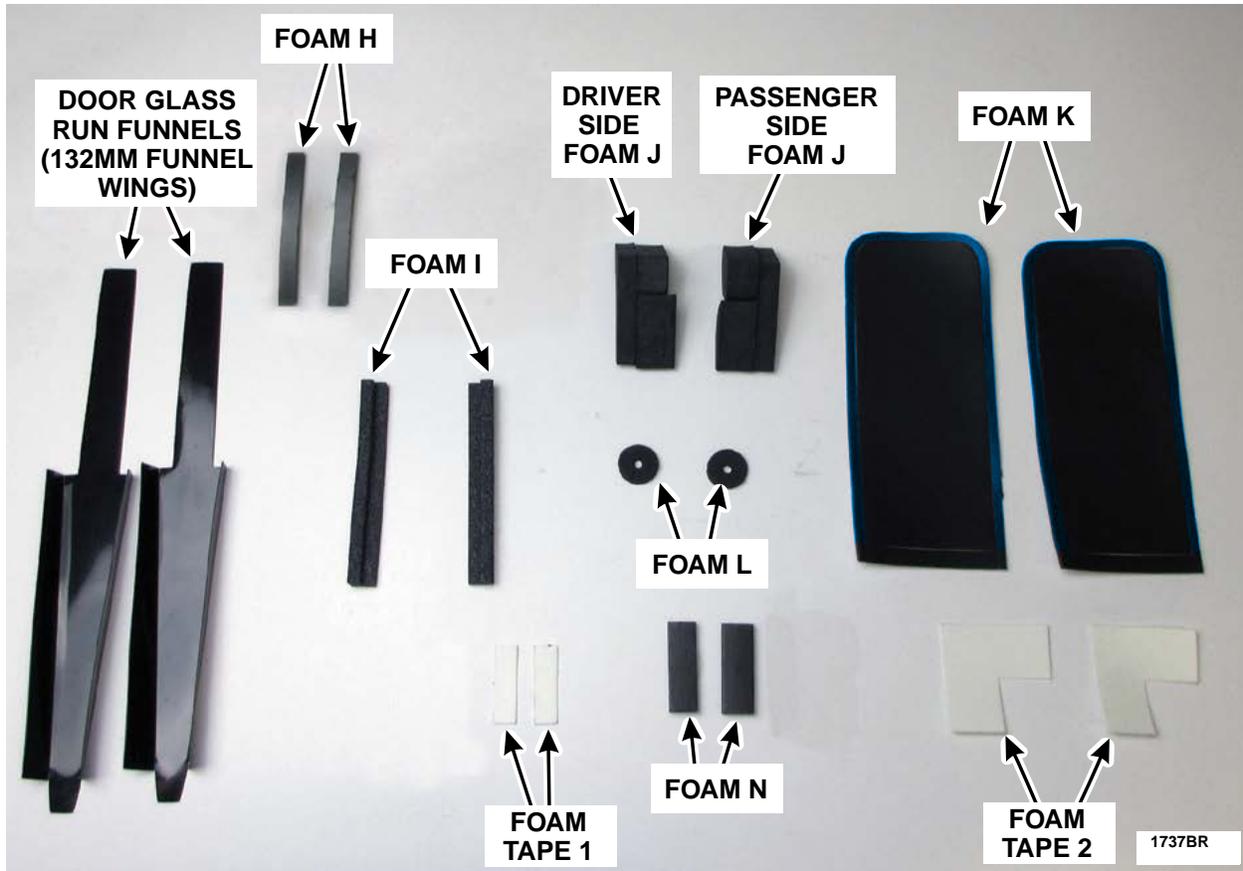
FIGURE 59

Complete Rear Door Part Kit

NOTE: The parts being installed in this procedure are not labeled. Refer to Figure 59 for component identification.

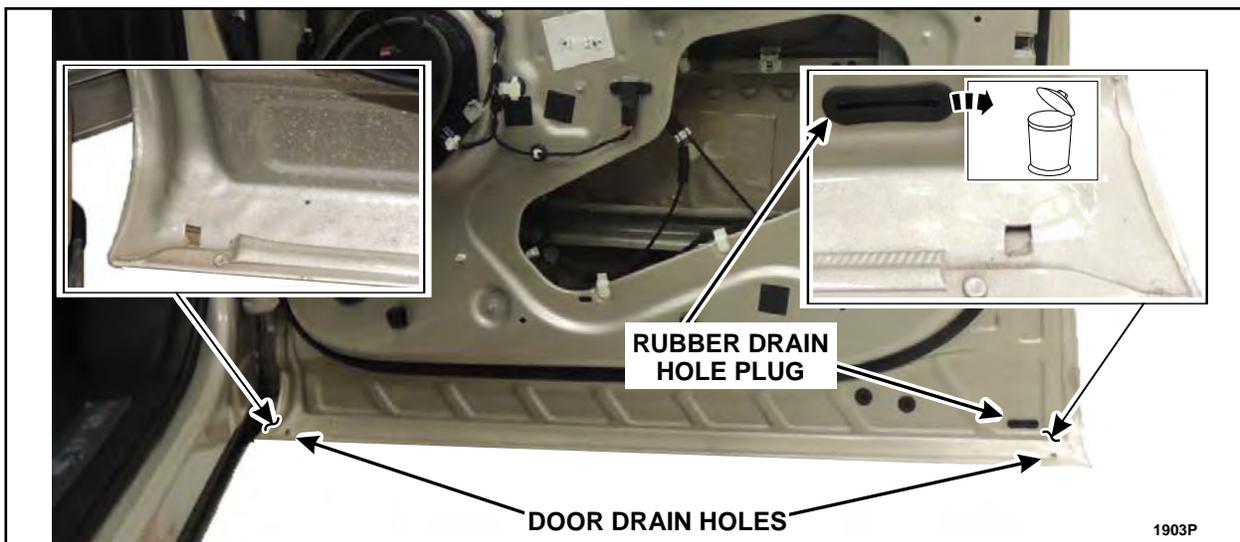
FIGURE 62

3. If water shield kit installation was not necessary, remove and discard the rubber drain plug and clean any obstructions, debris, foreign material and residual water from all of the door drain holes using compressed air and a *tool such as a plastic trim tool or a zip tie*. See Figure 62.

NOTE: Front passenger door shown, all doors similar.

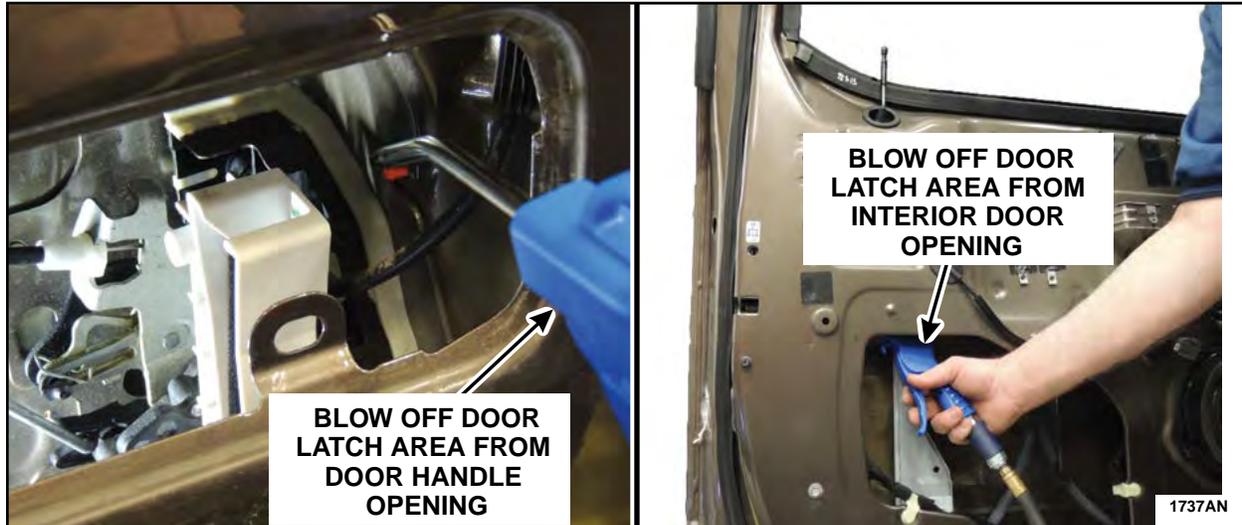
FIGURE 63

4. If not previously performed, use compressed air and blow out any debris or residual water from the door latch assembly, exterior door handle mechanism and cables for thirty seconds. Blow drying with compressed air for thirty seconds is critical to remove as much moisture as possible. See Figure 63.

NOTE: Driver front door latch shown, all door latches similar.

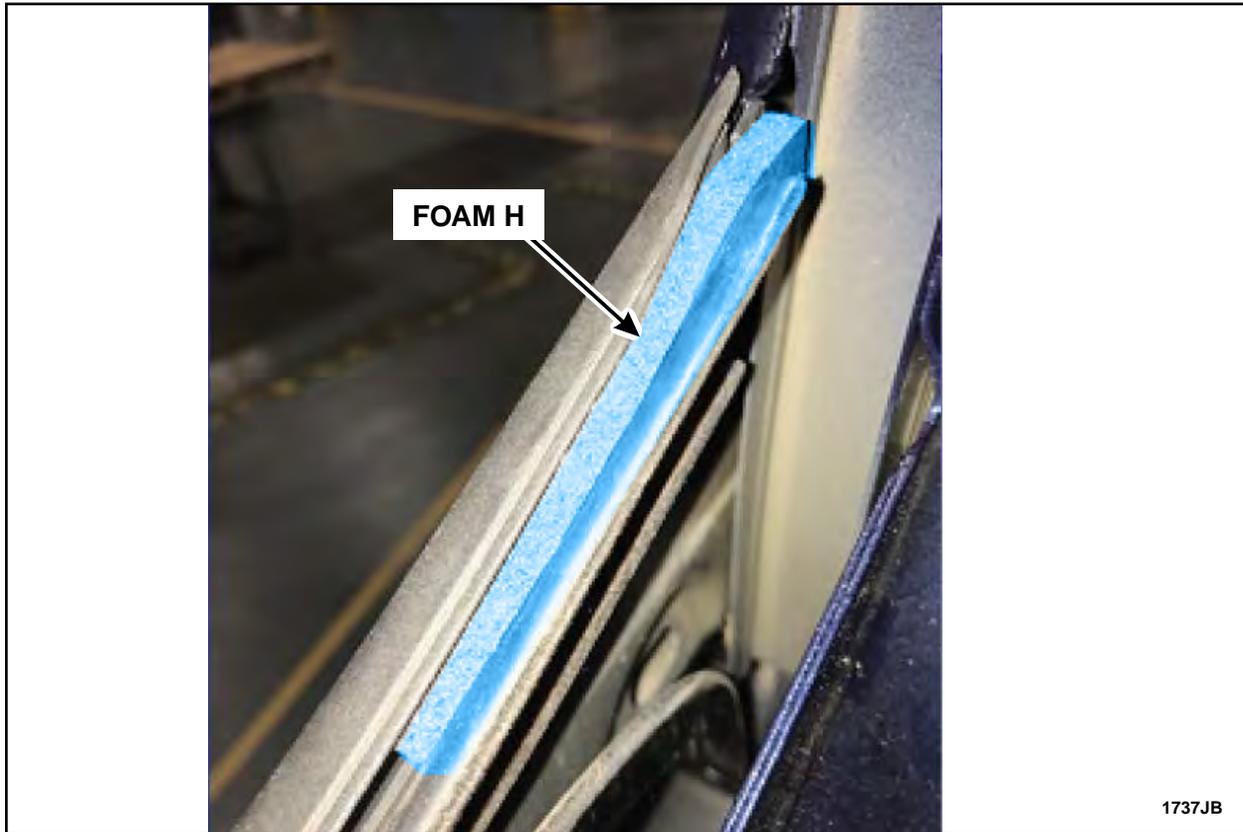
FIGURE 69

10. Install Foam H to the C-pillar end of the outer belt moulding. See Figure 69.

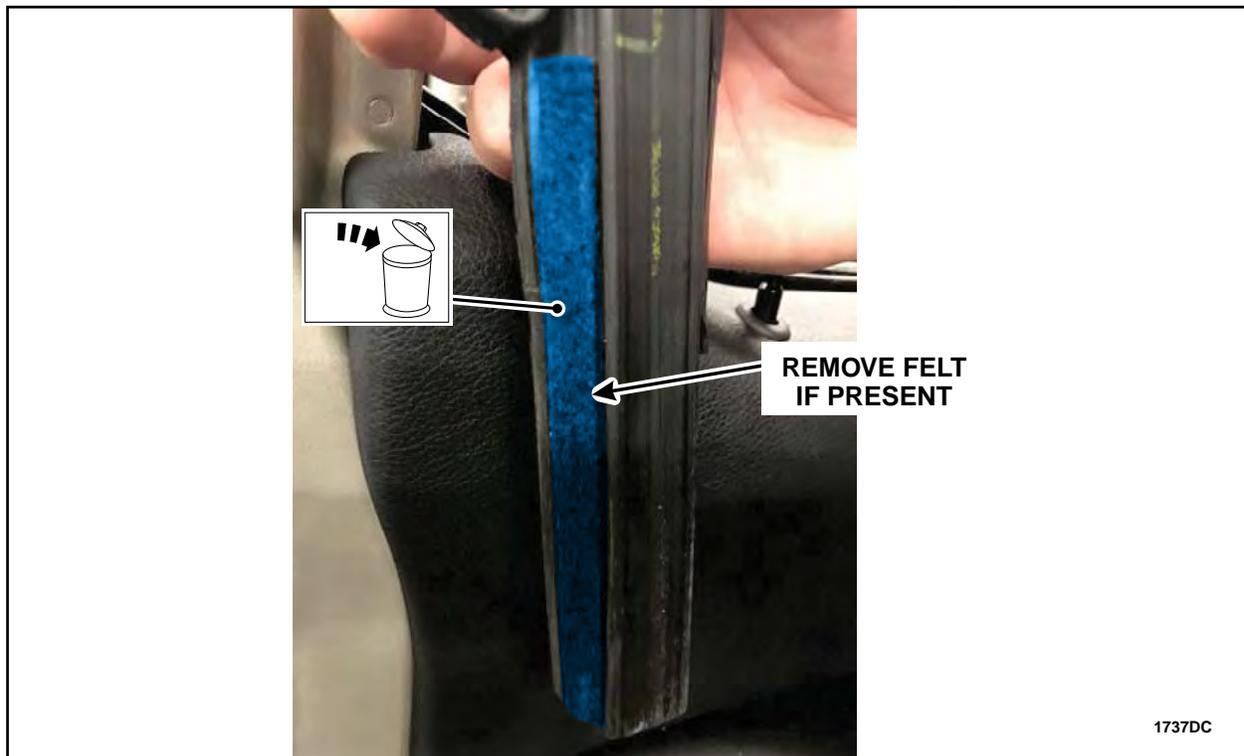
FIGURE 71

13. If present, remove and discard the felt on the rear door glass top run. See Figure 71.

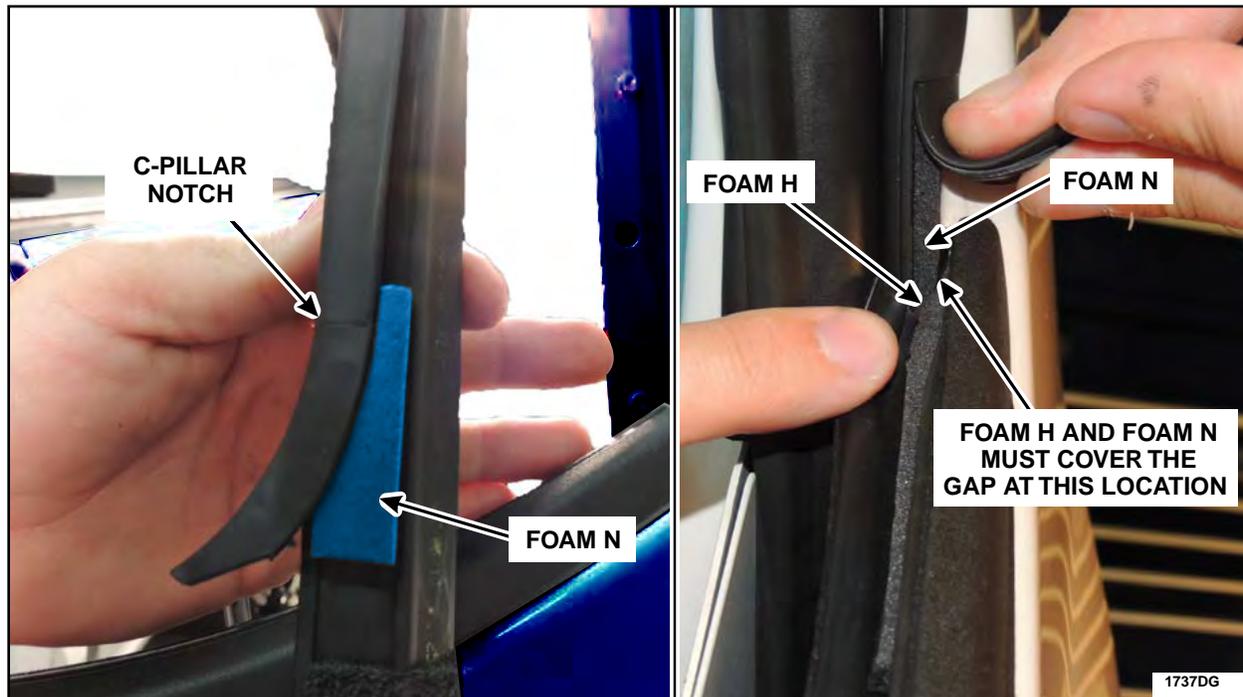
FIGURE 73

15. Install Foam N to the highlighted area of rear door glass top run making sure that the Foam N is under the C-Pillar notch. See Figure 73.

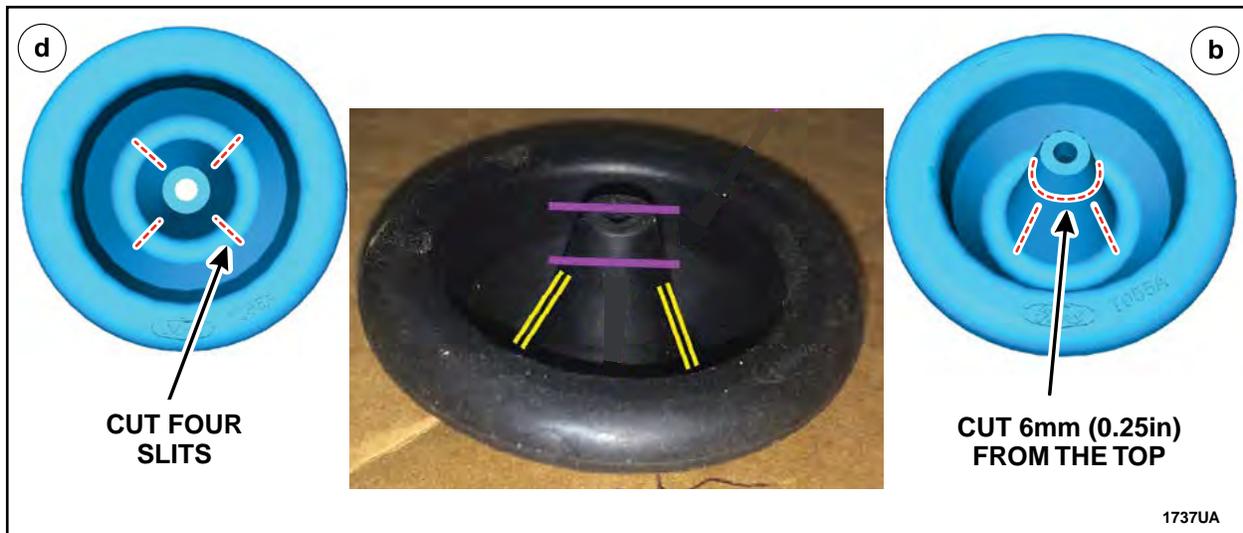
FIGURE 75

17. Modify the rear door lock rod grommet. See Figure 75.

- Remove the rear door lock rod grommet from the lock rod.
- Cut approximately 6 mm (0.25 in) off the top of the grommet.
- Install the rear door lock rod grommet back onto the lock rod.
- Using a utility knife, cut four 6 mm (0.25 in) long slits approximately 90° apart into the lower portion of the rear door lock rod grommet.
