David J. Johnson
 Director
 Service Engineering Operations
 Ford Customer Service Division

SUBJECT: **Customer Satisfaction Program 18N03 - Supplement #6**
 Certain 2015-2018 Model Year F-150 and 2017-2018 Model Year F-250-F-550
 Vehicles - Door Latch Freezing Concerns

REF: **Customer Satisfaction Program 18N03 - Supplement #5**
 Dated March 20, 2019

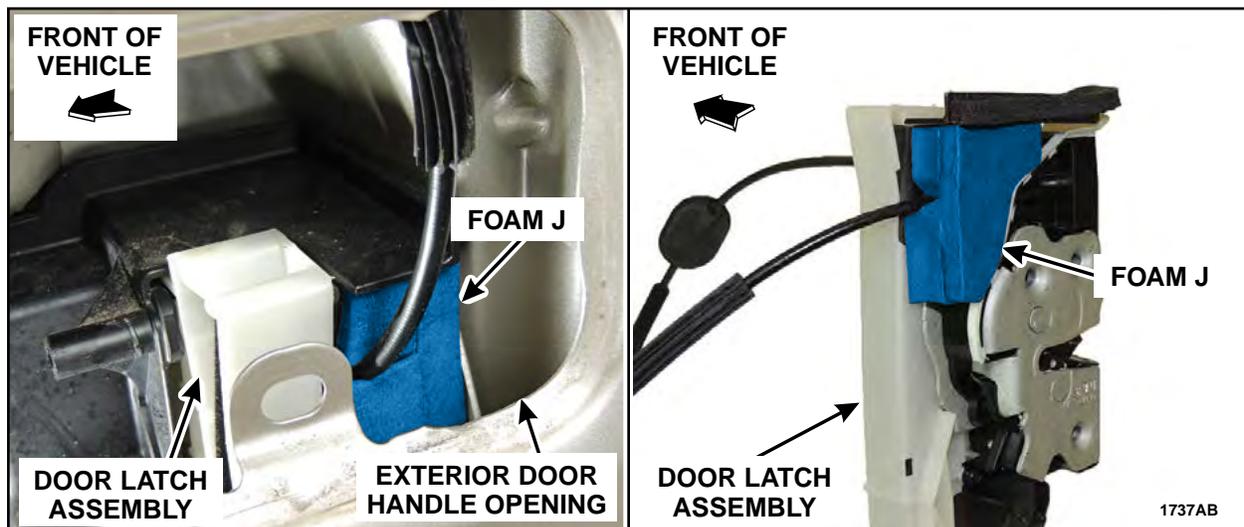
FIGURE 77

1. Install Foam J onto the rear door latch. See Figure 77.

NOTE: Driver door latch shown, passenger door latch similar.

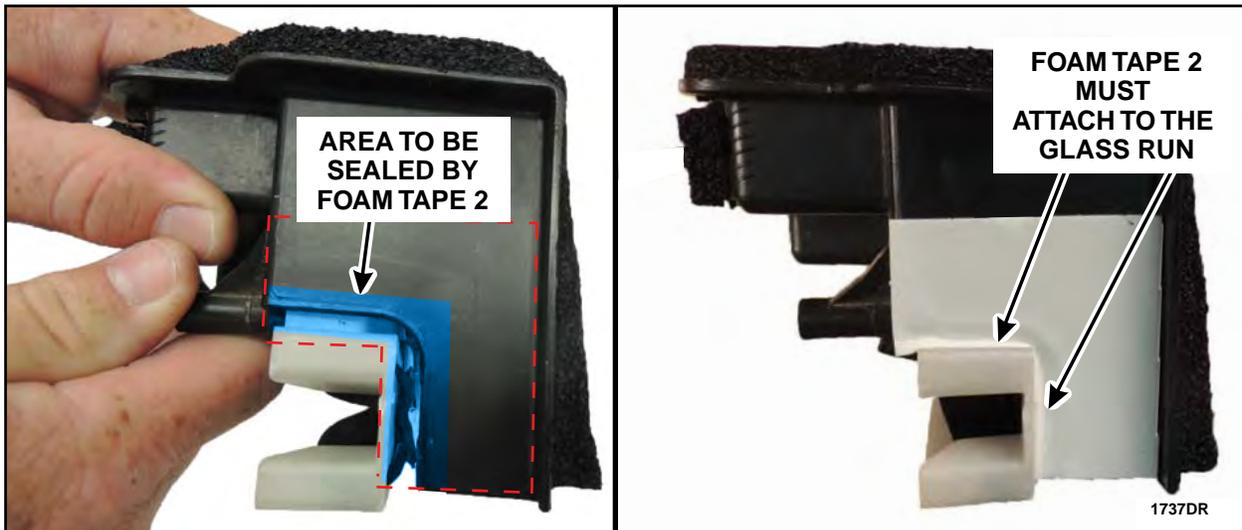
FIGURE 80

4. Install Foam Tape 2 on top of the rear door latch water shield. See Figures 80.

NOTE: Driver door latch shown, passenger door latch similar.

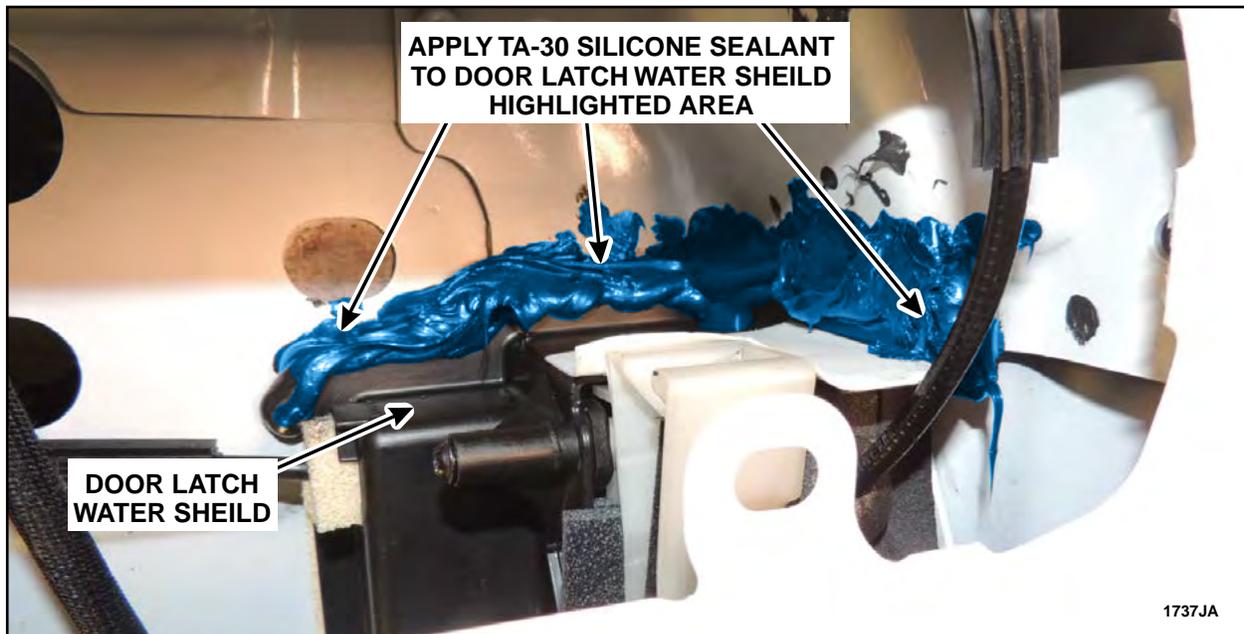
FIGURE 82

6. Apply Motorcraft® TA-30 silicone sealant in and over the mating area of the water shields to the door. Using light finger pressure smooth the bead of silicone. See Figure 82.

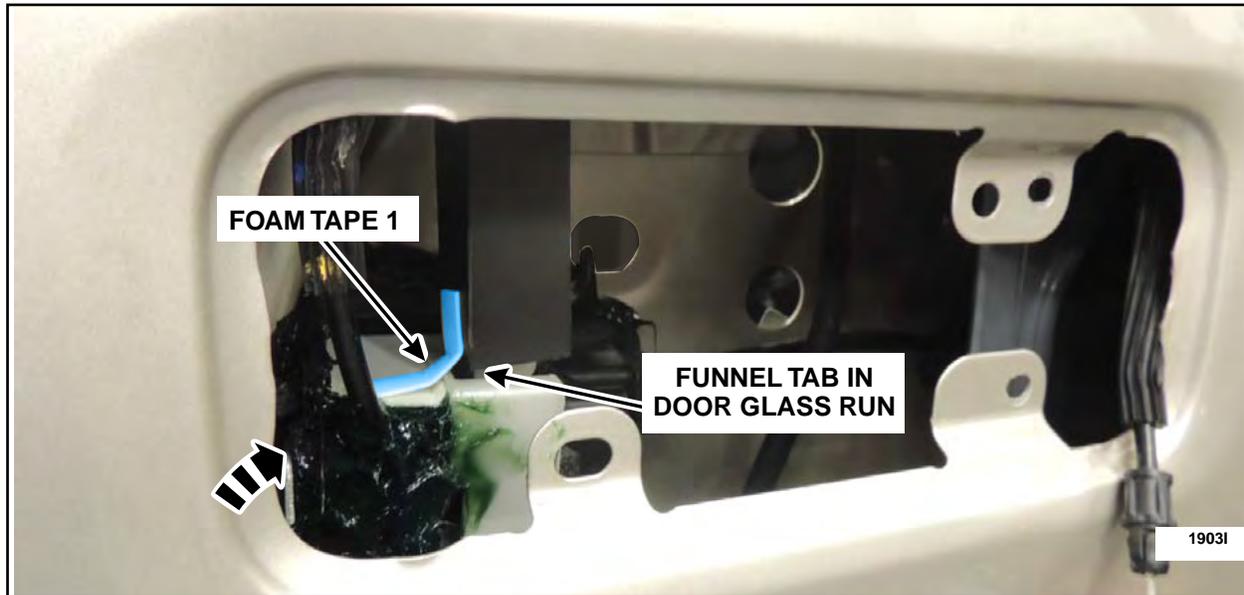
FIGURE 84

11. Apply supplied Foam Tape 1 in the location shown to hold the funnel in place. See Figure 84.

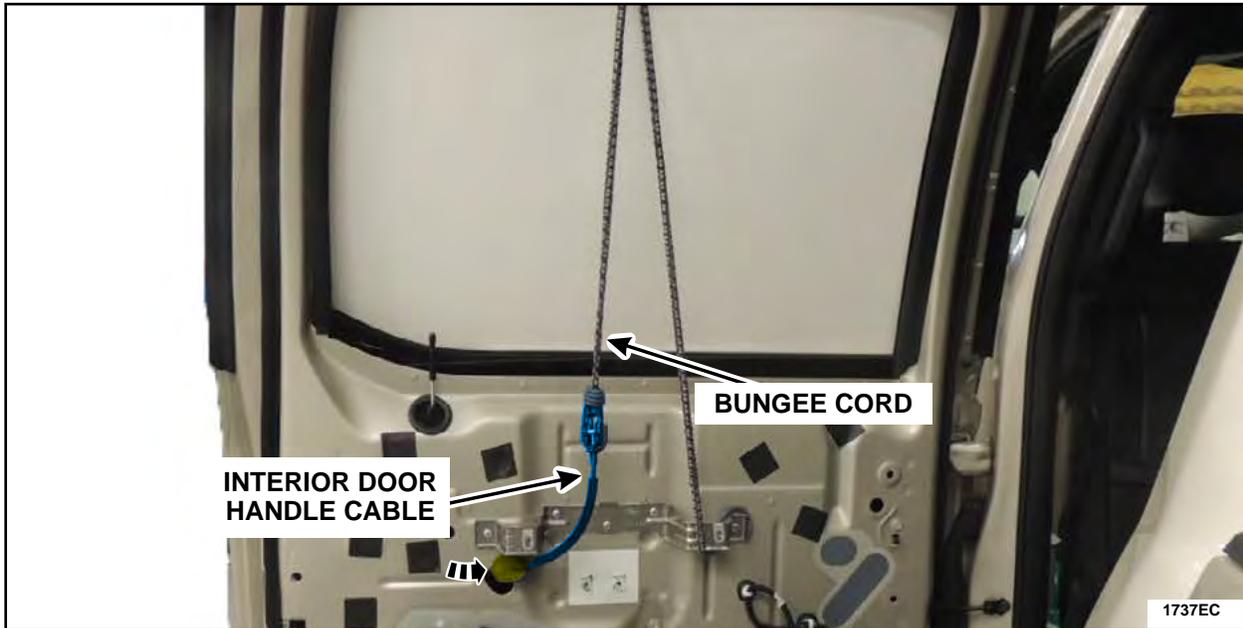
FIGURE 89

16. Using a bungee cord or other similar device, secure the interior door handle cable to the door in an upward position to allow the lubricant time to run down into the cable, until the interior door handle cable is reinstalled later in this procedure. See Figure 89.

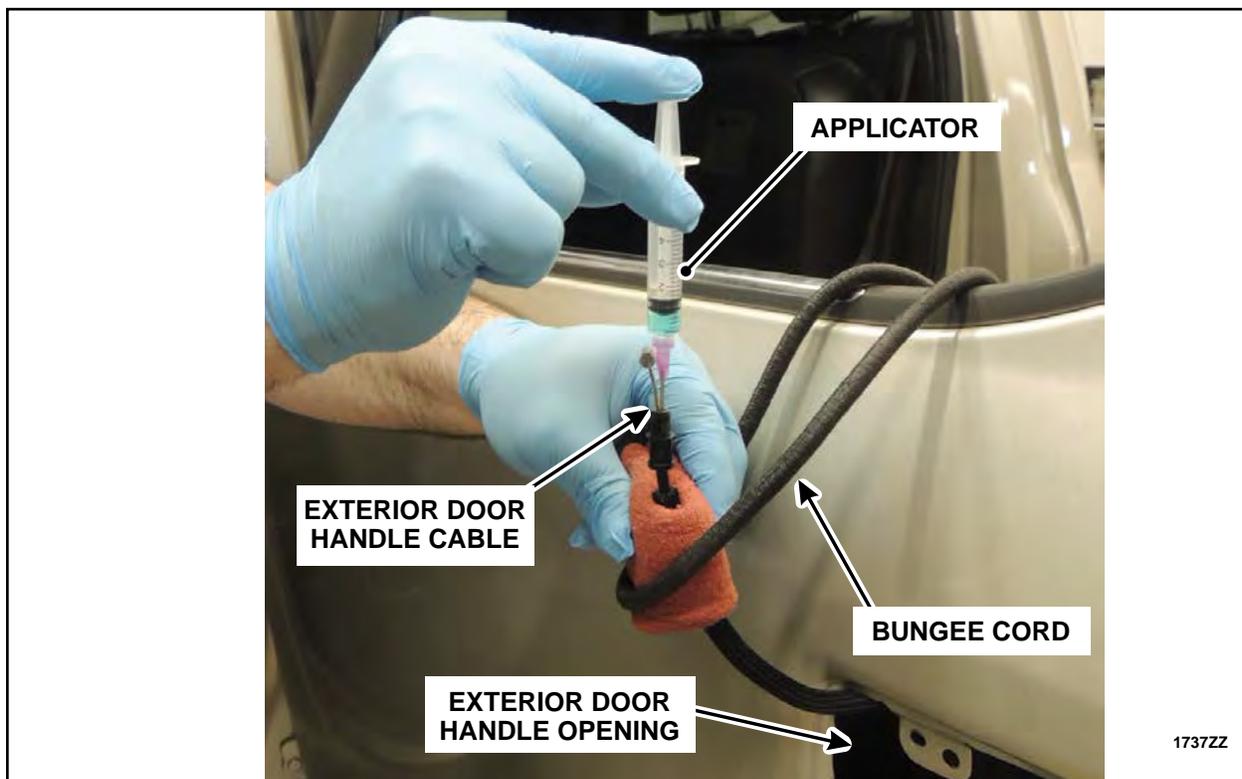
FIGURE 90

17. Towel dry the exterior door handle cable to absorb any residual moisture. Using a bungee cord or other similar device secure the exterior door handle cable to the door in an upward position as shown in Figure 90, to allow the undiluted Motorcraft® Premium Windshield Wash Concentrate (ZC-32-B2) or a 99 percent methyl hydrate (methanol) product time to run down into the cable, until the exterior door handle cable is reinstalled later in this procedure.

NOTE: Do not use a product that contains isopropyl alcohol. Only use a product containing methanol or a mix of methanol and ethylene glycol.

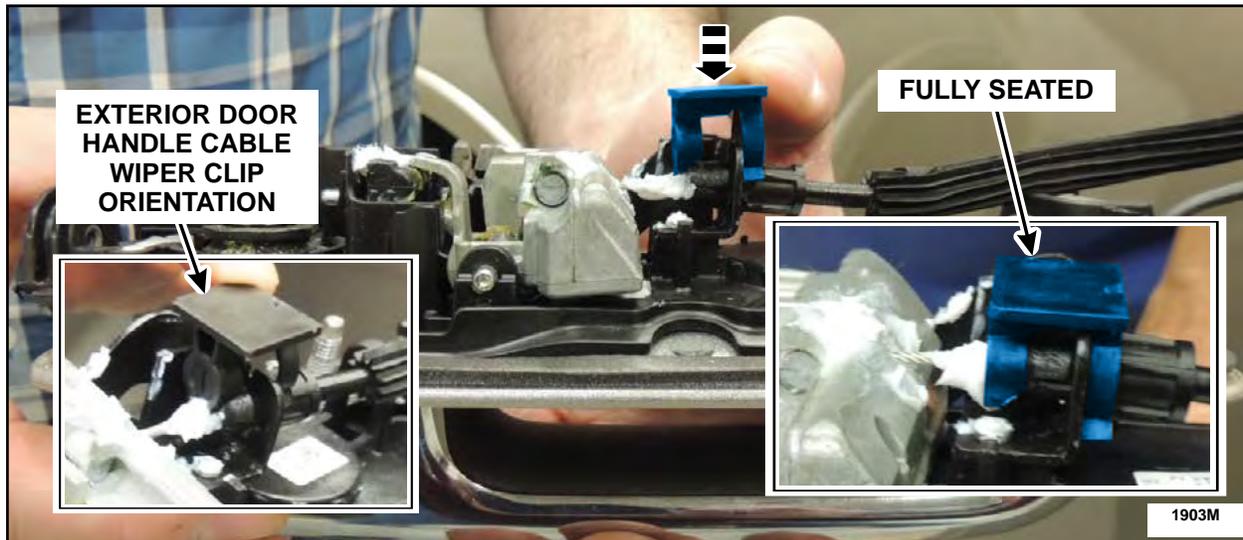
FIGURE 100

26. Install *a new* handle cable wiper clip on the exterior door handle cable end. See Figure 100.

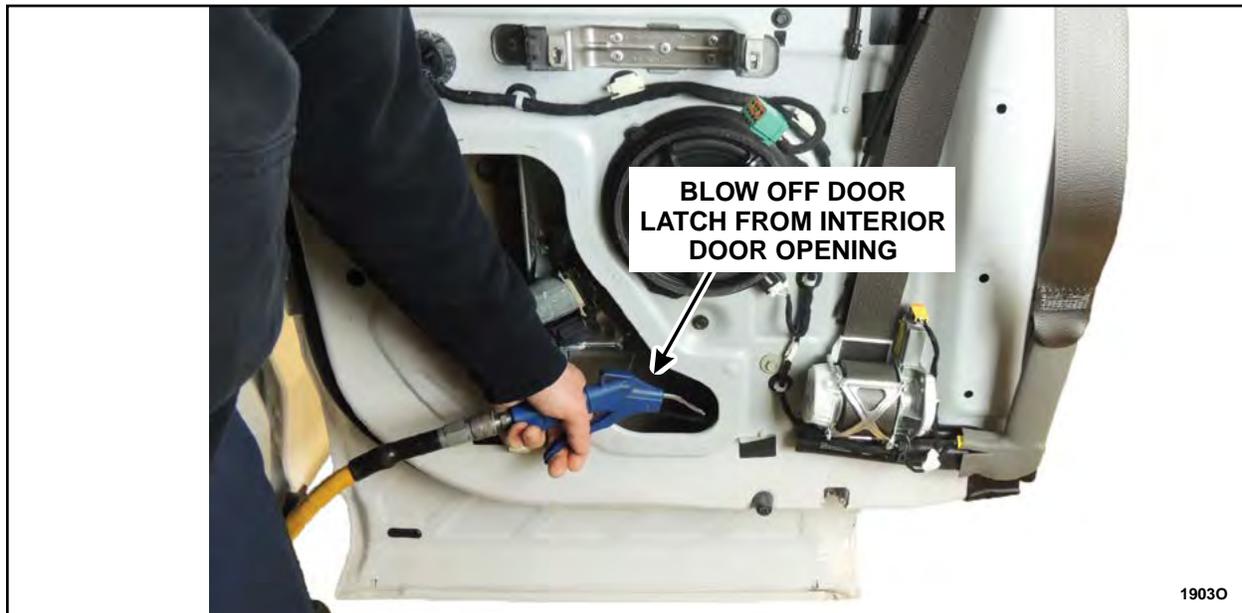
FIGURE 101

1. Remove the rear door interior trim panels. Please follow the WSM procedures in Section 501-05.
2. Remove the door panel weather shield for access. See Figure 101.
3. Using compressed air, blow out any debris or residual water from the latch assembly area. See Figure 101.

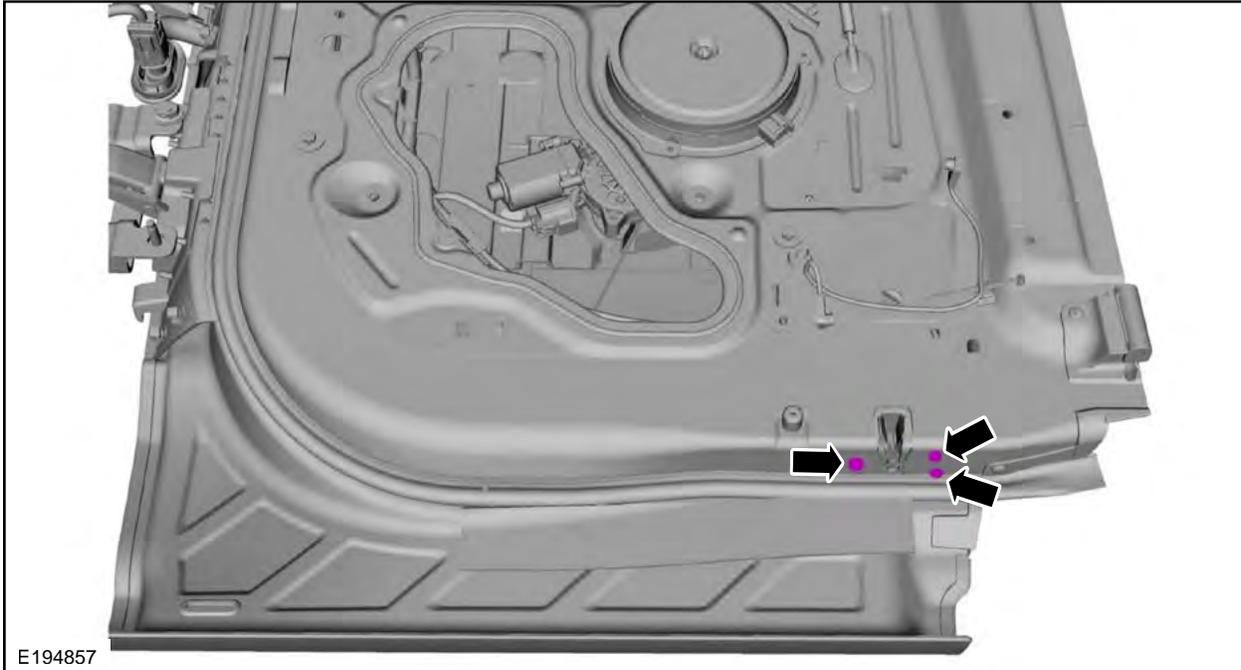
FIGURE 102

4. Inspect the interior door handle to latch cable for kinking. See Figure 103.
 - Correct any kinks found in the cable by straightening the cable by hand as required.
5. Remove the three lower door latch bolts. See Figure 102.

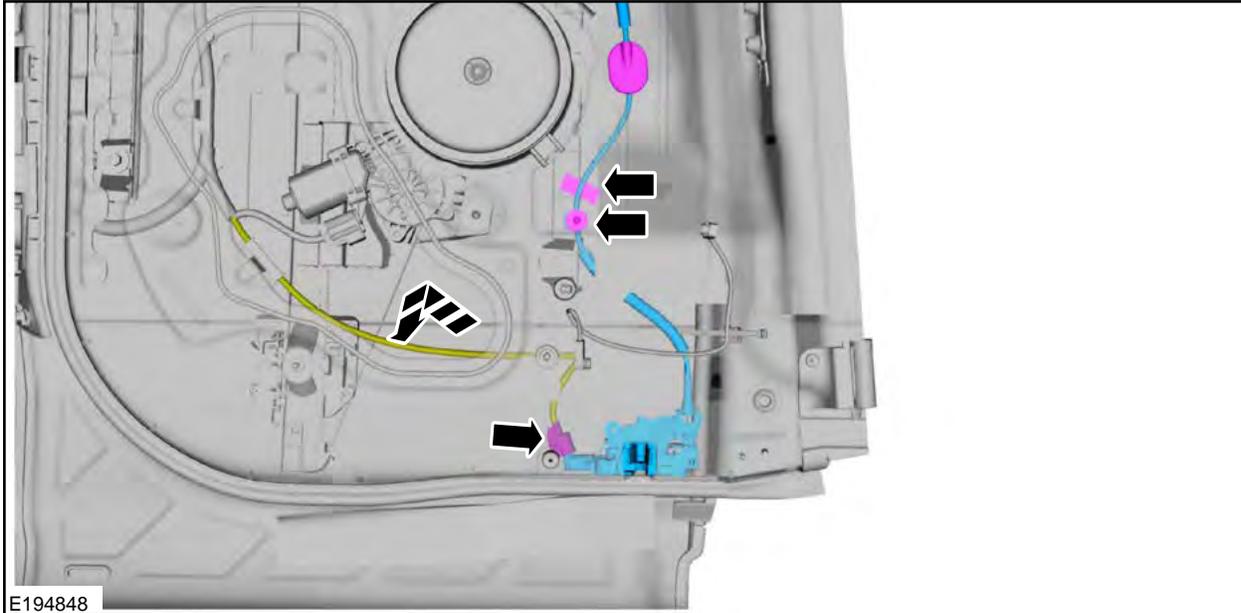
FIGURE 103

6. Detach the cable retainers and disconnect the electrical connector. Position the rear door latch outside of the door. See Figure 103.

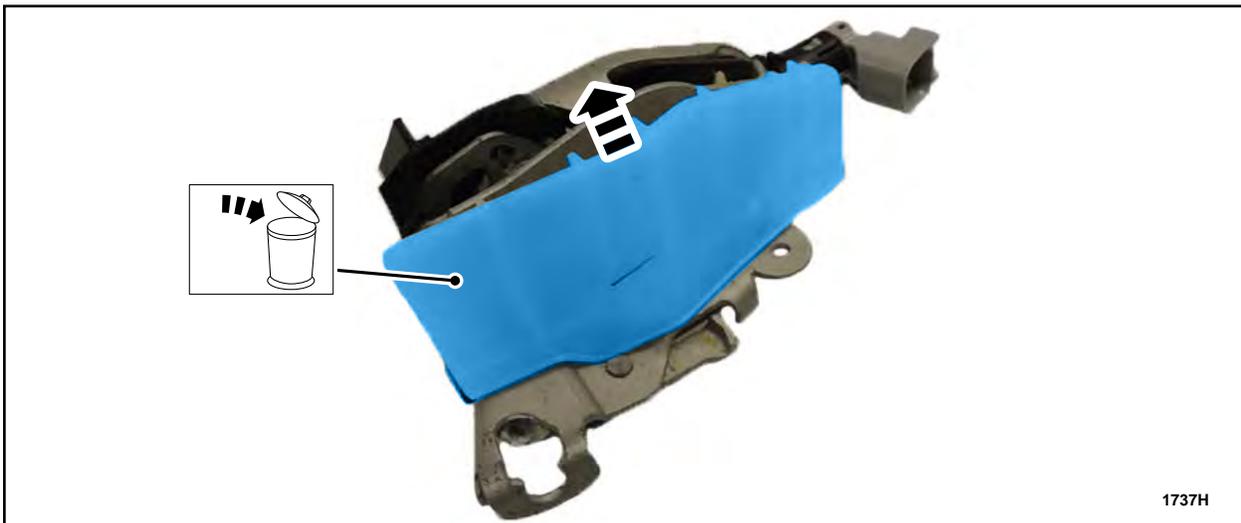
FIGURE 104

NOTE: Some F-150 SuperCab vehicles may be equipped with a smaller water shield than what is being installed in this program. The smaller shields must be removed and replaced. See Figure 104.

7. If equipped with small water shields, remove and discard the existing lower door latch water shields. See Figure 104.
