| <b>Subject:</b> Transcend 187MK, 261BH & 31RLS models<br>missing refrigerator baffels<br>187MK Unit #'s 803511 - 803520<br>261BH Unit #'s 803742 - 803751<br>31RLS Unit #'s 801299 - 804338 | | | | Number | | 19-003 |
| | | | | Date | | 5/1/2019 |
| | | | | Model | | Transcend |

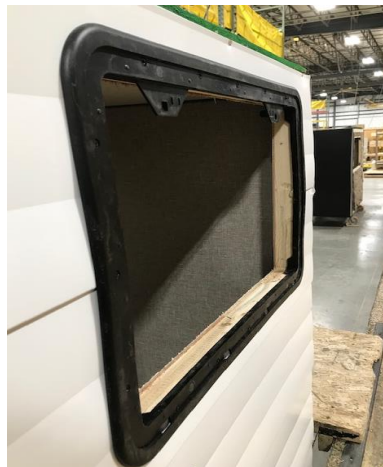
**Concern:** Missing refrigerator baffles may cause issue with refrigerator cooling properly.

1. Remove the upper exterior refrigerator vent
2. Install the pre-cut baffle in the opening as shown below

**Remedy:** Install pre-cut baffle on upper refrigerator vent - 21 1/2" x 7 3/8" on both the 187MK and 261BH floorplans. 21 1/2" x 8" for the 31 RLS Model

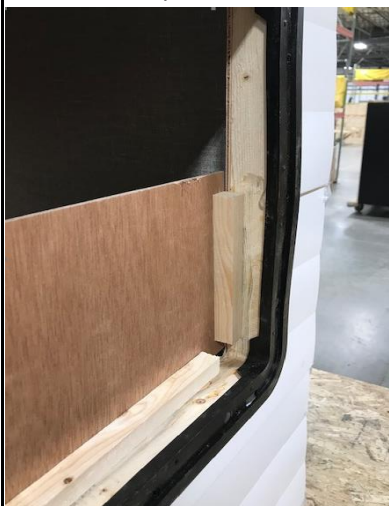
3. Install the pre-cut baffle, cleats out. Be sure the baffle is inset enough to allow for the reinstall of the interior vent.
