# Technical Service Bulletin

SUBJECT:			No: <b>TSB-19-42A-006</b>
<b>CAUTION ADDED TO VALVE INSTALLATION OF TPMS TRANSMITTER - SMR</b>			DATE: <b>April 2019</b>
			MODEL: <b>2013-19 Outlander Sport/RVR</b>
<b>CIRCULATE TO:</b>	<input type="checkbox"/> GENERAL MANAGER	<input checked="" type="checkbox"/> PARTS MANAGER	<input type="checkbox"/> TECHNICIAN
<input checked="" type="checkbox"/> SERVICE ADVISOR	<input checked="" type="checkbox"/> SERVICE MANAGER	<input type="checkbox"/> WARRANTY PROCESSOR	<input type="checkbox"/> SALES MANAGER

This TSB updates the Body section of the affected Service Manual to add a Caution to the installation service points of the TPMS valve (rubber snap-in type only).

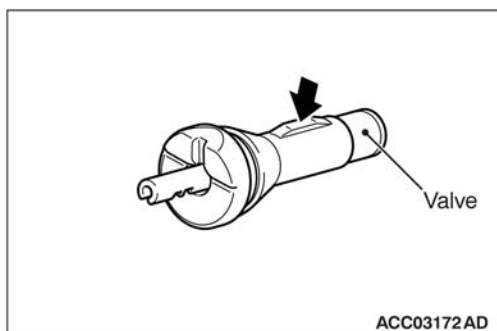
1. The projection shown by the arrow should face towards the outside of the wheel.

#### **! CAUTION**

**Install the valve only onto the wheel first <Added>**
