## Service Bulletin

**34-077**

34-Lighting and Wiring

Proper Closure of Power Distribution Box Cover

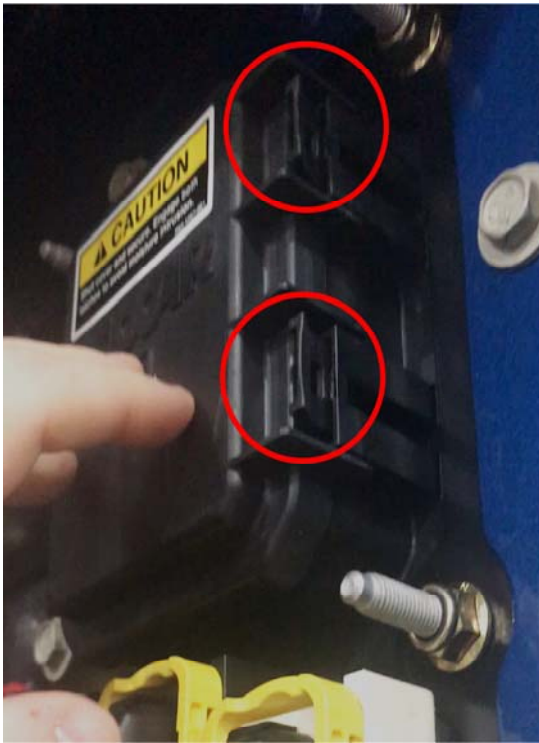
The PD box door does not always latch if it is only pressed. Loud, audible clicks can be heard when each latch fully engages.

**Figure 1 PD box door latches not seated**

1. Close the PD box door.
2. Press the door closed.
3. Confirm that both latches are seated. If the latches are not seated, gently, but firmly press the door near the unseated latch.

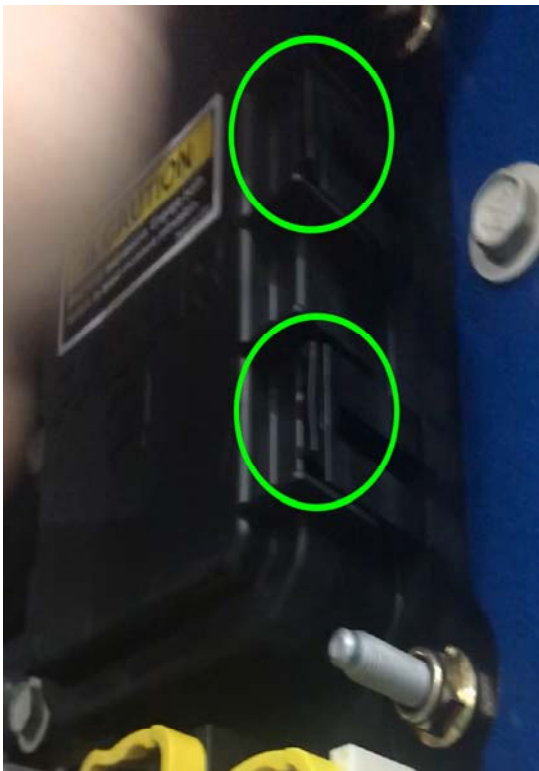
**Figure 2 PD box door latches properly seated**
