Subject: N192219210 - Service Update
Transmission Torque Converter

Models: 2019 Chevrolet Sonic

Service Update

N192219210 Transmission Torque Converter

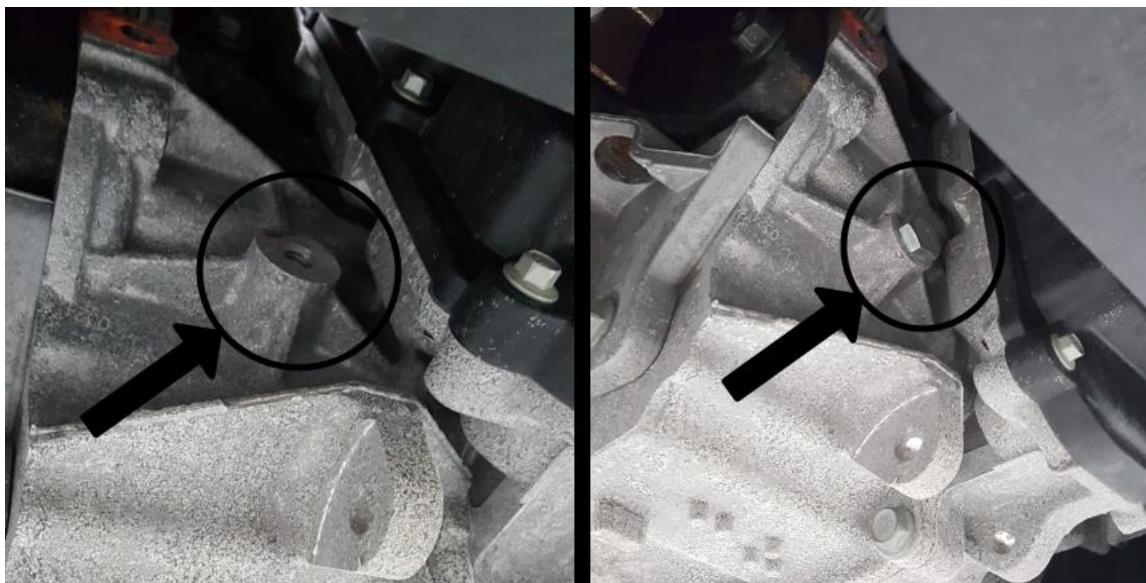
Condition	Certain 2019 model year Chevrolet Sonic vehicles may have a torque converter housing hole drilled too deep.
Correction	Dealer to insert an adhesive coated bolt to prevent external leaks.

1. Lift the vehicle. Refer to *Lifting and Jacking the Vehicle* in SI.
2. Locate the threaded bolt hole in the front of the transmission as shown above.
3. Install the provided bolt in the hole and torque to 19Ft-lbs (25N-m).
4. Lower the vehicle. Refer to *Lifting and Jacking the Vehicle* in SI.
