# Field campaign

| Topic | Front air spring dampers (SC19/05) |
| Brand | Bentley |
| Campaign number | EB19 |

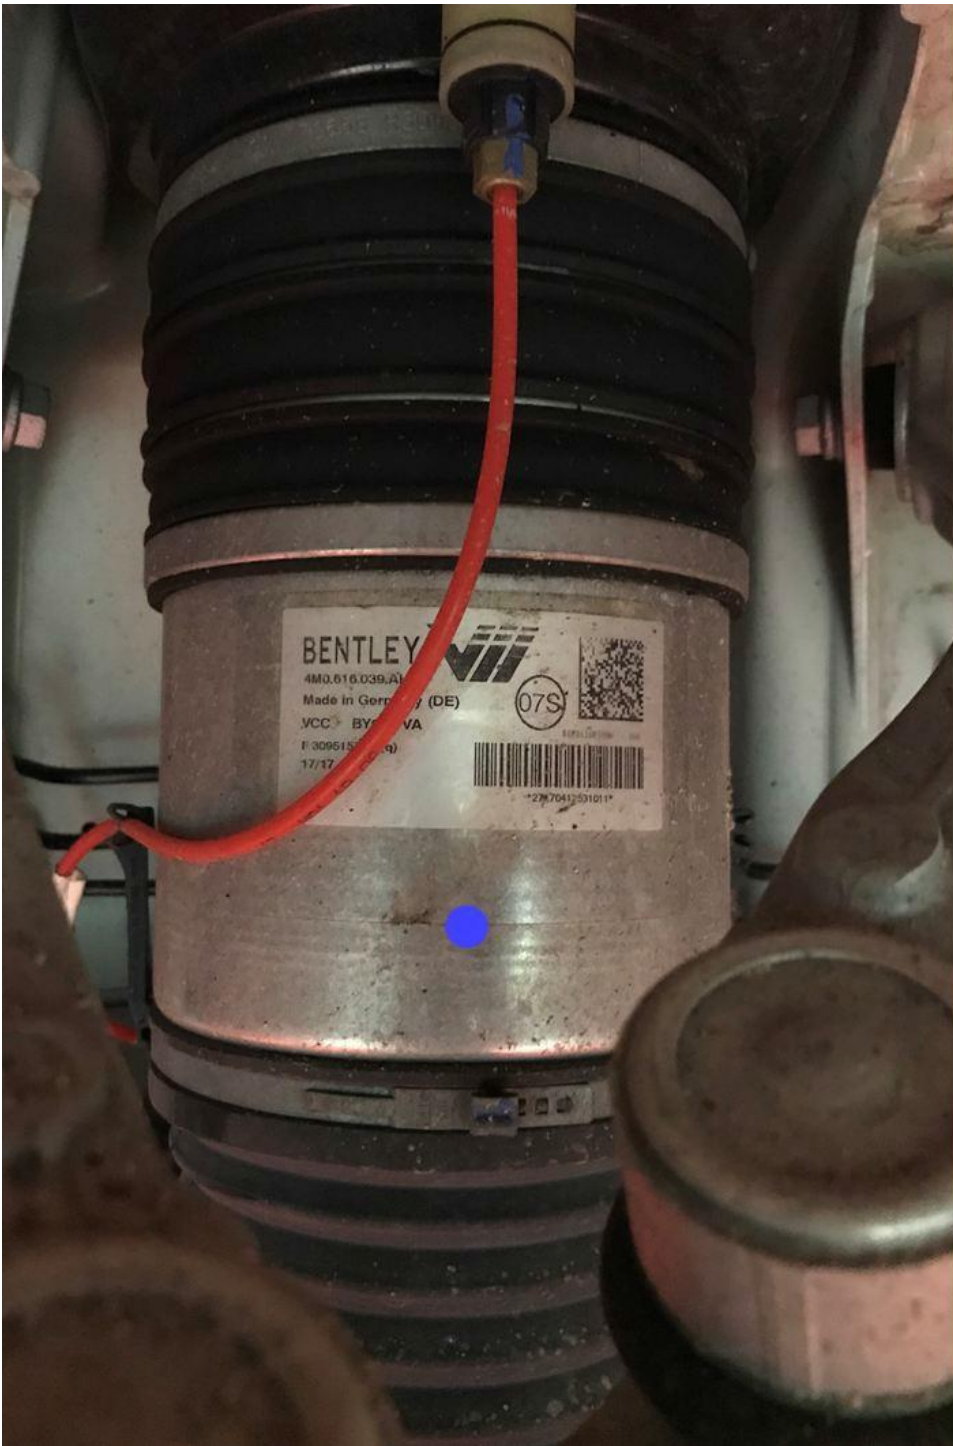
Figure 1

On completion apply a blue campaign completion mark to each of the front dampers (see Figure 1). The presence of the blue identification marks confirms campaign completion.
