PRODUCT CAMPAIGN BULLETIN

APPLICABILITY: 2012-14MY Impreza 2.0
2013MY Crosstrek
2013MY BRZ

NUMBER: WTY-84R

SUBJECT: 2.0L Engine Valve Spring Fracture May Cause Engine Stall

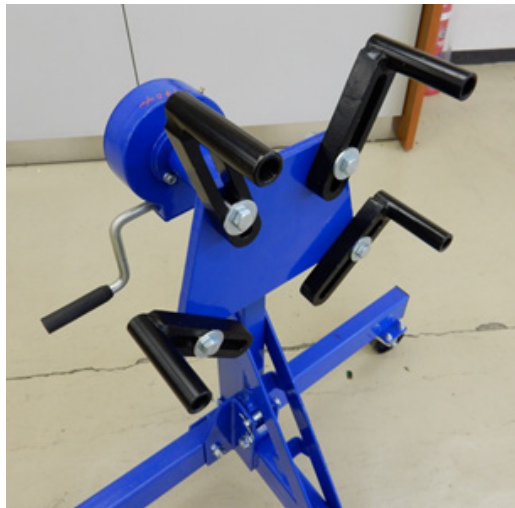
- **Engine Stand**, p.n. 99850AA050

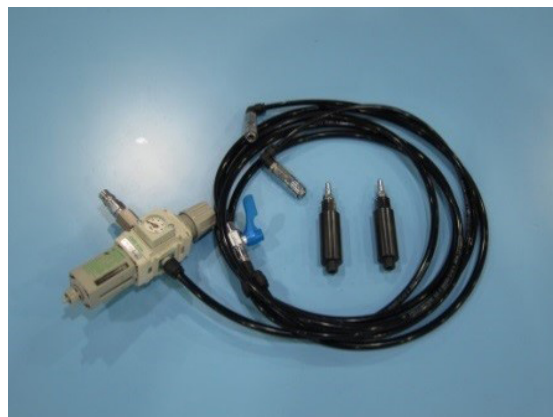
- **Air Hose Assembly**, p.n. 99850AA010 includes: air pressure regulator, 2 spark plug adapters, air hose w/ “Y” connector, 2 spark plug adaptor quick-connectors and main shut-off valve. This tool is used on both FA and FB engines.

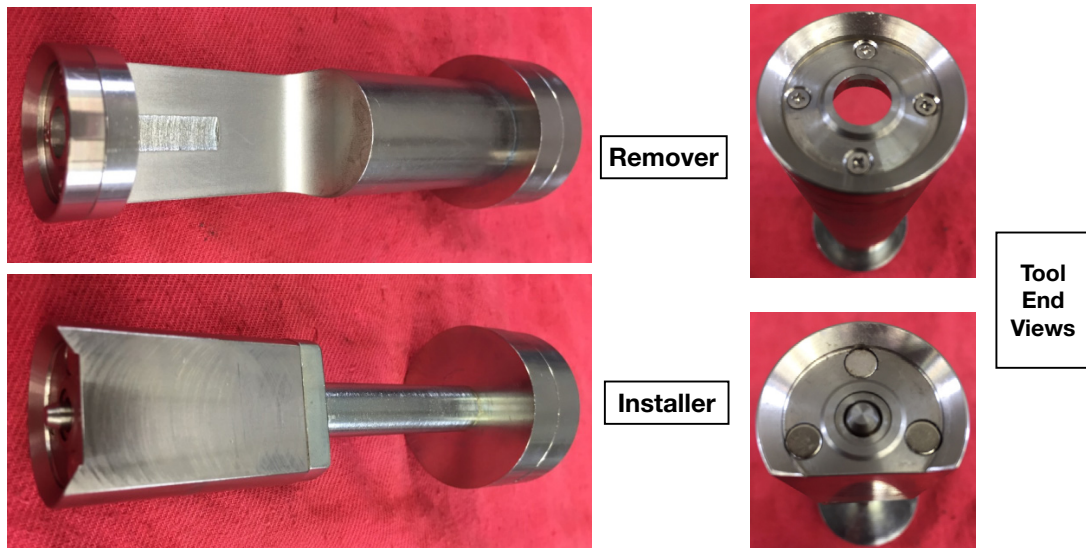
- **Valve Spring Replacement Tool Set**, p.n. 99850AA000 (for use on **FA** engines **ONLY**)

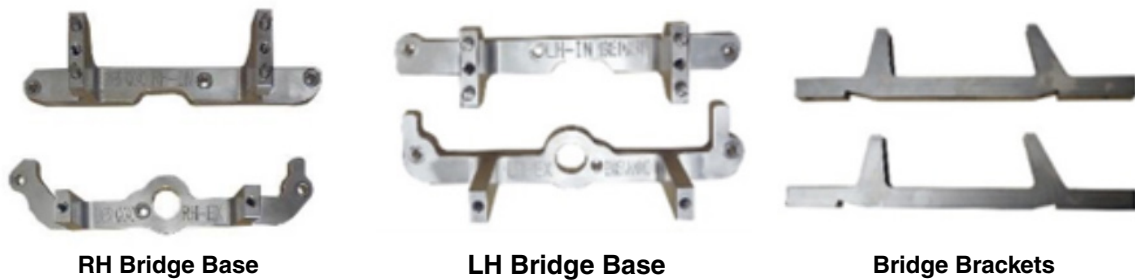
- **Bridge Base and Bracket Set**, p.n. 99850AA020 (for use on **FB** engines **ONLY**)

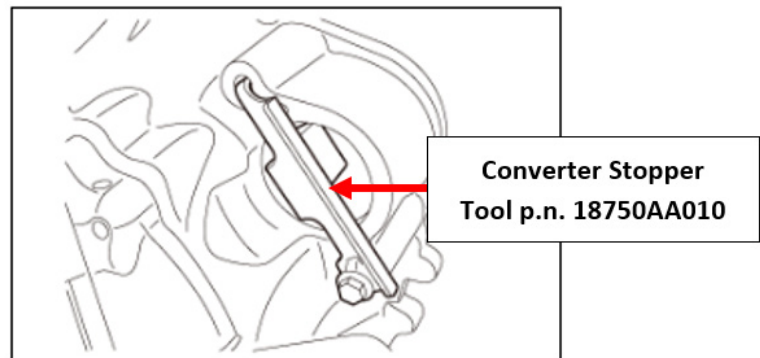
- On A/T models, use the special support tool p.n. 18632AA010 to support the transmission while the engine is removed. **VERY IMPORTANT: NEVER** use a jack or a block of wood on the oil pan of the A/T assembly as valve body damage can occur easily. On M/T models, a block of wood can be used to support the transmission.
- Also on A/T models, **ALWAYS** install the torque converter stopper tool to keep the converter secured in the transmission when separating the engine.

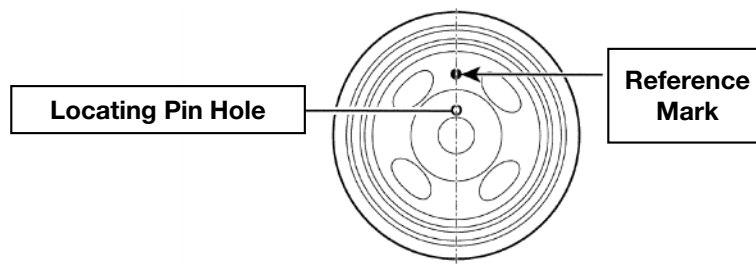
9) Apply a reference mark to the face of the removed crankshaft pulley using touch-up paint or a grease pencil adjacent to the locating pin hole as shown below.

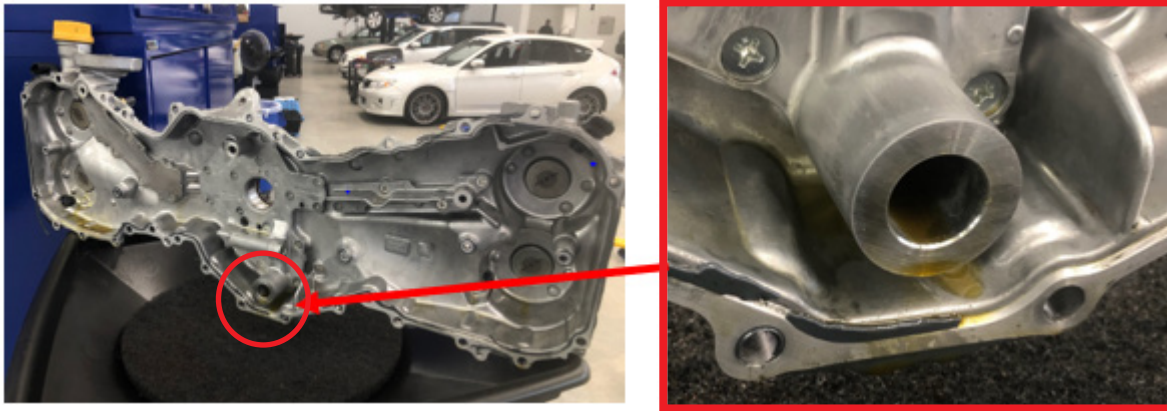
TIPS: Stand the removed timing cover up as shown to allow any remaining oil to drain from the internal passages. This keeps residual oil from potentially contaminating fresh sealer applied to the cover at reassembly (which could cause a leak or a possible comeback).

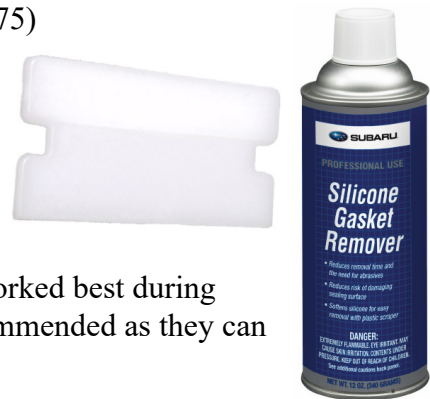
Use of aerosol Subaru Silicone Gasket Remover (p.n. SOA868V9175) along with white plastic razor blades and / or a sharpened plastic trim removal stick to use as a non-marring scraper will make this critical part of the procedure easier. Applying the Gasket Remover spray and allowing it to “soak” while performing other steps of the procedure will make the sealer removal job considerably easier. There are other color blades available but different colors have different stiffness characteristics. The WHITE color blades worked best during development of these procedures. Steel razor blades are NOT recommended as they can easily damage machined aluminum sealing surfaces.

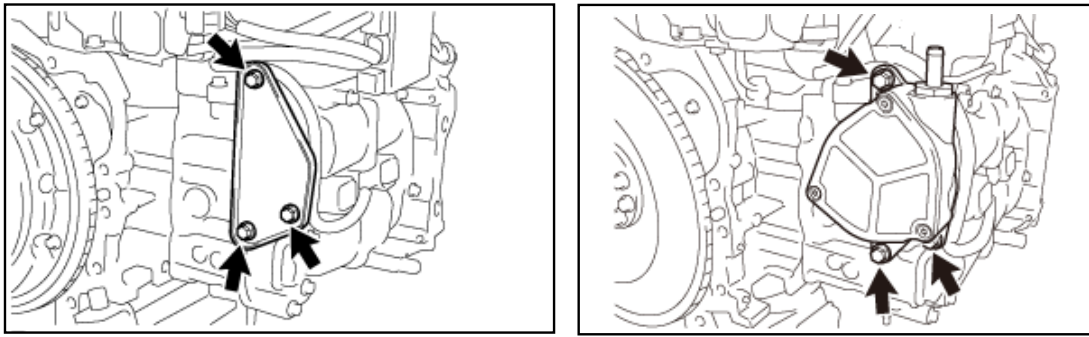
11) **CAREFULLY** remove the camshaft caps, both camshafts, spark plug tube seals (discard, 1-time use) and either the cylinder head plate (on M/T models) or the vacuum pump (on A/T models) as shown below. Spray any remaining sealer with gasket remover and allow to soak.

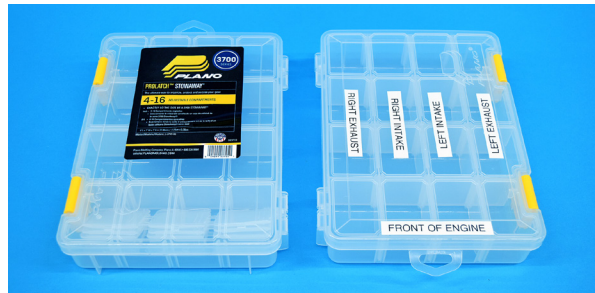
A. Always record the positions of the cam caps, every rocker arm and valve shim as each is removed to insure they get reinstalled back into their original locations and proper orientation. The use of a closeable partitioned tray as shown below or an equivalent organizer is **STRONGLY** recommended to keep valve train parts organized.

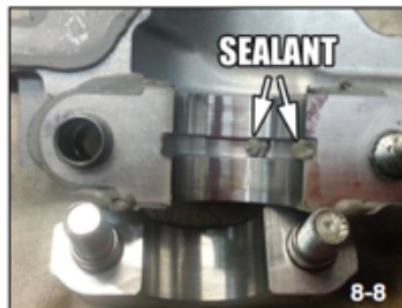
Sealant Plugging Lubrication Channel

D. **IMPORTANT:** Always keep close watch for any loose pieces of sealer, large or small as components are disassembled and remove them right away. This will help prevent them from getting into oil passages, restricting oil flow and potentially causing damage as shown here.

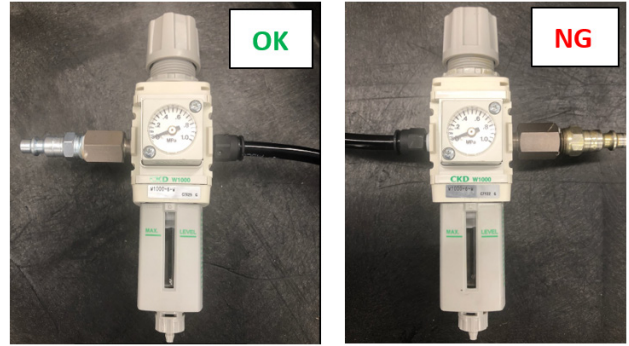
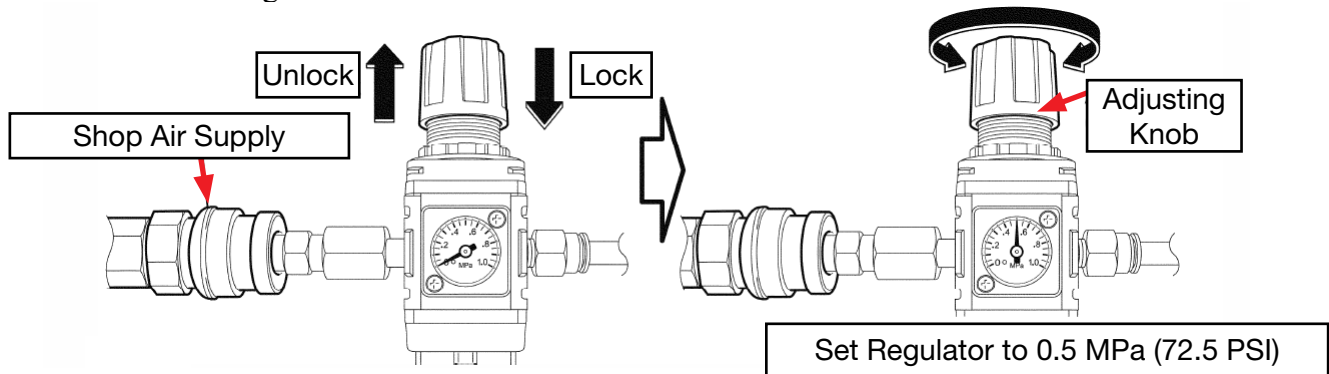
Assemble the air pressure regulator assembly as shown with the shop air supply inlet on the left and the outlet fitting to connect the plastic tubing to the right. The air pressure regulator will be ineffective otherwise. Once the tool is assembled, connect shop air, open the valve and let air flow through to make sure it is clean. Pull up on the adjustment knob, adjust to **0.5 MPa** then push the knob back down to lock the setting.

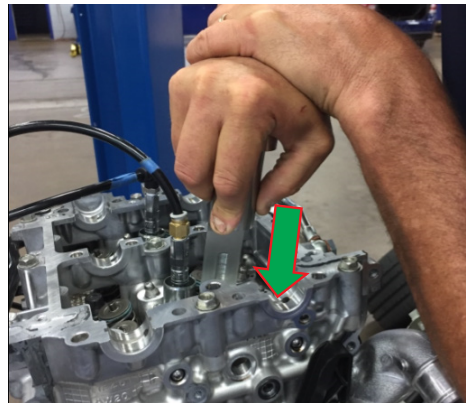
Valve Spring Remover

Using the removal tool, press down firmly on the top of the remover while keeping the tool aligned with the valve stem then remove one of the valve springs on #1 cylinder. **NOTE: NEVER HIT ANY OF THESE TOOLS WITH A HAMMER!** It is recommended to do the removal and installation one spring at a time to keep the retainer, keepers together as a set in the organizer.

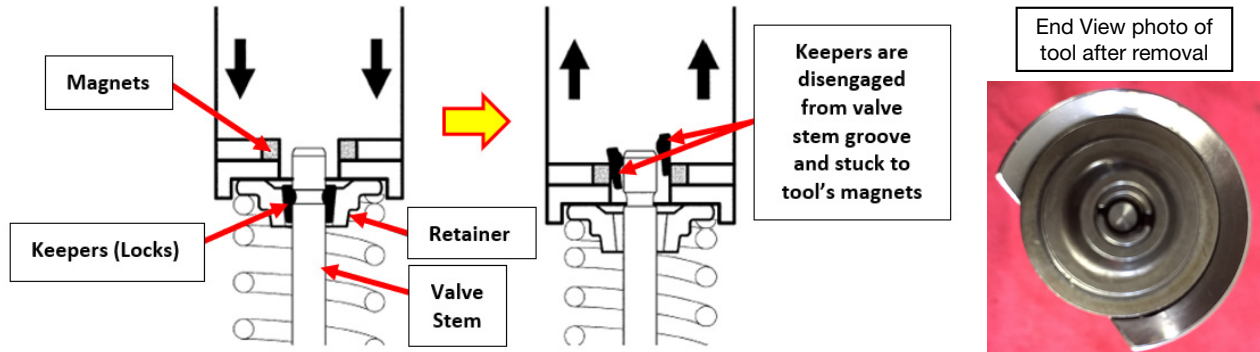
The cutaway illustration below provides extra detail on how the Remover tool operates. When the tool is pushed down, the keepers disengage from both the retainer and the valve stem. Once they are loose, all three pieces (2 keepers and the retainer) are attracted to the tool's magnets for removal.

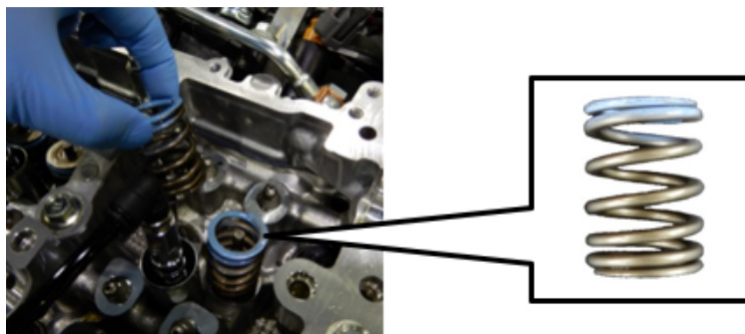
Install the new valve spring with the blue painted end up (toward the retainer).

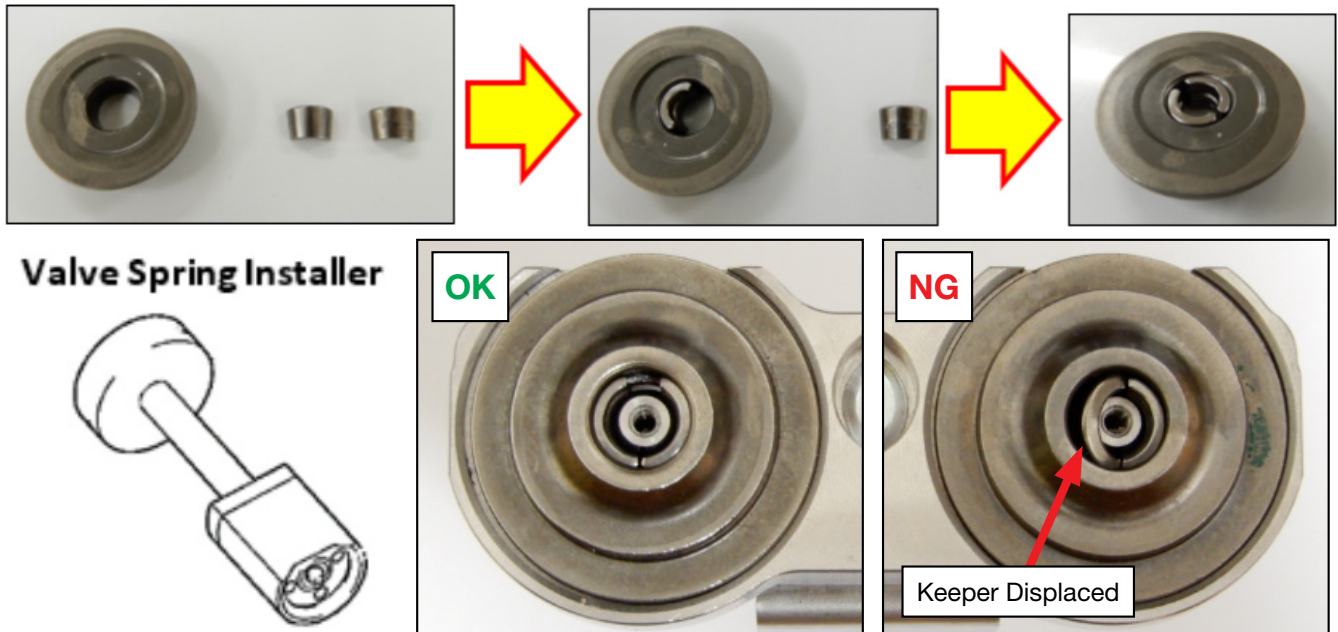
Assemble the keepers and retainer then install onto the Valve Spring Installer as shown below. The tool is also equipped with magnets to keep the components in place during reassembly. OK and NG photos are provided below for reference.

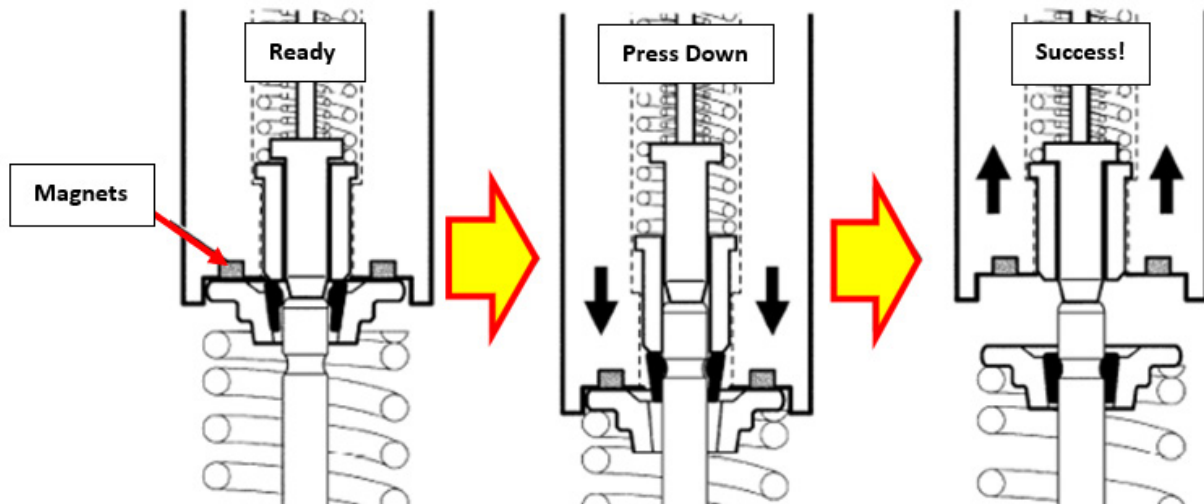
This cutaway illustration provides additional detail on how the Installer tool operates.

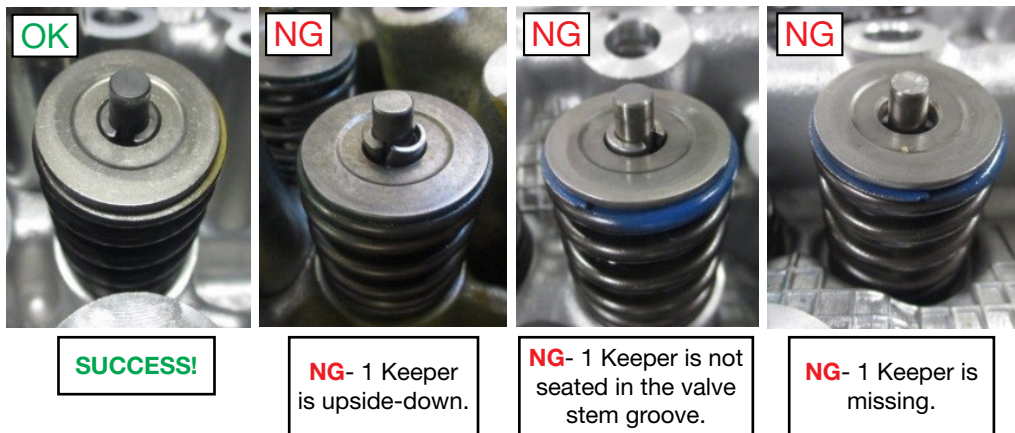
EXTREMELY CRITICAL: A post-installation inspection to confirm success as shown above **MUST** be performed as each spring is reassembled. Left undetected, a mis-placed or out of position keeper **WILL** cause **MAJOR** engine damage when the engine is restarted.

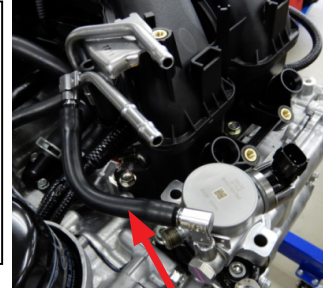
Remove and discard Fuel Delivery Pipe #2 (1-time use). A replacement is included in the Parts Kit.

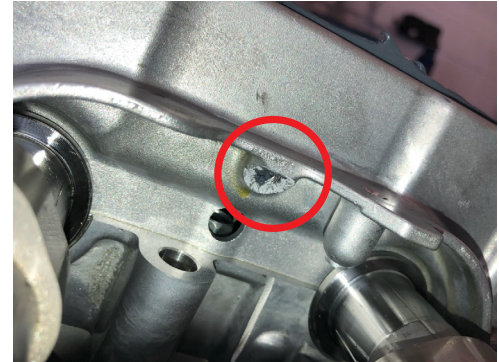
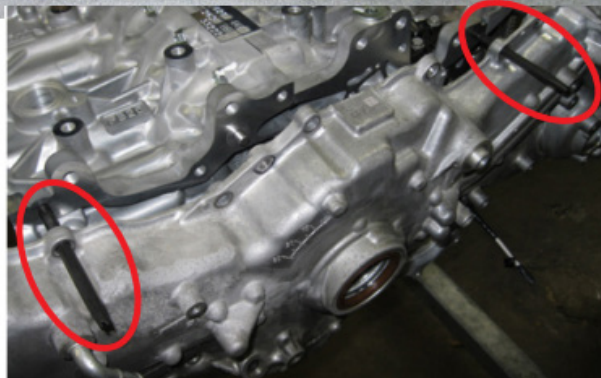
- When re-installing the front cover assembly, be very careful to not allow it to contact the timing sprockets. If contact does occur, it is almost a guarantee the fresh sealant beads applied to the cover will be disturbed. To minimize the possibility of this happening, ALWAYS use the alignment pins shown below to “guide” the cover into its proper position without disturbing the fresh sealer. The Subaru Special Tool Kit number is J-51972. Each kit includes 2 alignment pins.

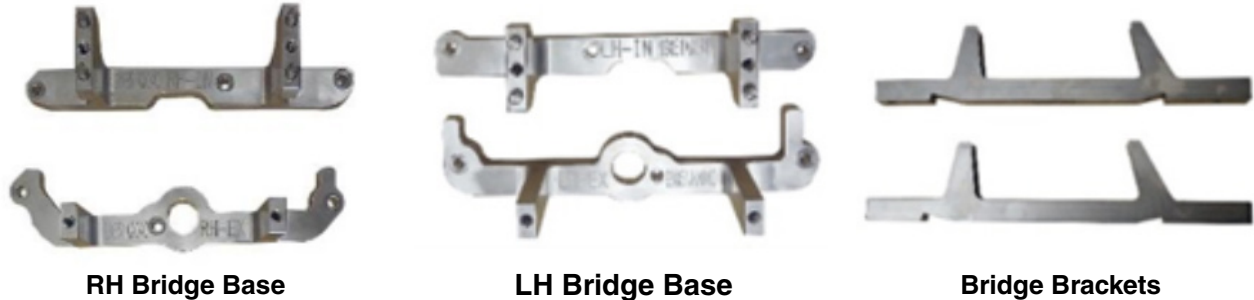
- **Bridge Base and Bracket Set**, p.n. 99850AA020 (for use on **FB engines ONLY**)

IMPORTANT REMINDER: NEVER attempt to use any of these valve spring replacement tools on a 2015MY or later 2.5L FB engine. Although the Bridge Base and Bracket set bolts to the cylinder heads normally, the spacing between the valve stems is different. Attempting to use any of the compressor tools or spring installers on a 2015MY or later 2.5L FB engine **WILL** damage them.

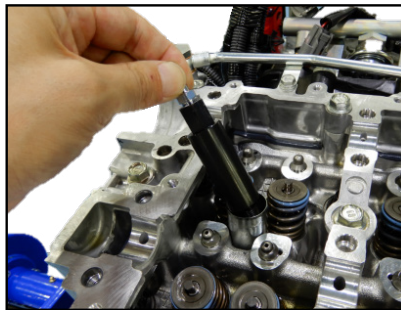
- Always turn the crankshaft **clockwise** when instructed to reposition it.
- 8) Install the 2 spark plug adapters into #1 and #3 spark plug holes. **Make them tight WITHOUT using any extra tightening tools. Hand-tightening only will seal the adapters sufficiently.**

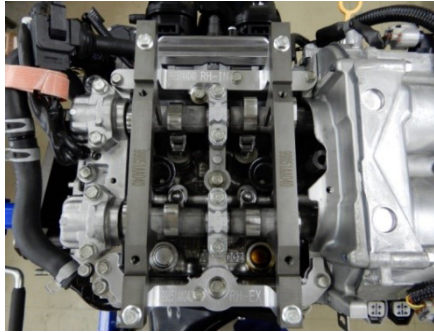
Bridge Bases and Brackets assembled on RH cylinder head.

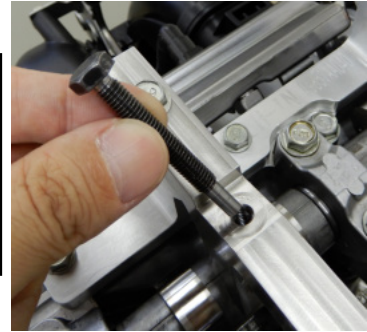
Special 6 mm Push Bolt and their locations on the bridge brackets.

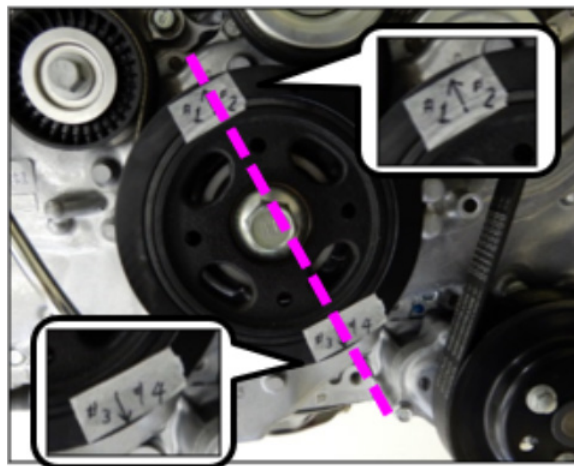
- A. Rotate the crankshaft clockwise until #1 piston is at TDC. Mark the crankshaft pulley as shown for reference. This will make locating TDC for each cylinder easier. TDC of #1 and #2 cylinders are 180 degrees opposite of #3 and #4.

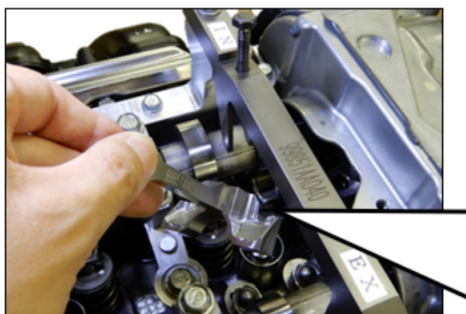
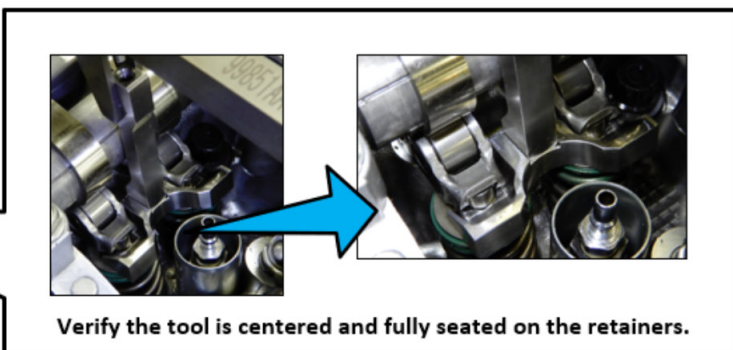
- B. Confirm all four rockers on #1 cylinder are “relaxed” or “free”.
- C. Insert compression tool 2.0/2.5 IN-A (WHITE paint mark) into the corresponding bridge bracket guide slot and onto the retainers and keepers for #1 cylinder’s INTAKE valves.

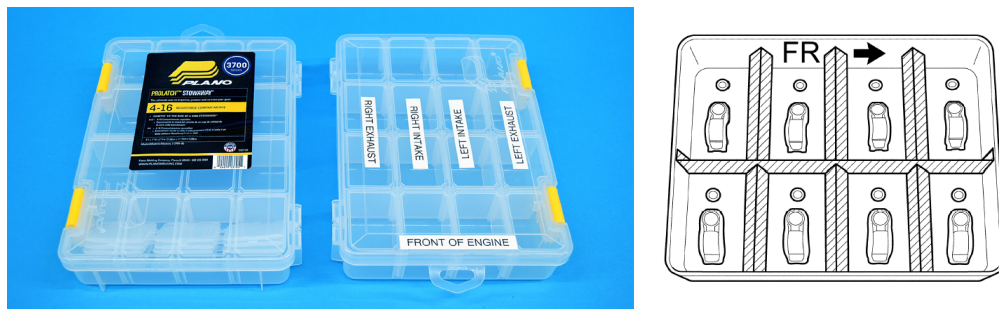
REMINDER: Always record the positions of every rocker arm and valve shim as each is removed to insure they get reinstalled back into their original locations. The use of a closeable partitioned tray as shown below or an equivalent organizer is **STRONGLY** recommended to keep valve train parts organized.

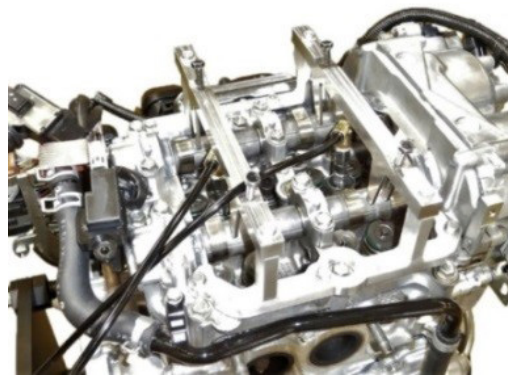
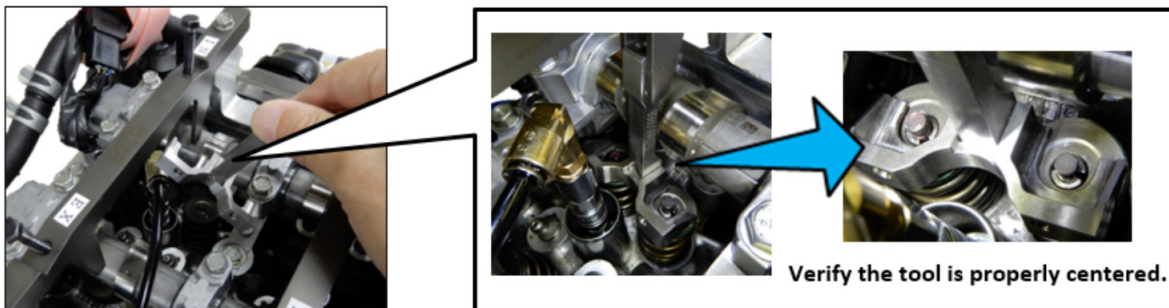
M. Insert compression tool 2.0/2.5 IN-B (WHITE paint mark) into the corresponding bridge bracket guide slot and onto the retainers for #3 cylinder's INTAKE valves. As shown below, the opening on these spring compression tools is wider than the compression tools used previously. This allows room for the keepers to come loose from the valve stem when the spring is compressed.

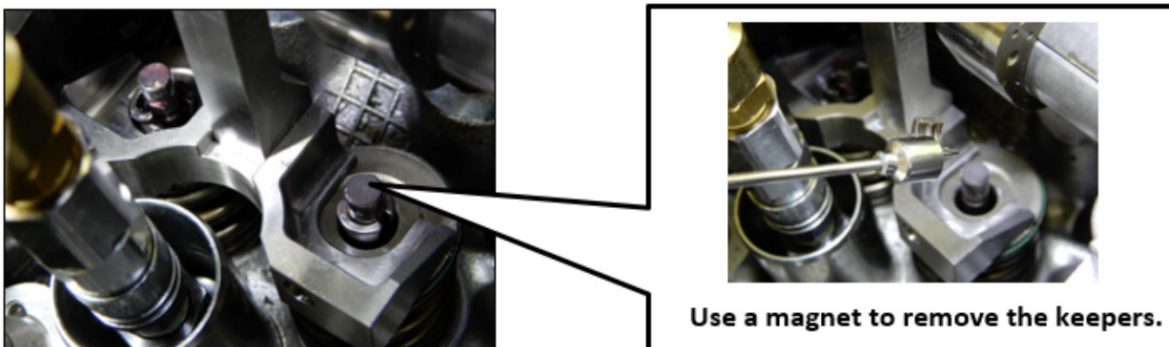
N. Tighten the push bolt only as much as needed then use a magnet to remove the keepers and put them in the organizer with the corresponding rockers and shims.

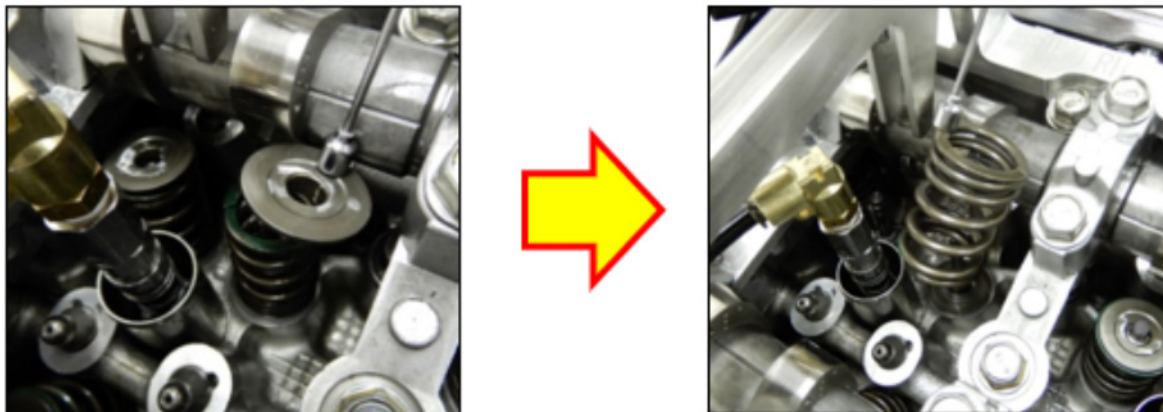
P. Remove the retainers and original valve springs using a magnet.

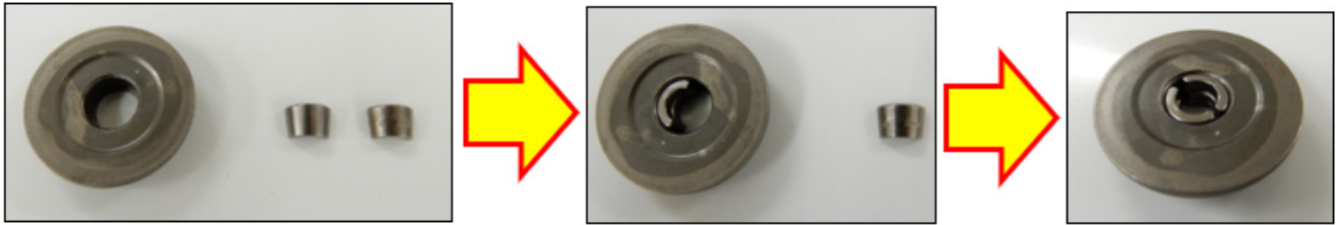
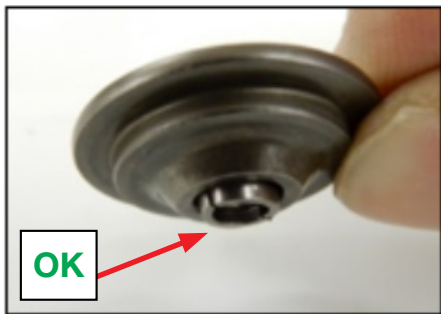
- Q. Set #3 cylinder's pair of INTAKE valve springs in place on the cylinder head with the blue painted end up (toward the retainer).
- R. Assemble the pair of INTAKE keepers and corresponding retainers onto the installer tool 2.0/2.5 IN-C (WHITE paint mark). Both installer tools utilize magnets to keep the retainers and keepers in position. Use the photos below as a guide for proper component assembly onto the installer tool.

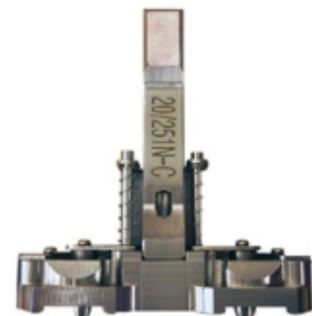
INTAKE Installer Tool: 20/25 IN-C

Both keepers are protruding the same amount from the bottom of the retainer.

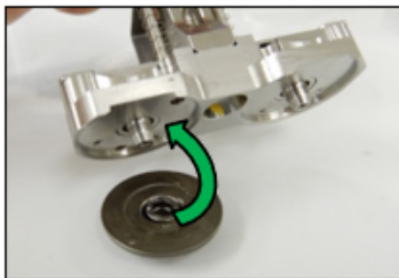
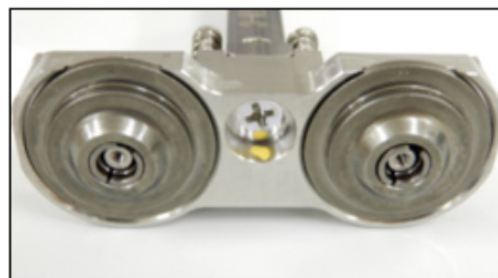
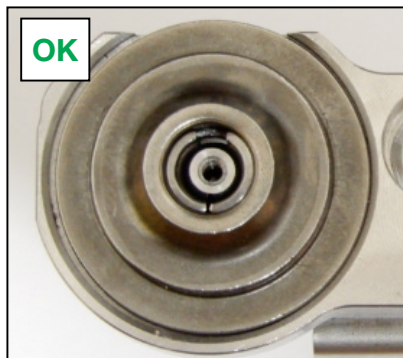
NOTE: When the retainers and keepers are properly assembled (or “loaded”) on the installer tool, the keepers will be drawn upward into the tool by the tool’s magnets as shown in the photo below, right. This is normal. **OK** and **NG** reference photos of the components loaded on the installer tool are provided below.

Keepers are centered.

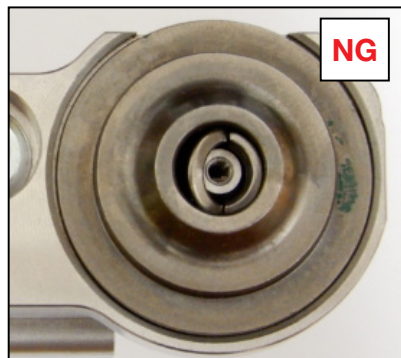
Keepers are either mis-aligned or, one is upside-down.

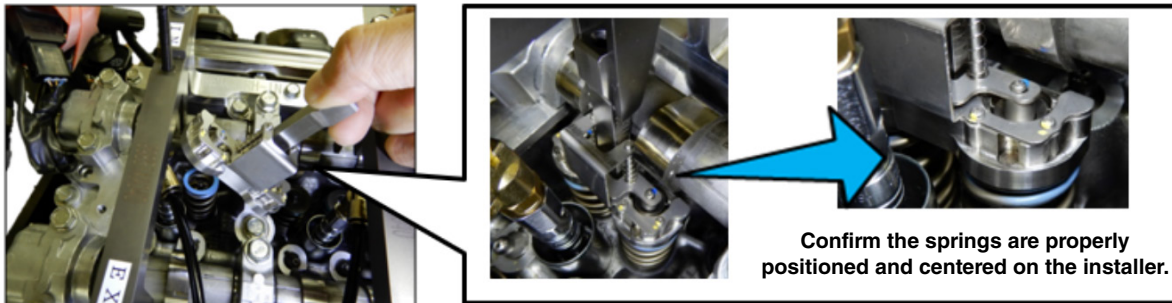
- S. Set the loaded valve spring installer tool into the guide slot on the bridge bracket and down onto the #3 cylinder INTAKE valve springs. Finger-tighten the push bolt to remove all free-play. Make a final check to confirm the tool is properly positioned on the new pair of valve springs then SLOWLY start to tighten the push bolt only as much as needed to install the retainers and keepers.

CAUTION: If air pressure begins to leak from the cylinder (past the valve seat into the intake or exhaust ports) when starting to tighten the push bolt, it means the installer tool is not positioned properly (not centered) and the intake valves are starting to be pushed open. Loosen the push bolt and re-confirm the retainers and keepers are still in their proper positions and the loaded tool is also in the proper position on the valve springs. **SLOWLY** re-tighten the push bolt only as much as needed to install the retainers and keepers.

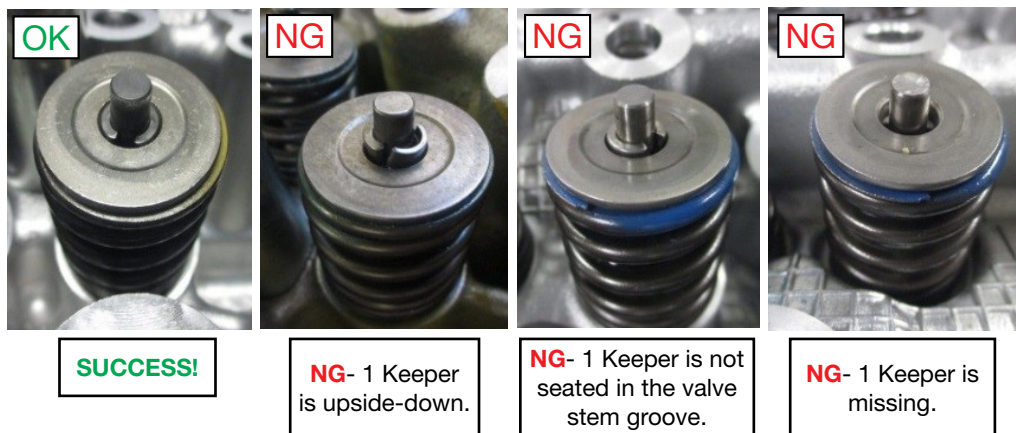
- T. Loosen the push bolt and remove the installer tool. **CAREFULLY** inspect both springs for successful, properly seated retainers and keepers. Use the reference photos below as a guide for confirmation.

EXTREMELY CRITICAL: If any of the **NG** conditions shown above exist, use the applicable spring compressor tool to remove the pair of retainers and keepers then return to **Step R** above and start over. If installation is successful, proceed to install the EXHAUST springs.

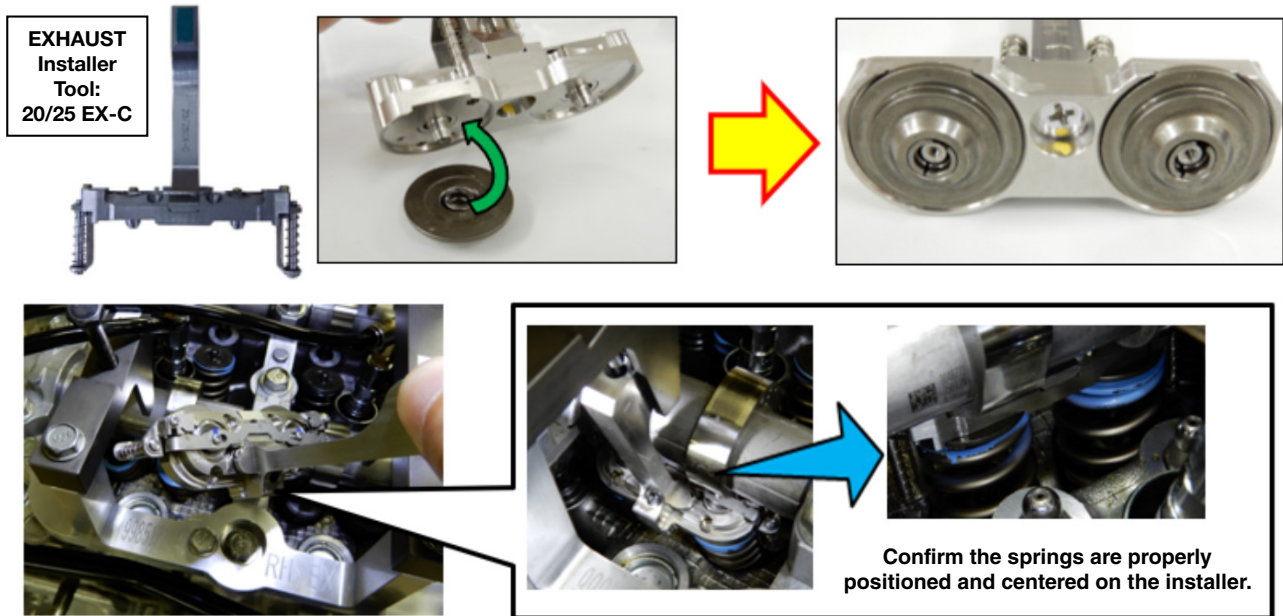
W. Assemble the pair of EXHAUST keepers and corresponding retainers onto the installer tool **2.0/2.5 EX-C** (**GREEN** paint mark) as shown below and in **Step S** above. Both installer tools utilize magnets to keep the retainers and keepers in position. Although the exhaust spring installer looks somewhat different than the intake tool, they function the same way but they are **NOT** interchangeable.

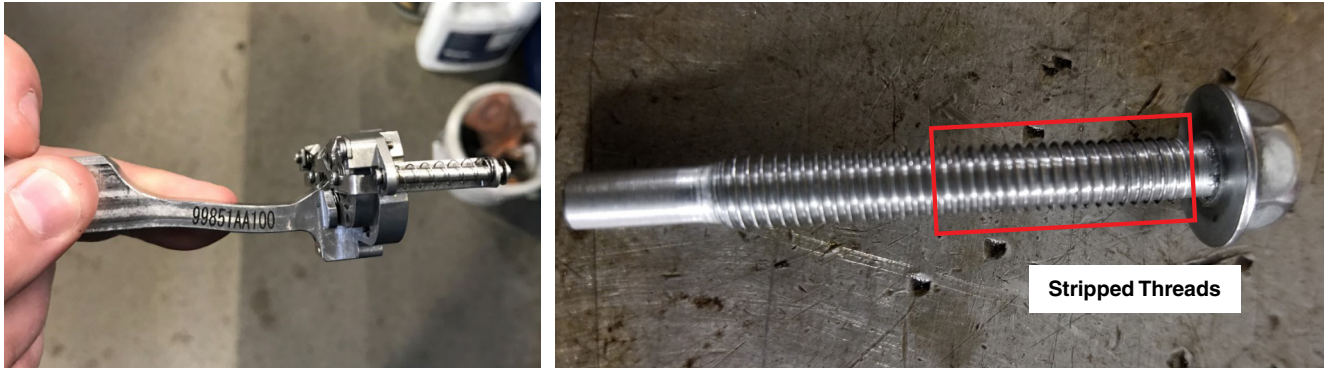
The photos below show examples of damaged tools caused by improper use or the use of air or electrically-operated power tools.

The most common reports received involve damage to the valve spring re-installation tools. A close inspection of the tools to see how they work is highly recommended. Although they may appear complex with a lot of small moving parts, when used as designed, they will make the process easy to perform every time. The photos below show close-ups of damaged installer components, all resulting from excessive force and not stopping when additional resistance is felt when turning the push bolt.

The root cause of this damage is not centering the spring and retainers to the head, valve stem and the installer tool before compressing the spring pair.

CAUTION: If these procedures are not followed, damage to the tool **WILL** occur when the end of the valve stem catches the bottom of the keeper ring and bends sensitive parts of the tool.

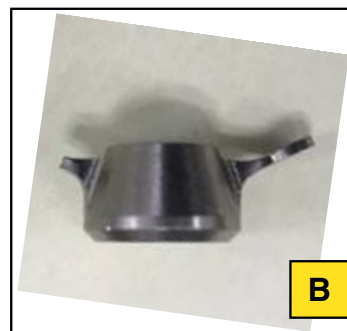
In this photo, one ear of the keeper ring is bent and the other has been snapped off.

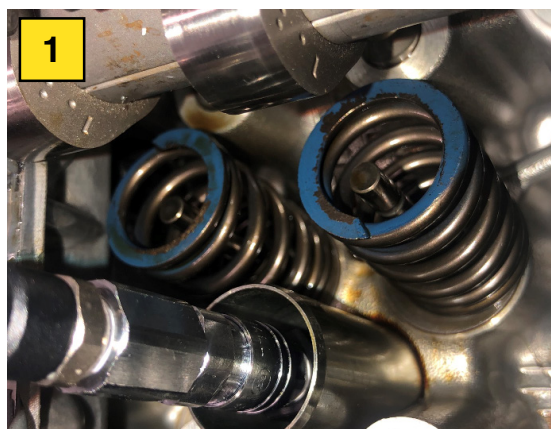
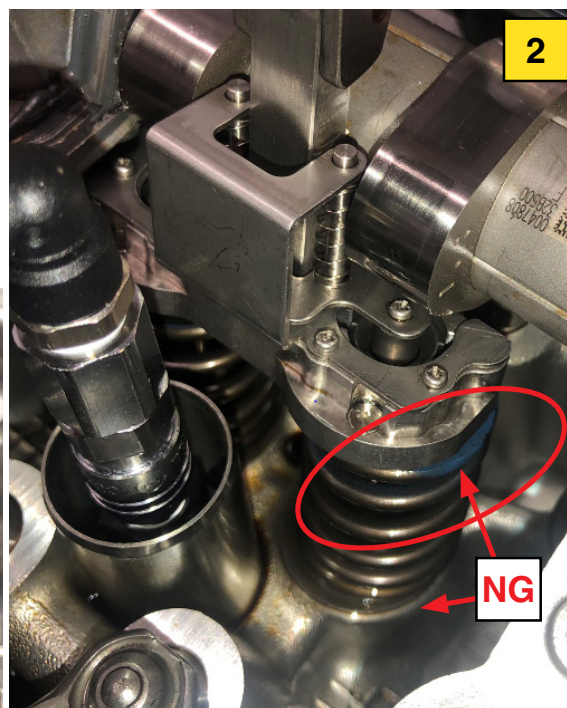
In photo 2, the retainers and keepers have been loaded onto the installer and the installer onto the springs. Notice how the spring is protruding from the right edge of the installer and also not centered on the underside of the tool or the spring seat cast into the cylinder head. If the Technician were to proceed with tightening the push bolt at this point, the installer would most likely be damaged.
