Popping or Crackling from the Speakers? Check the MOST Bus Network

AFFECTED VEHICLES

Year	Model	Trim
2018-19	Odyssey	ALL except LX
2019	Pilot	ALL except LX
2019	Passport	ALL except Sport

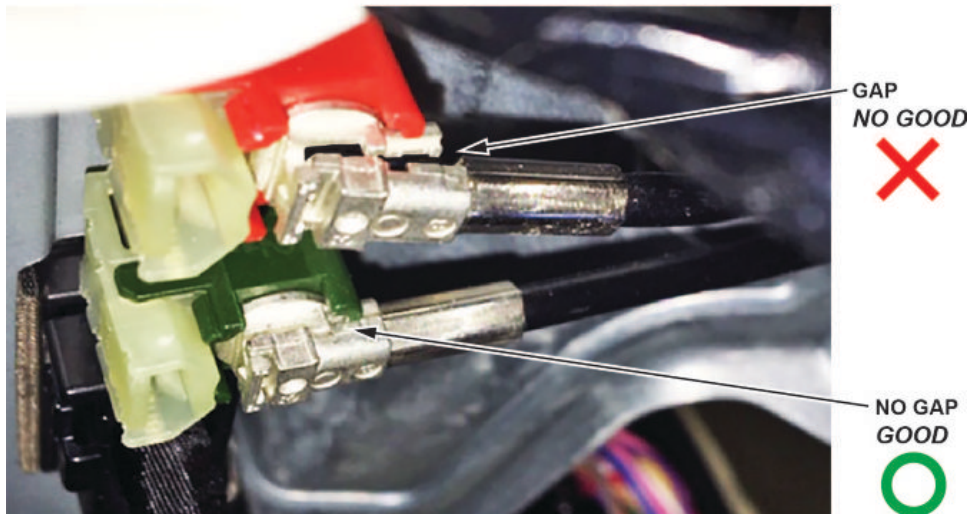
Are you hearing a popping or crackling from the speakers? This may be due to a connection issue in the MOST bus network, which can be identified by the unique red and green connectors at each component of the infotainment system.

During component inspection or replacement, you can easily damage these connectors if the cable is used for leverage when unplugging them.

To save you time during troubleshooting, check the repair history on the vehicle. Most reported cases happened after a separate previous repair was made to the system. Be sure to inspect the MOST connectors at all components and any connections between the harnesses. If a connector is found to be damaged, like you see here, the entire harness must be replaced. These connectors **are not** repairable.
