Bulletin No.: PIT5652B

PIT5652B Clock Shows Dashes And Cannot Be Set After Battery Disconnect

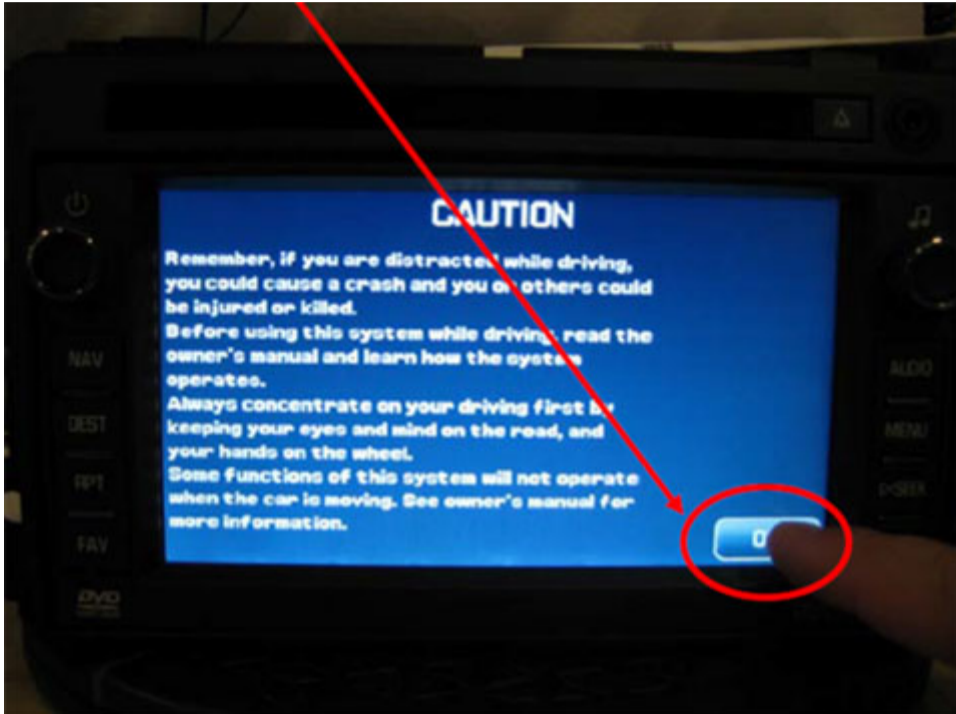
1. Turn vehicle and radio on
2. If the "Caution" screen is displayed, press "OK"

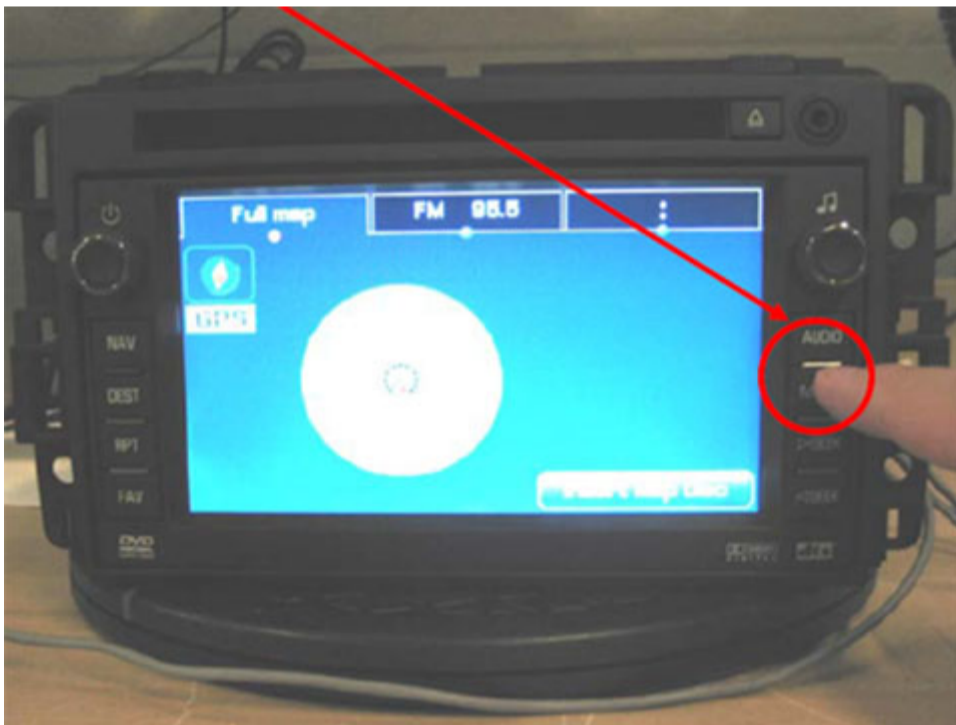
3. Press the Hard button "Menu" on the right side of the radio

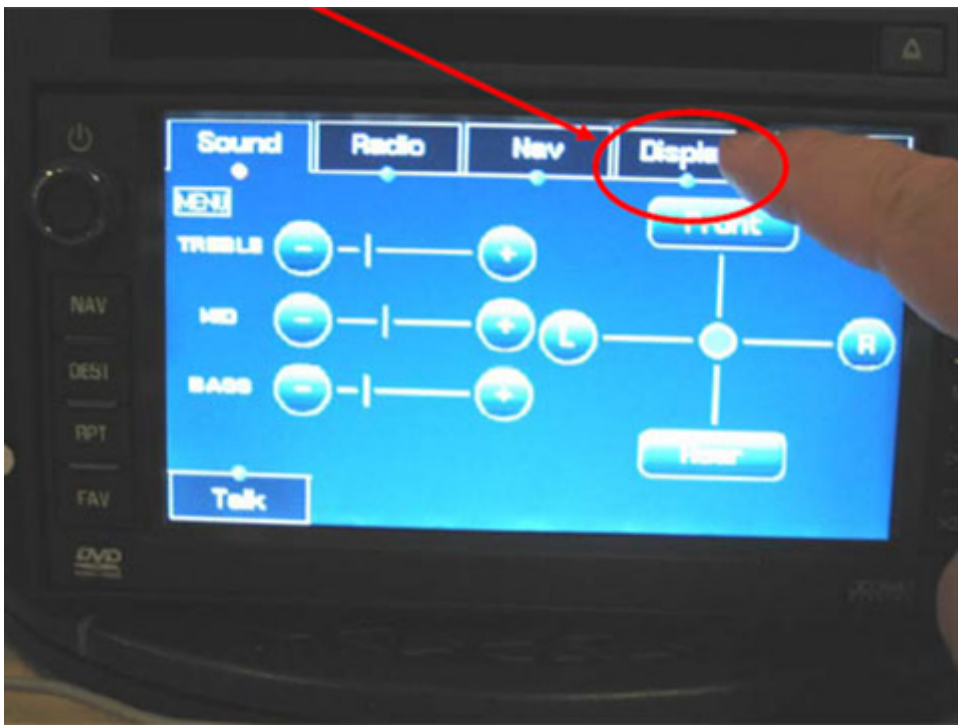
4. At the top of the display, press the "display" soft key

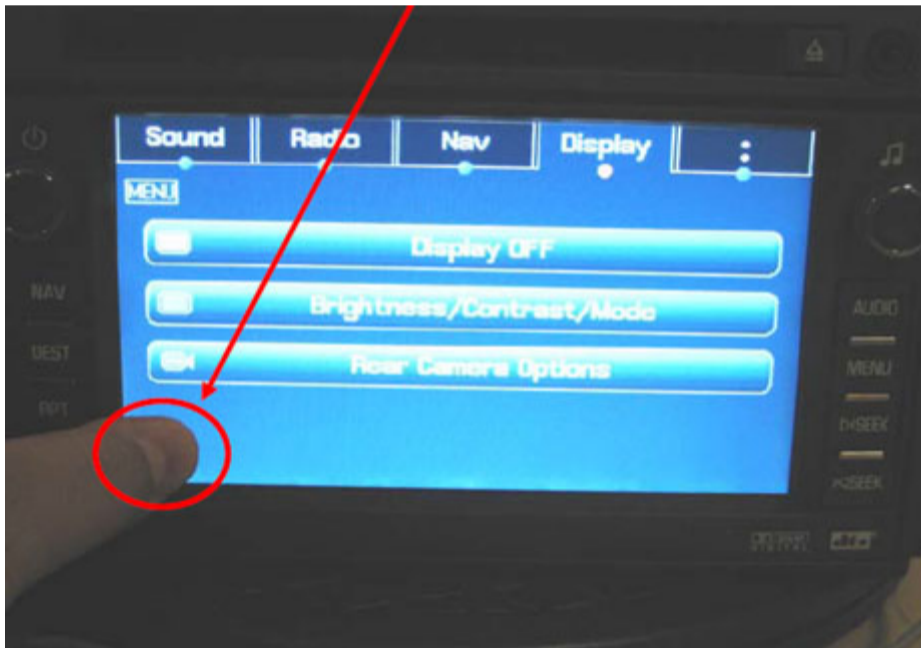
5. In the lower left of the next screen press and hold in the lower left of the screen for 5-10 seconds (there will not be a button shown, the button is hidden)

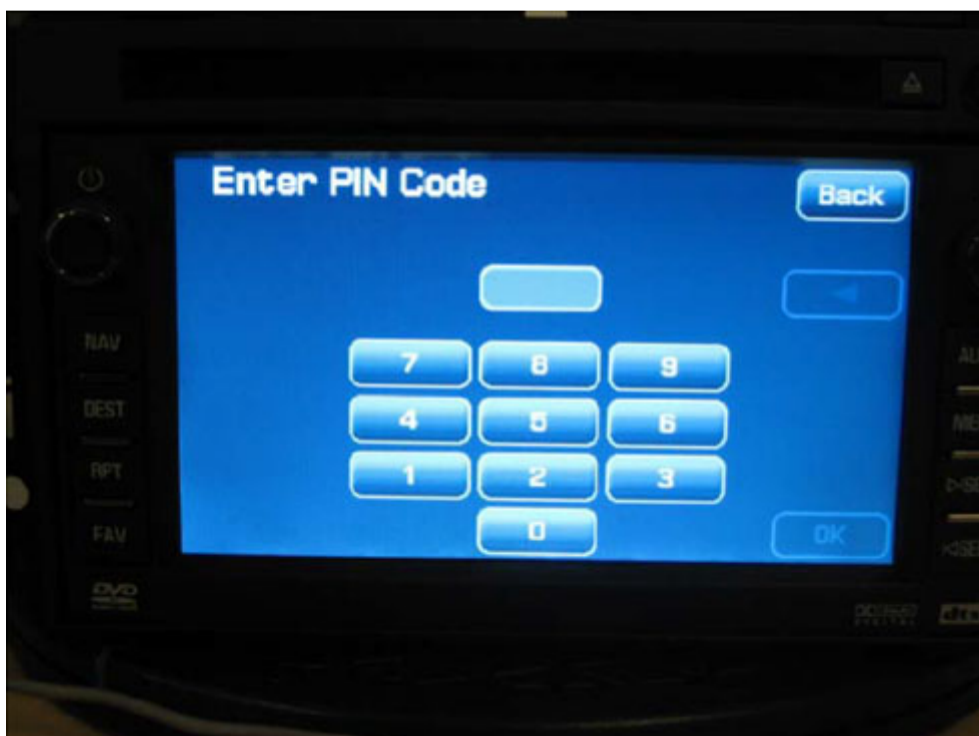
6. When the screen pops up asking for a pin, enter "660" (Other codes that may work if the next page icon is missing are 295660, 3657, 9448, 1791, 1765, 1756, 3366, 296645)

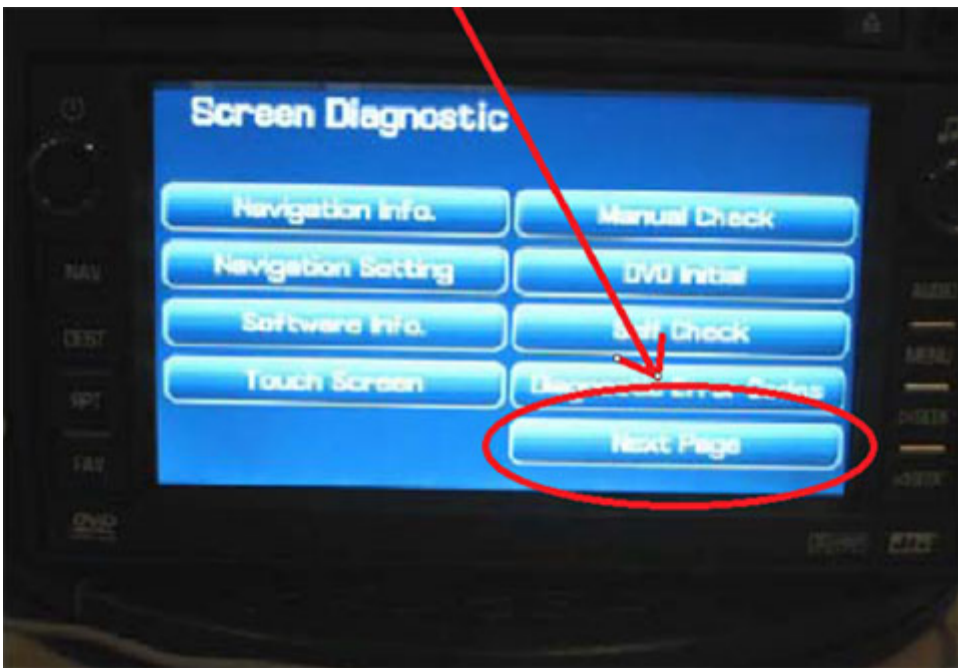
7. Select next page from below the list

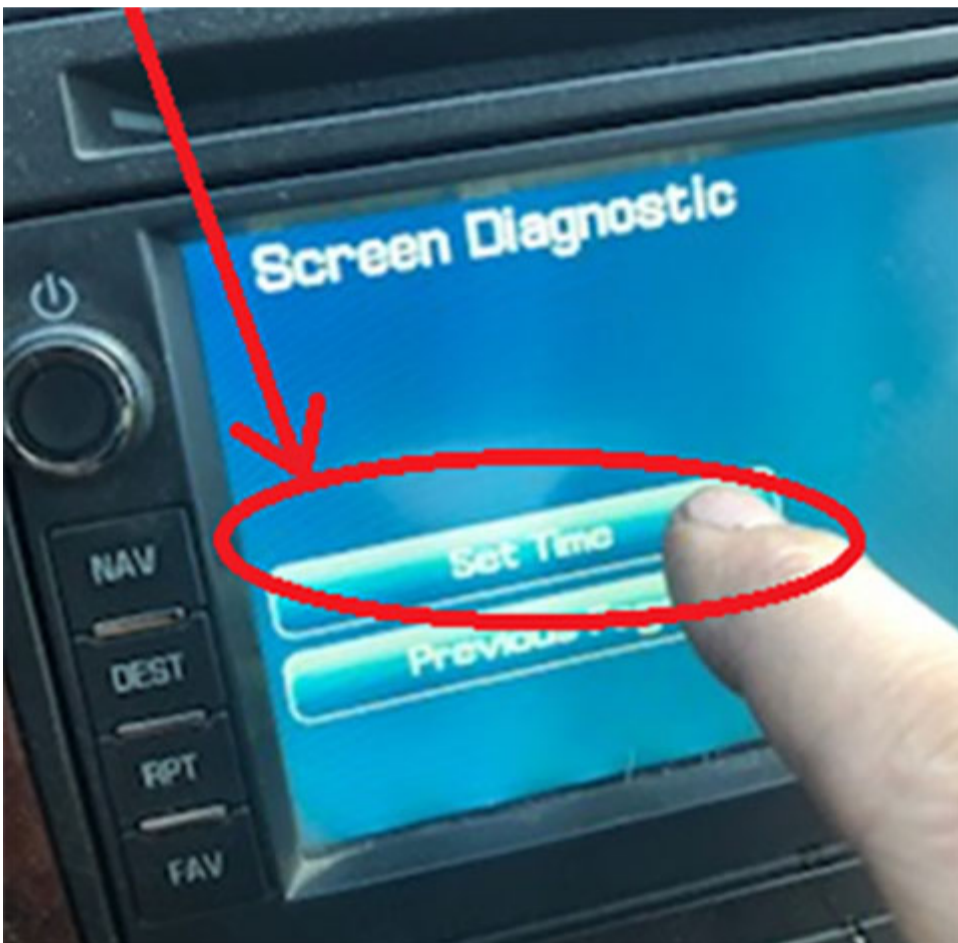
8. Select "Set time"

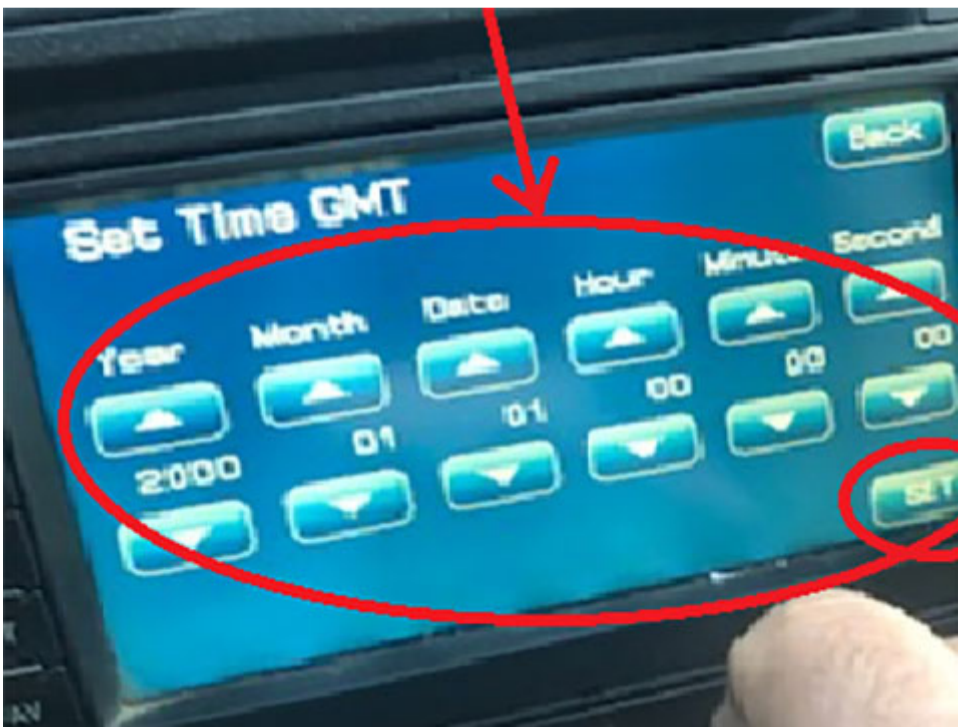
9. Enter the current date and time then select "set" from the lower right of display

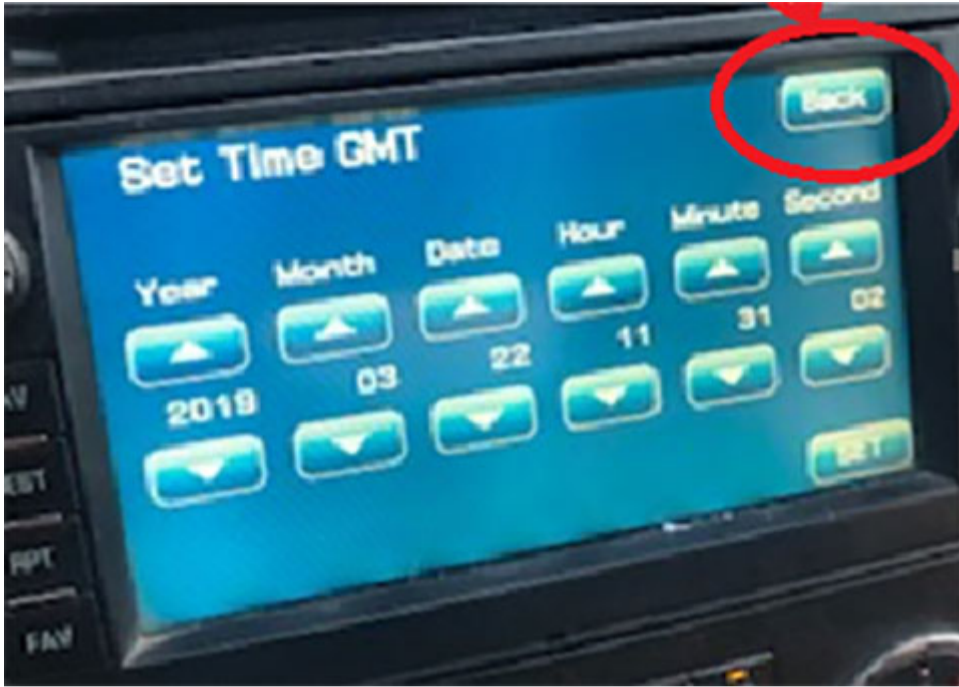
10. Press "back" to return to previous screen
