Business Class M2  
> Cascadia  
108SD/114SD  
> New Cascadia

**Freightliner  
Service Bulletin**

# Exhauster Splash Covers Do Not Fully Latch

# 60-165

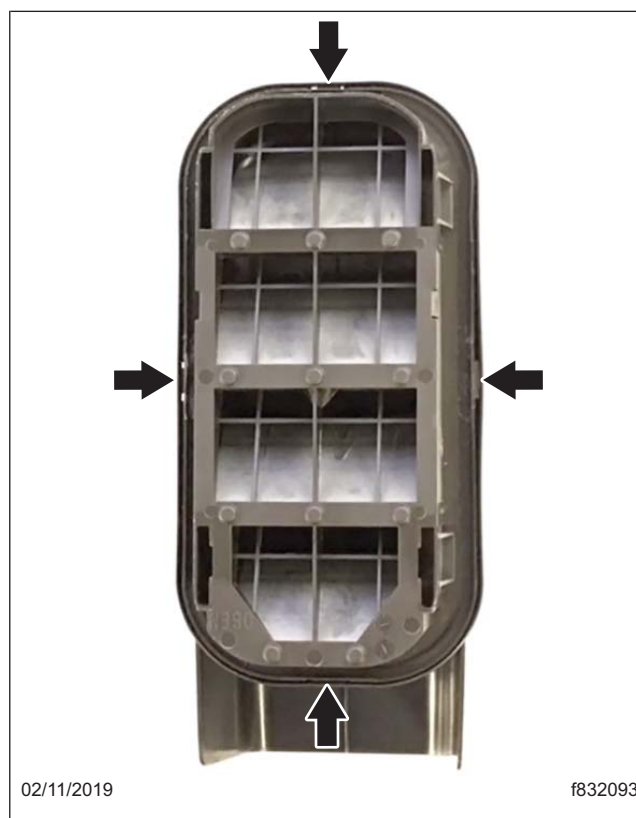
See [Fig.1](#) for the location of the latches on the cab exhauster that snap into the cab exhauster splash cover.

**Fig. 1, Location of Cab Exhauster Latches for Cab Exhauster Splash Cover**

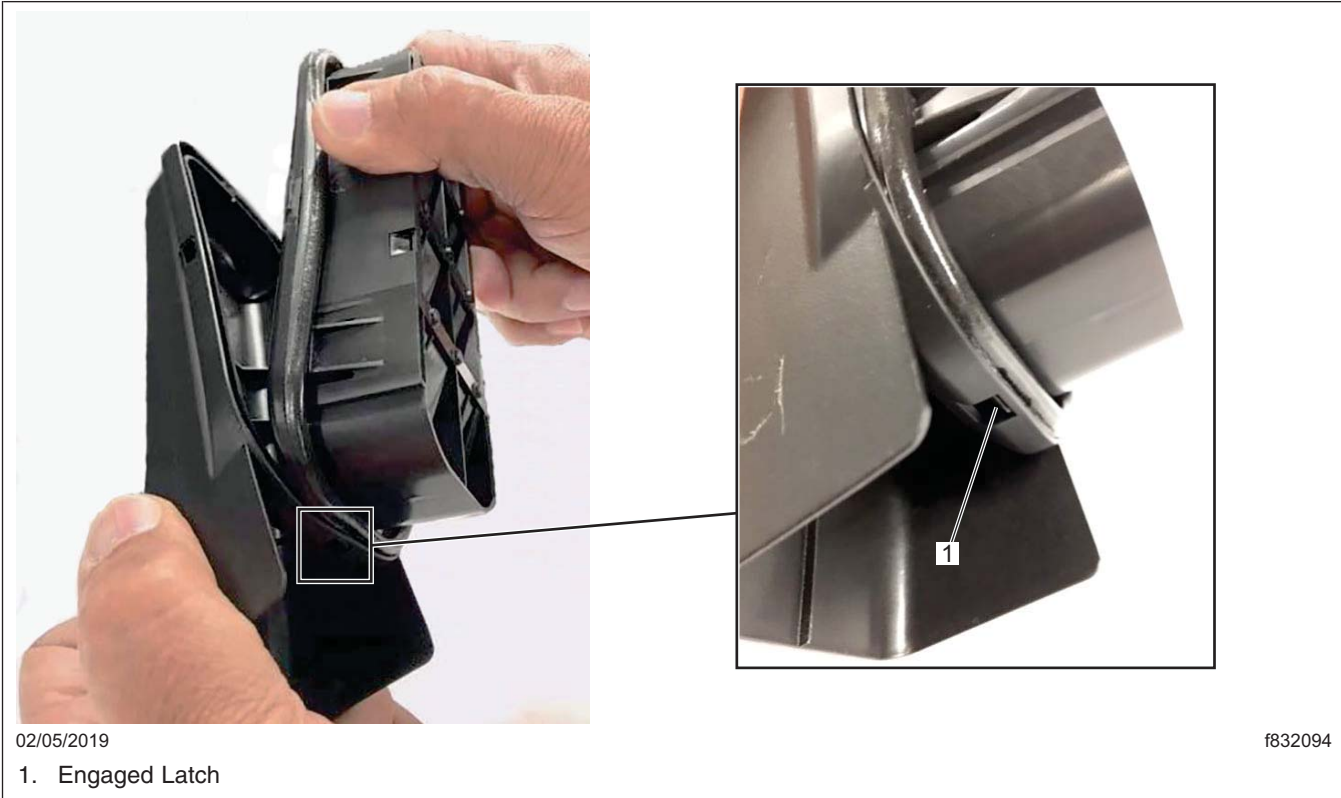
**Fig. 2, Engaging the Bottom Latch**

3. Fully engage the bottom latch of the cab exhauster with the splash cover (part number 22-73755-000). There should be an audible click when the latches engage. See [Fig. 2](#).

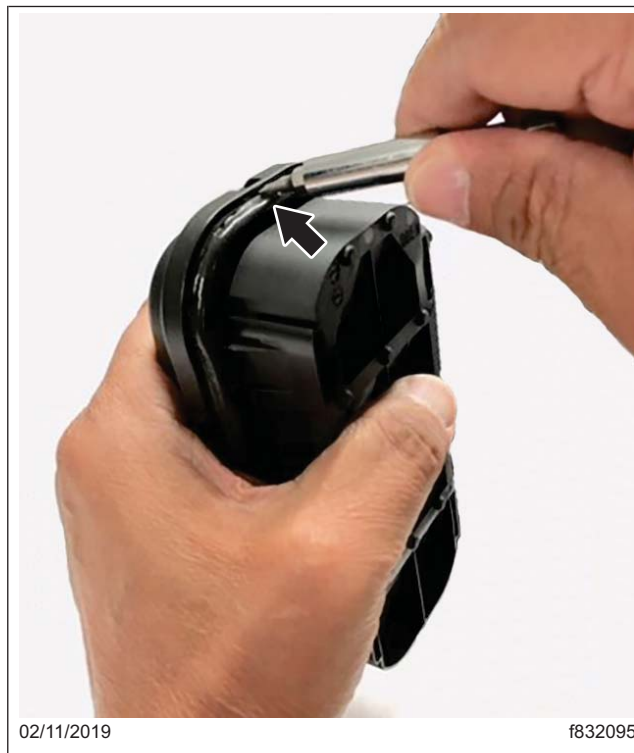
**Fig. 3, Engaging the Top Latch**

4. Firmly hold the cab exhauster and splash cover together, then using a flat-headed screwdriver, push the latch tab to engage the top latch. See [Fig. 3](#).

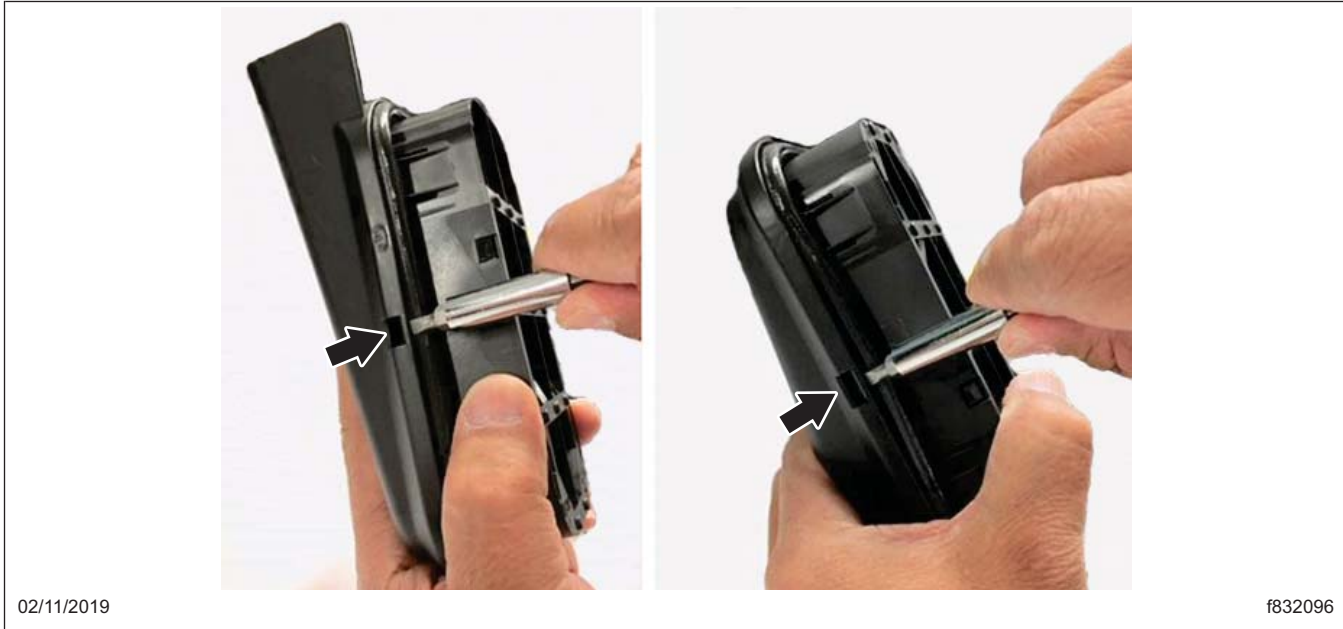
**Fig. 4, Engaging the Side Latches**

5. Use the flat-head screwdriver to push the latch tabs to engage the side latches. See [Fig. 4](#).

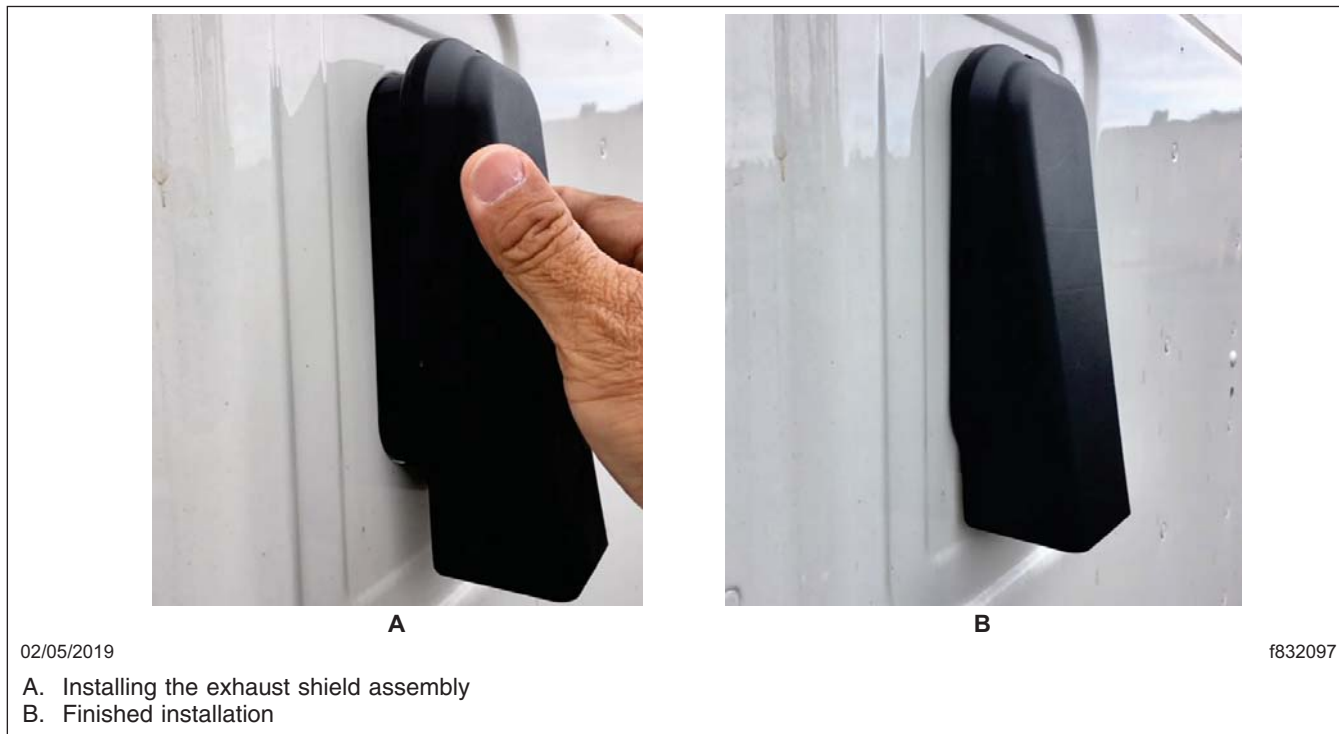
**Fig. 5, Installing the Assembly on the Back Wall of the Cab**

6. Install the assembly into the back wall of the cab, pushing it into place. It should be flat against the back wall of the cab and feel firmly set in place. See [Fig. 5](#).
