# SS 1034216 Detroit Assurance Radar Front End Shipping Label

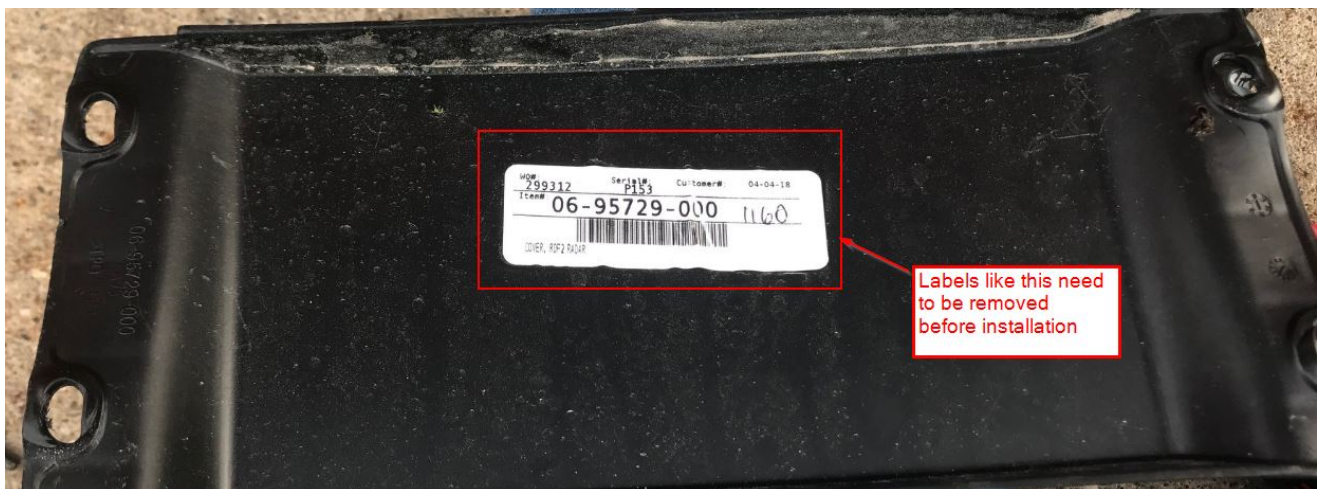
It has been reported that in some cases shipping labels were affixed to the inside center of the front cover. The shipping label have since been moved to the outer edge of the front cover, which does not affect the RDF's ability to properly sense obstacles located in front of the vehicle.

If a new RDF cover is received with a shipping label located on the face of the front cover it should be removed (reference picture below).
