IMPORTANT SAFETY RECALL

SAFETY RECALL # 19V264

Hackney has decided that certain model year 2018-2019 Beverage style bodies have a potential defect in the ASA Electronics rearview camera system.

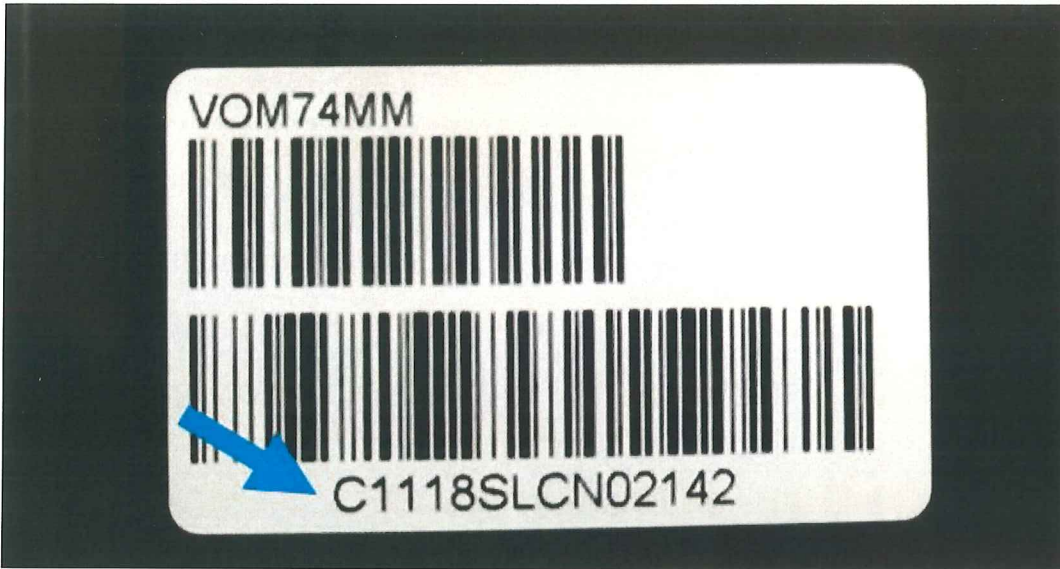
Picture of the serial number found on your Monitor.

This decal is visible without removing the monitor from the vehicle.

The serial numbers associated with the mirror monitors start with an "A", "B", or "C".

To assure the correct repair kit is provided please forward the monitor VOM74MM serial number see page 2 of this document for information on locating the serial number. Hackney will contact ASA Electronics and have the materials forwarded at no cost to you. The repair labor will also be covered at no expense to you. The repairs to the camera harness may take up to 30 minutes.
