| DOC # | PROCESS NAME | PAGE | REVISION | STATION | BY | DATE |
|---|---|---|---|---|---|---|
| AR868 | 2018 SOI Door Shift Interlock | 1 of 1 | - | SER-E | C.Ward | 6/5/2019 |

**Complaint:** Ability to shift unit in gears with doors open and park brake off

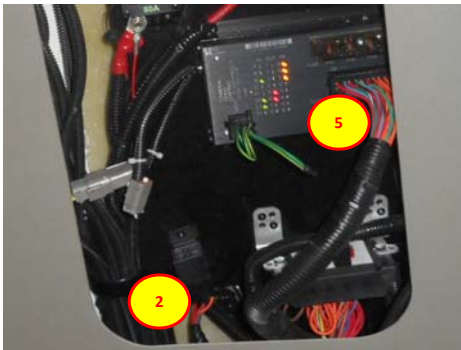
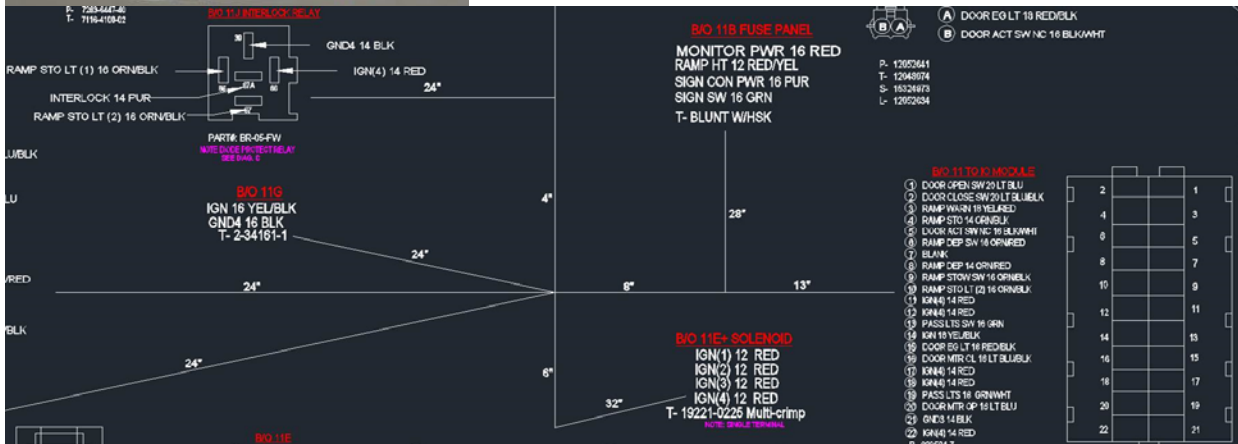
Step 2: Locate and de-pin the 14 AWG Purple Wire (87A) in the relay located to the lower left of the I/O controller.

Step 3: For the wire removed in previous step - cut pin connector from wire, strip wire, and butt connect to the red wires in the jumper harness.

Step 4: Connect the black wire with pin into 87A which purple wire was removed.

Step 5: Remove the plug connector on the I/O Control Module.

Step 6: Locate pin 5 (Door ACT SW NC 16 BLK/WHT) wire.

Step 7: With adequate slack, splice into the wire, strip, and butt connect to the white wire in the jumper harness.
