# Keystone RV Company

## SERVICE ADVISORY # 19-352

### Hideout 262RES TV Panel Support

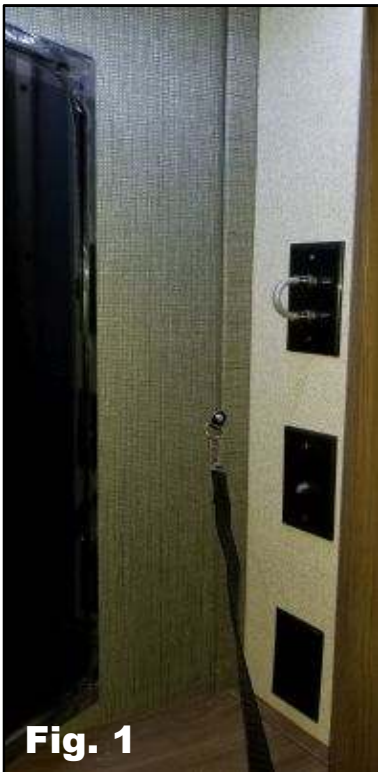
**Fig. 1**

Remove the two pieces of vertical trim (on either side of the TV panel) and the travel strap. TV does not need to be removed, Figure 1.

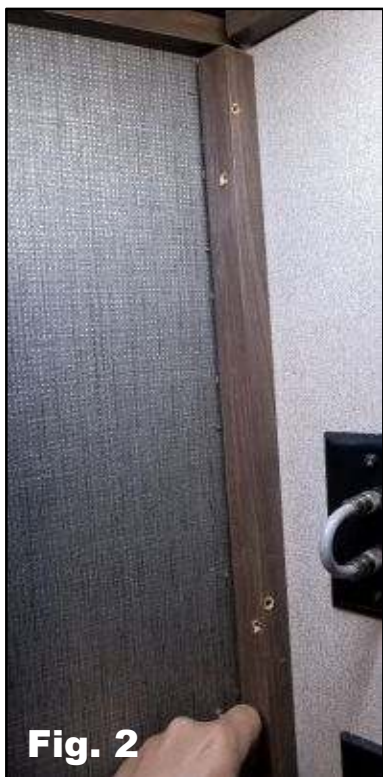
**Fig. 2**

Measure and cut two pieces of stile as shown in Figures 2 and 3. **Please note:** The stiles must be pre-drilled to prevent damage, Figure 2.

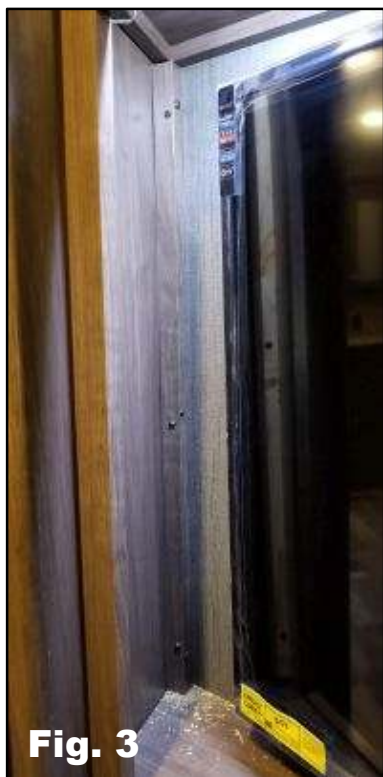
**Fig. 3****Step 3**

Pre-drill six pilot holes per stile and attach the stiles using #8 – 1 3/4" washer head wood screws on the right and left side of the TV back panel as shown in Figure 3.
