LATEST VEHICLE CONCERN FIXES

Check Engine Lamp with DTC P026B	18-19 MY Range Rover and Range Rover Sport equipped with AJ133
<p><u>Customer Voice:</u></p> <ul style="list-style-type: none">- The Check Engine Lamp is on. <p><u>Technical Description:</u></p> <ul style="list-style-type: none">- DTC P026B-00 and injector specific DTC are stored in the PCM.- DTC may appear as 185733 Undefined. <p><u>Status:</u></p> <ul style="list-style-type: none">- Inspect the electrical circuit between the PCM and injector including inspection of connectors, pin fit and proper pin tension. If no faults are identified in the circuit, raise a TA for diagnostic support.- We are currently seeking a faulting vehicle at a retailer to fit a logger to in order to gather data to support root cause analysis.

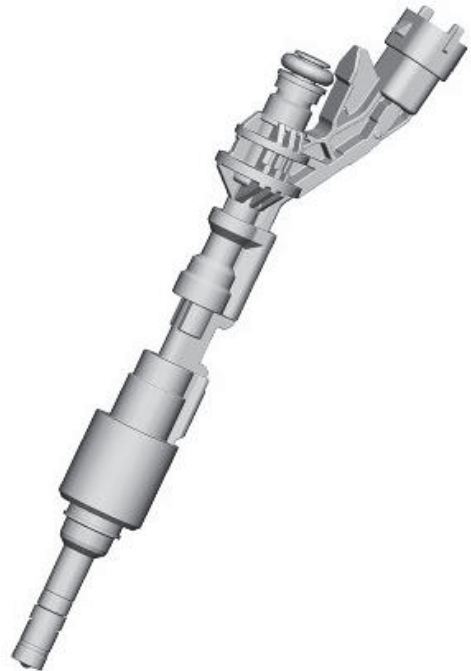
A detailed 3D CAD rendering of an AJ133 injector. The component is shown at an angle, highlighting its complex mechanical structure, including the nozzle at the bottom, the body, and the electrical connector at the top.
